Rehabilitation Evaluation Report  
for the  
Chestnut Street (S.H. 150) Pedestrian Bridge Over the  
Colorado River in Bastrop, Texas

Prepared for:

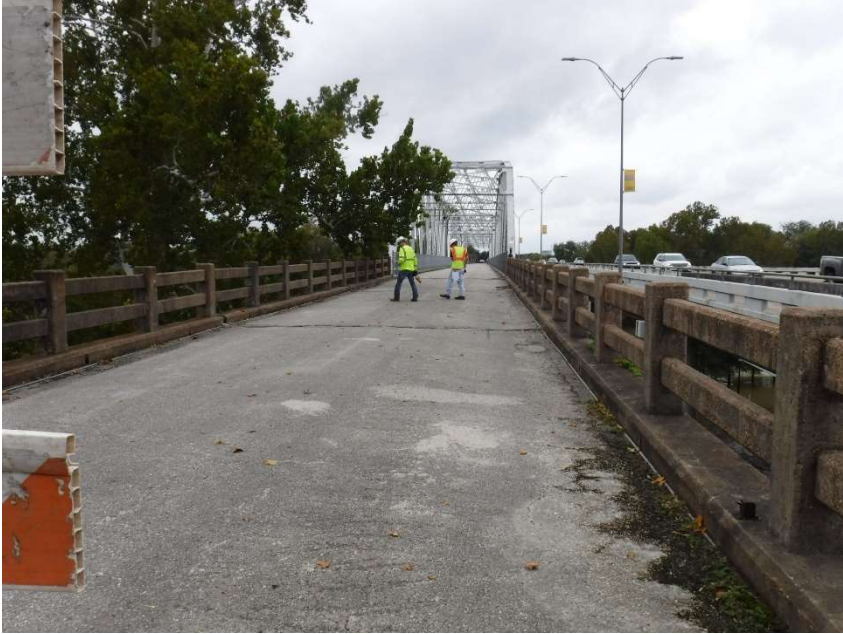
Photo 1 - East Approach Bridge Deck (Spans 1-3)

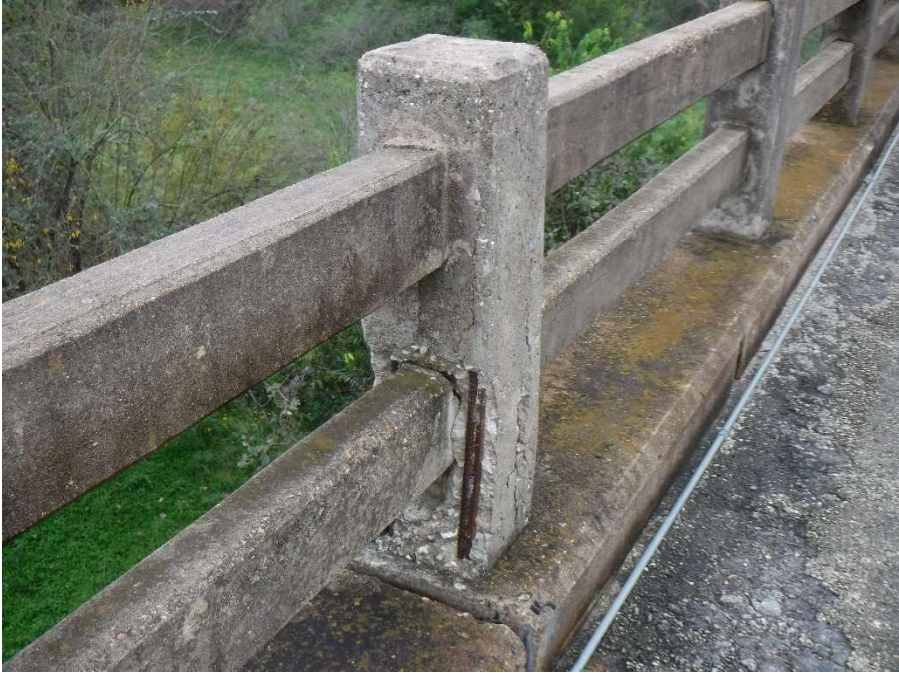
Photo 12 - Delamination and Cover Spalling at South Rail Post over Bent 13

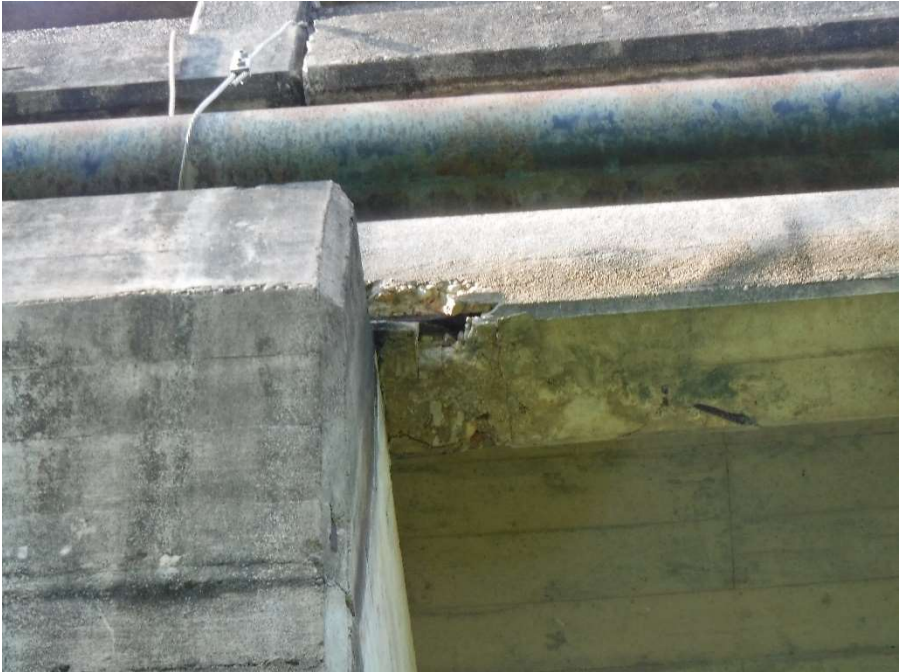
Photo 13 - Cover Spalling on T-beam 1 over Bent 14

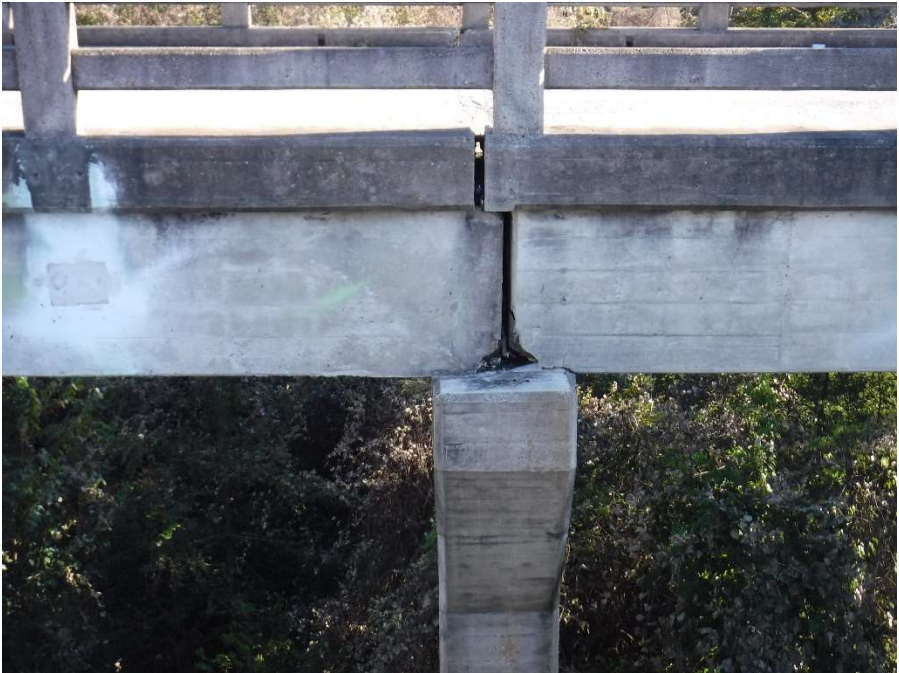
Photo 14 - Cover spalling at T-beam 4 over Bent 8

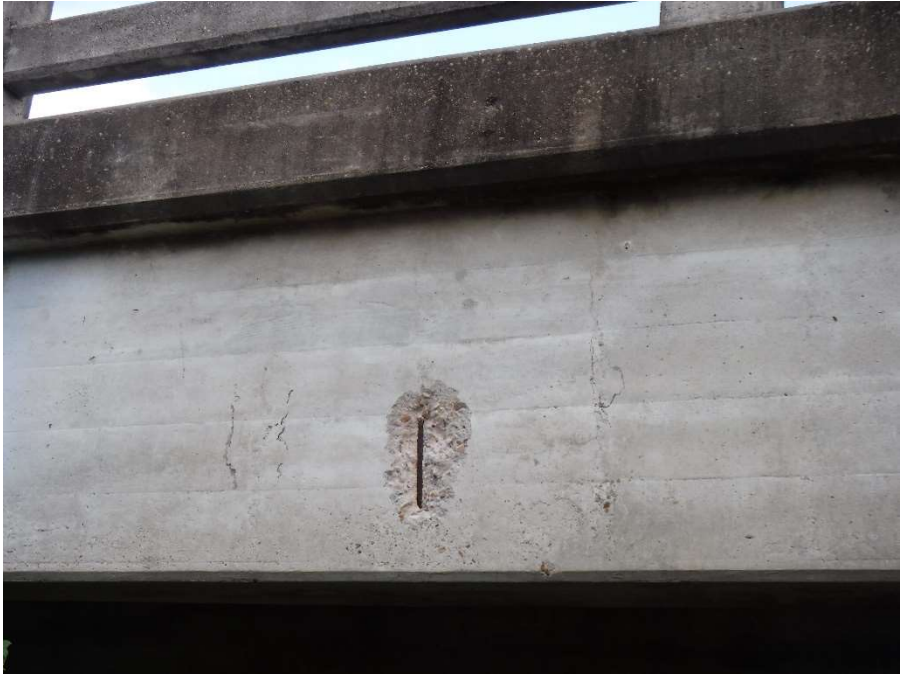
Photo 15 - Delamination and Cover Spalling on Stem of T-beam 4 at Span 21

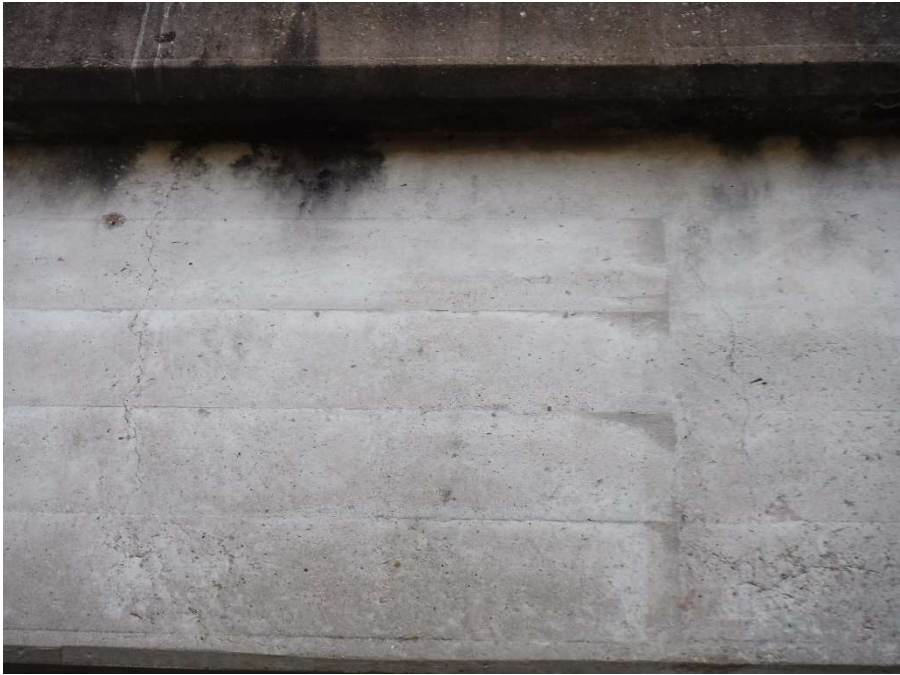
Photo 16 - Transverse Cracking on Stem of T-beam 4 at Span 21

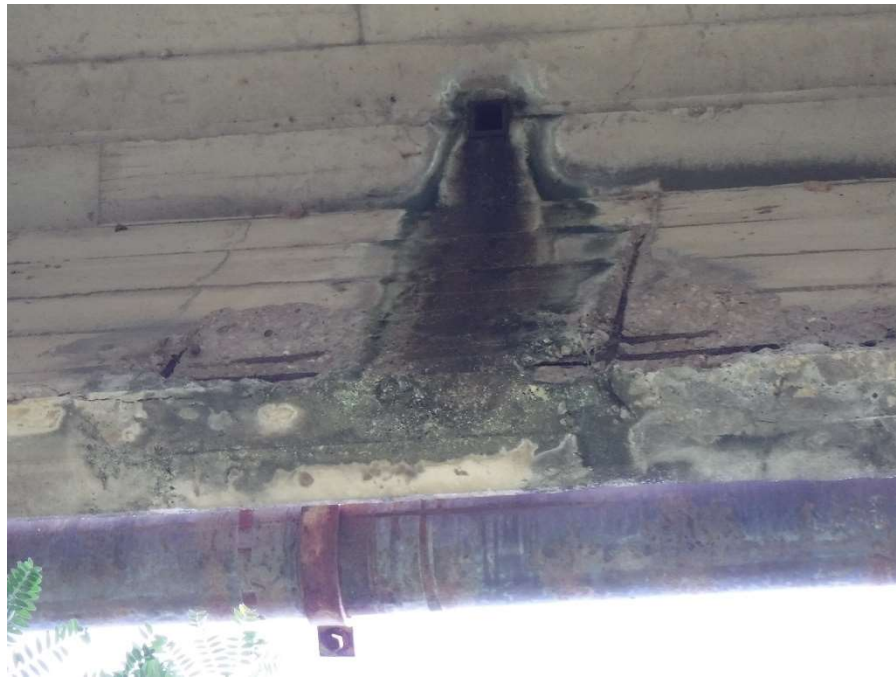
Photo 17 - Transverse Cracking and Cover Spalling on Inside Face of T-beam 1 at Span 13 Drain

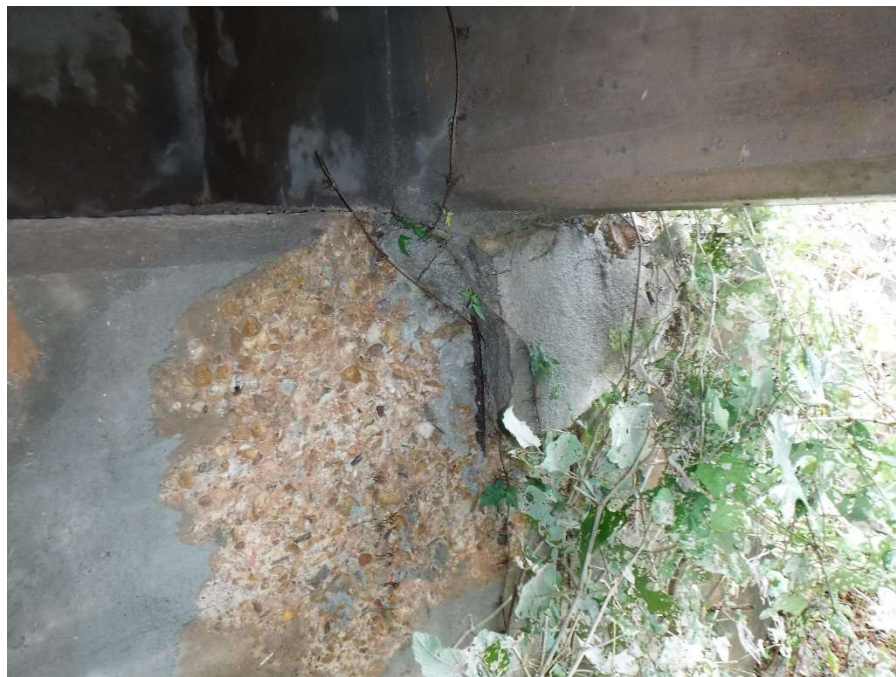
Photo 18 - Cover Spalling on West Abutment Cap

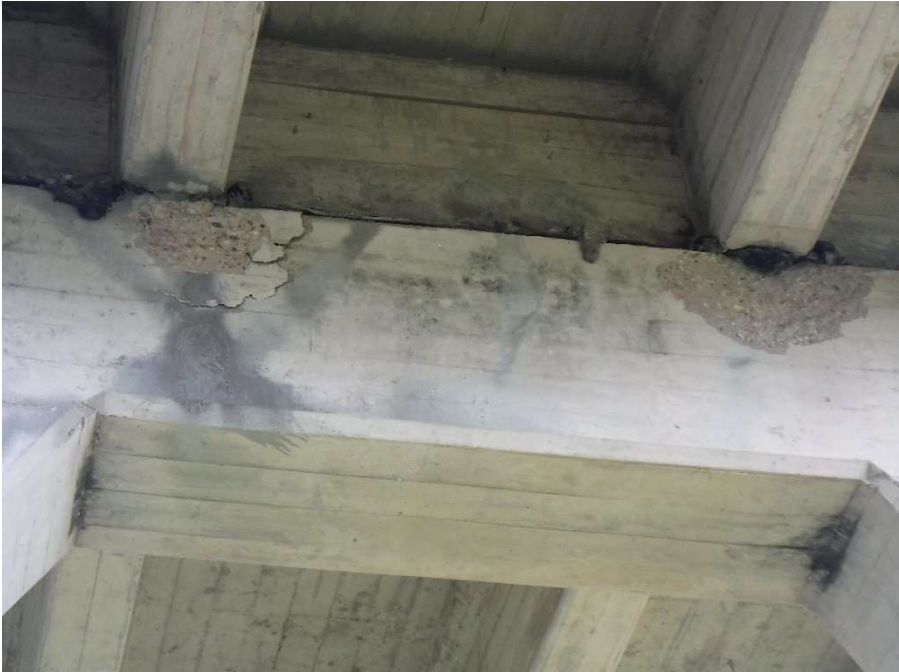
Photo 19 - Delamination and Spalling at Bearing Areas on Bent 13 Cap

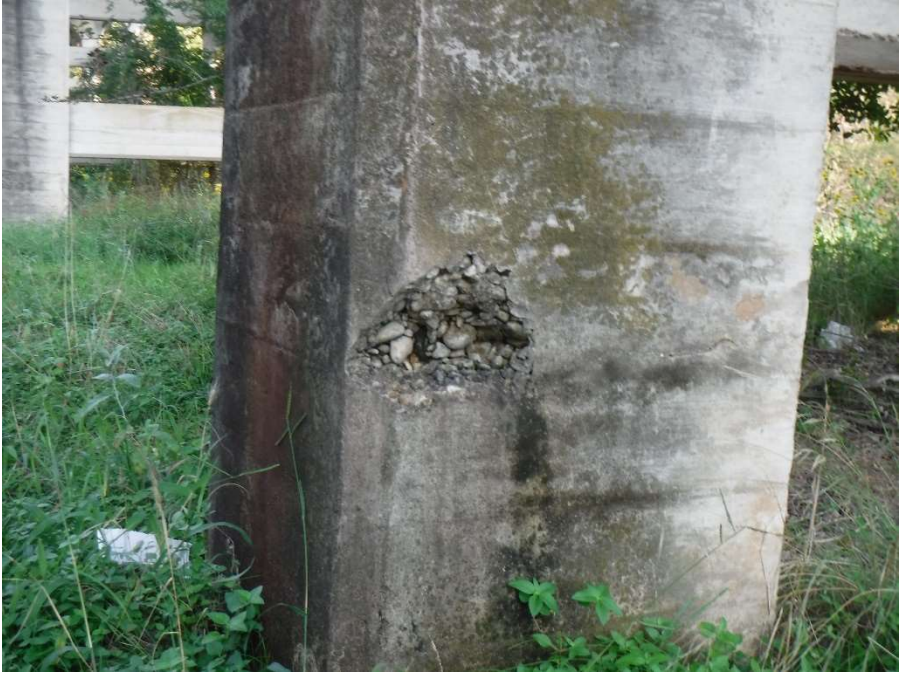
Photo 20 - Unconsolidated Concrete Spalling on Column at Bent 14

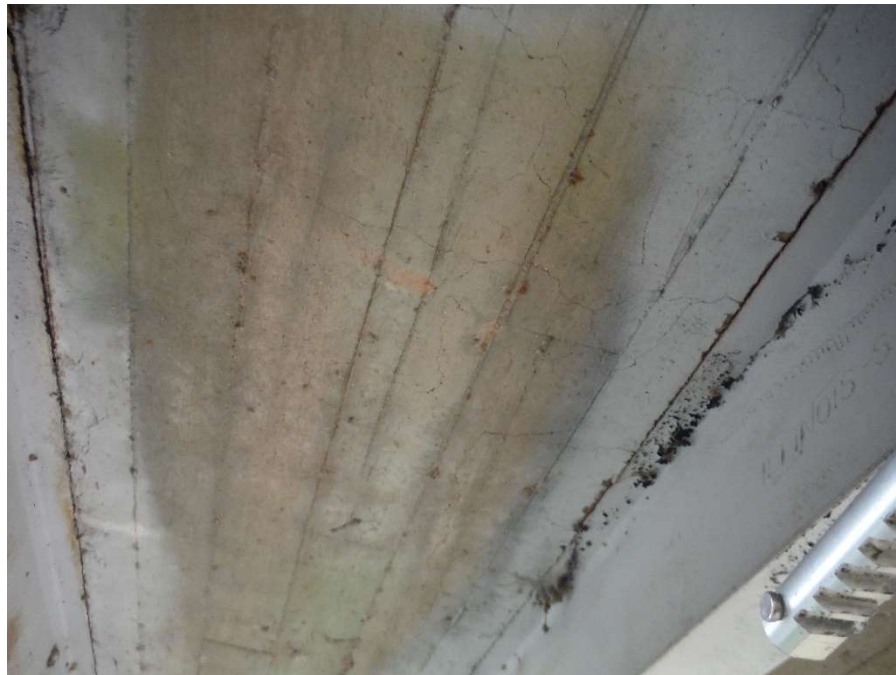
Photo 21 - Typical Cracking on Deck Soffit at Main Spans

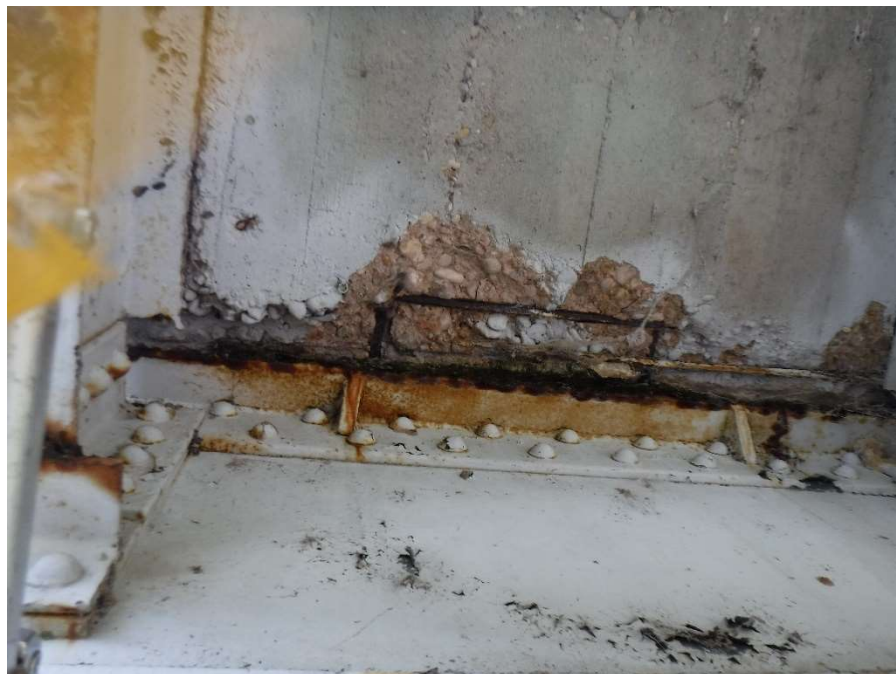
Photo 22 - Typical Spalling on Deck over Floorbeams

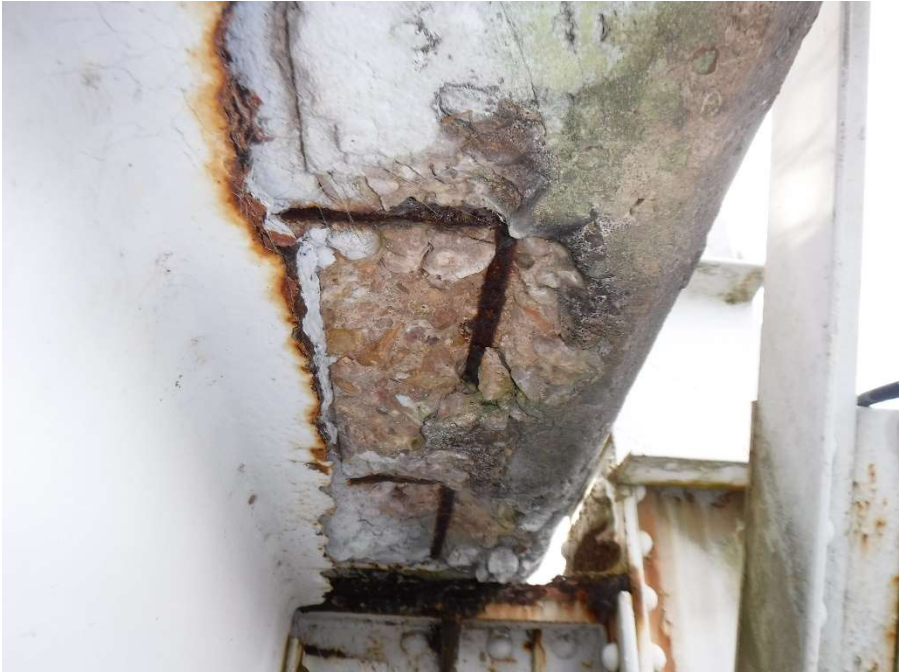
Photo 23 - Typical Spalling on Deck Overhang Near Joint

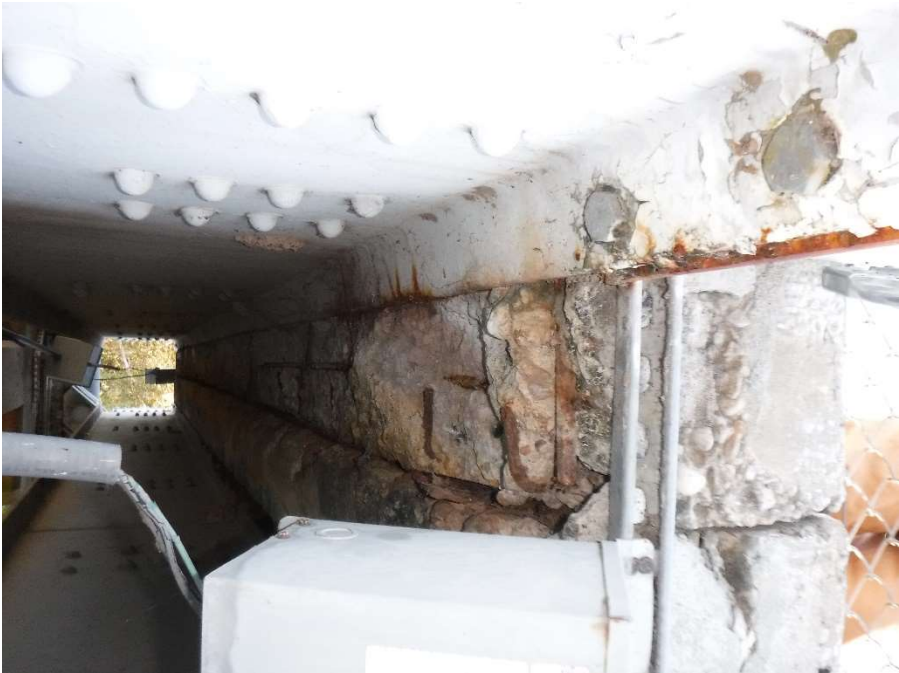
Photo 24 - Cover Spalling on Deck Soffit along Joint at Bent 6

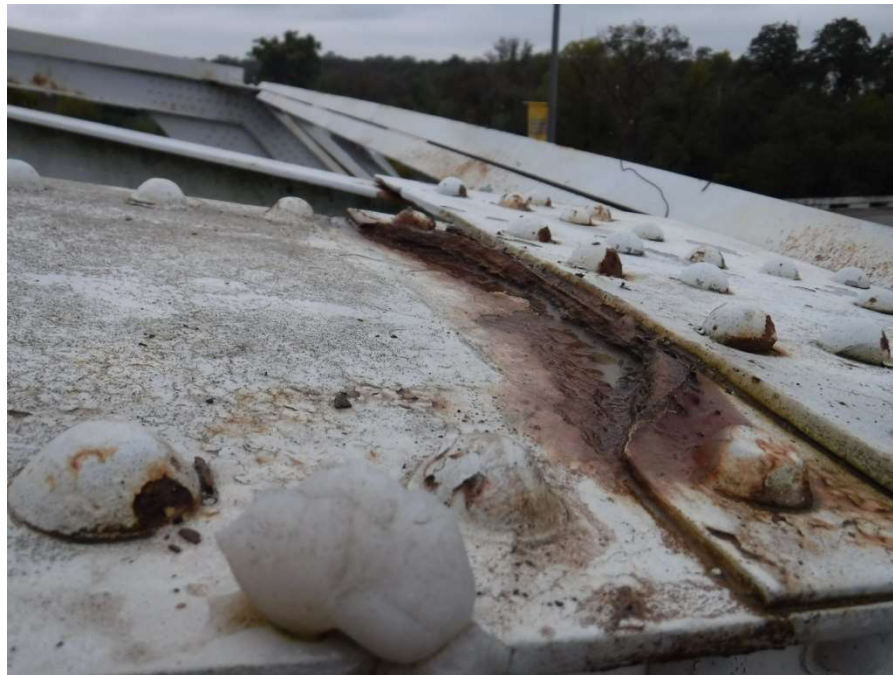
Photo 25 - Typical Condition of Filler Plate and Upper Chord Cover Plate at Joints U1 and U8

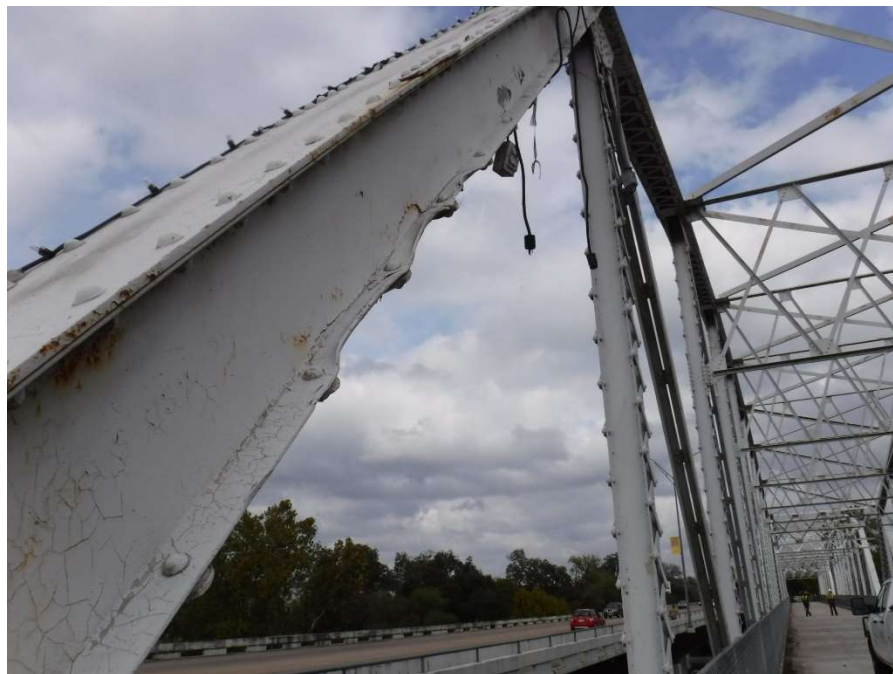
Photo 26 - Typical Local Impact Damage on Upper Chord Member L0U1

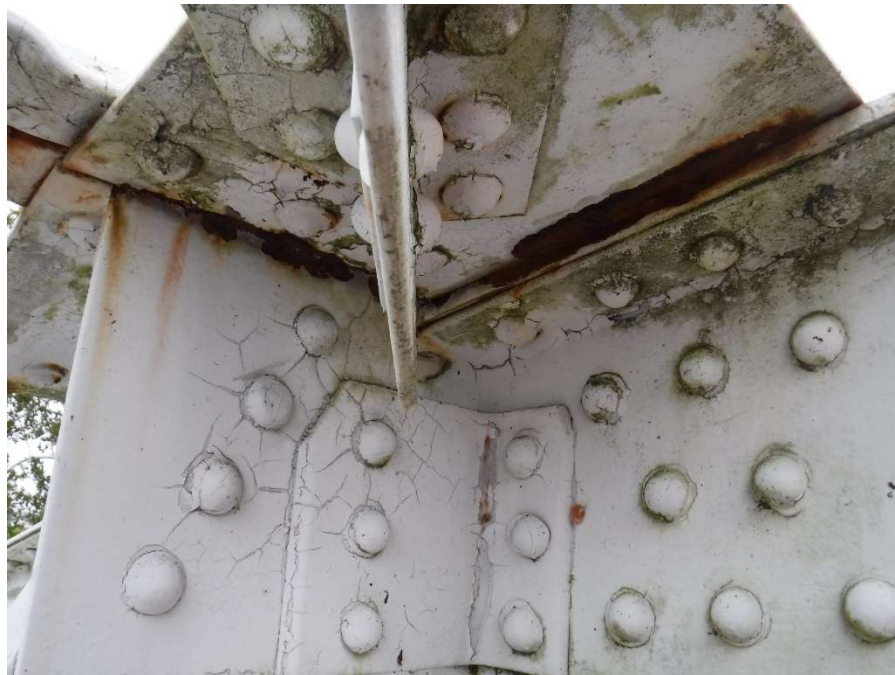
Photo 27 - Typical Section Loss on Horizontal Gusset Plate

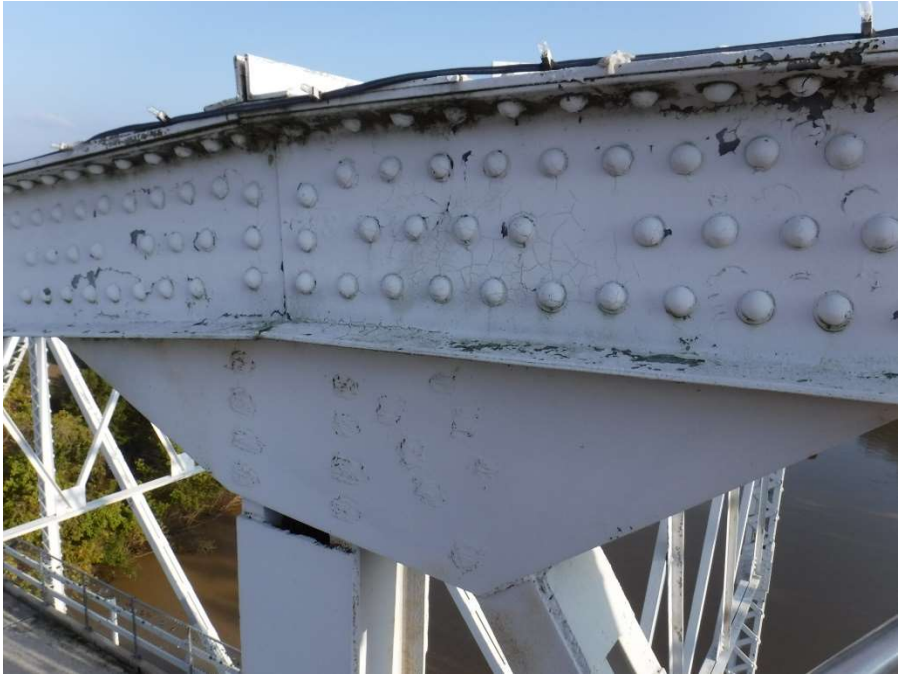
Photo 29 - Repaired Connection to Diagonal and Vertical Members at Joint U6, Truss 2, Span 4

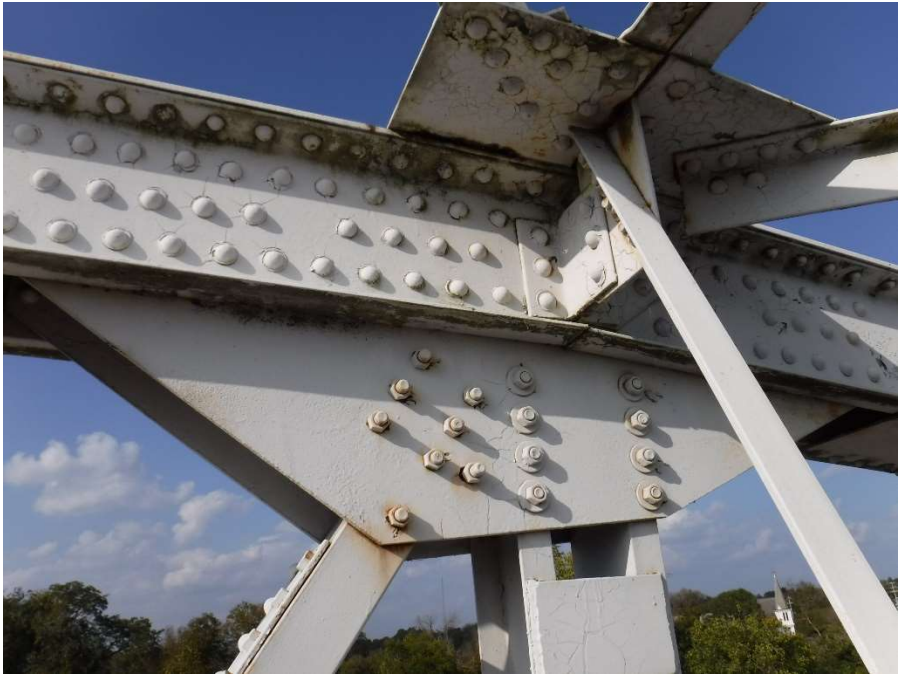
Photo 30 - Repaired Connection to Diagonal and Vertical Members at Joint U6, Truss 2, Span 5

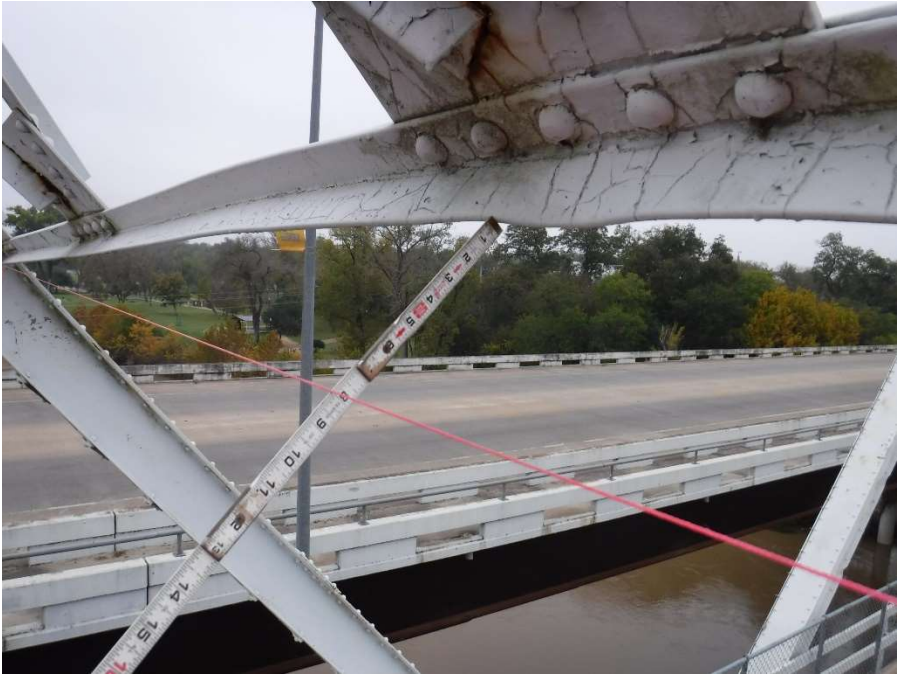
Photo 31 - Impact Deformation up to 8 inches at Lower Chord of Cross Frame at U8 in Span 6

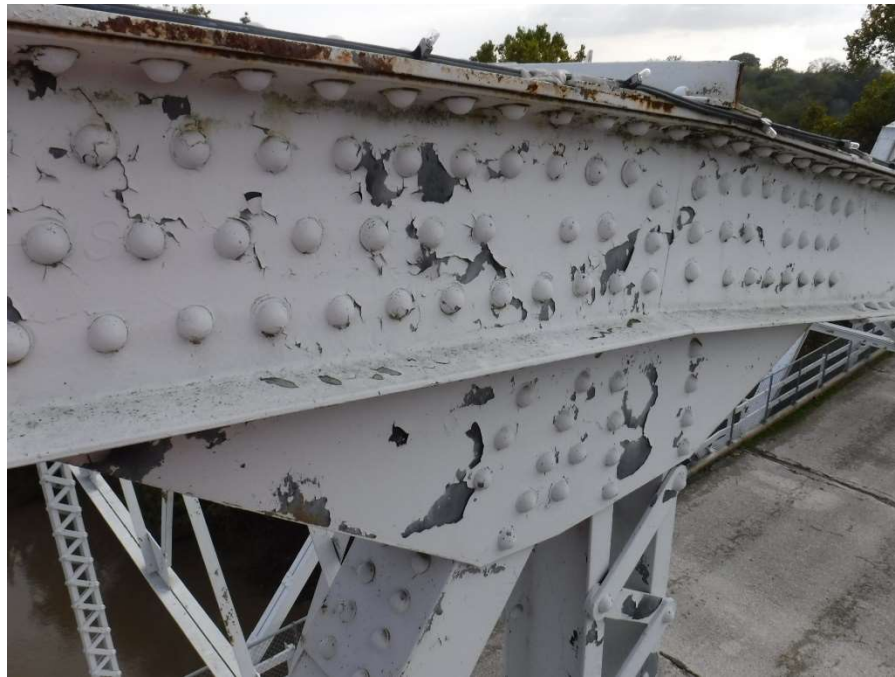
Photo 33 - Typical Paint Failure on Truss Members

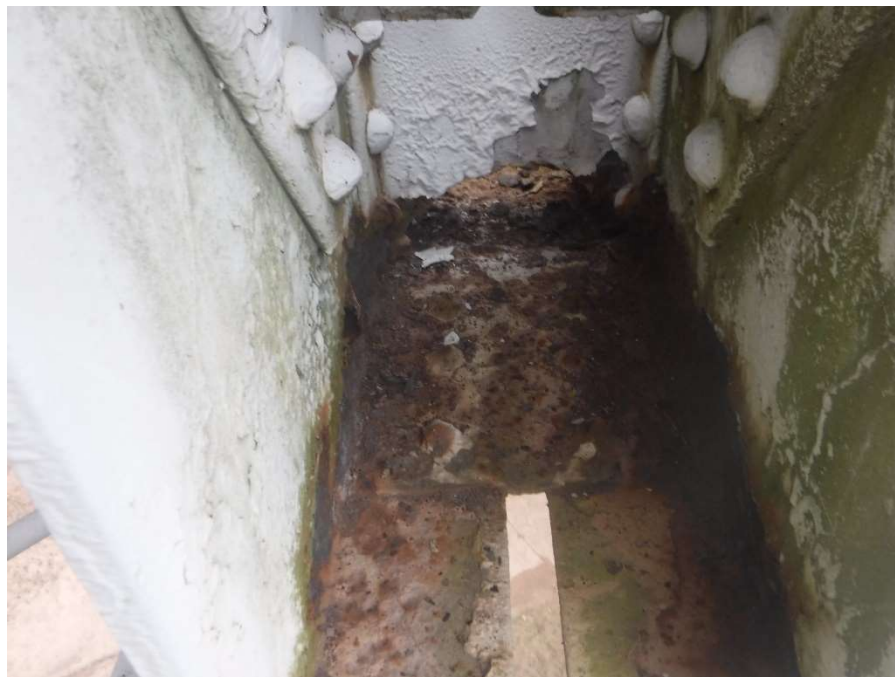
Photo 34 - Typical Condition of Lower Chord Channels

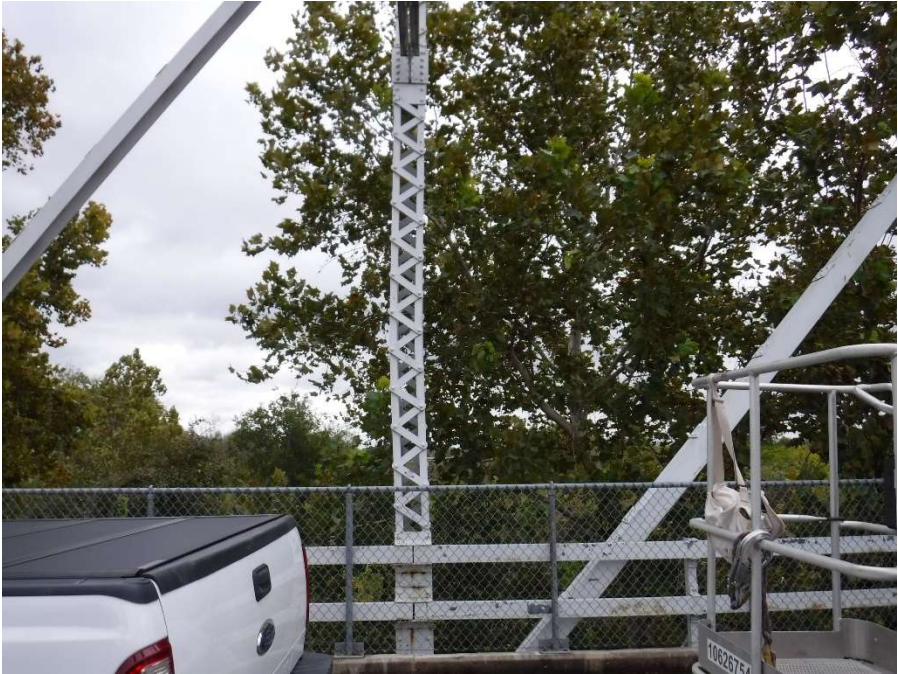
Photo 35 - Condition of Vertical Member L2U2, Truss 1, Span 6

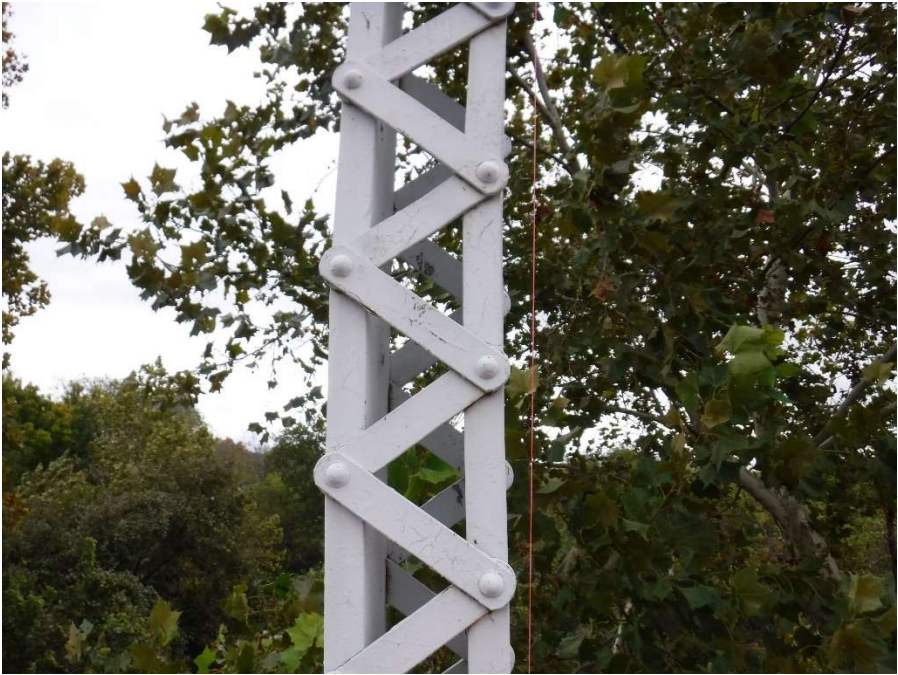
Photo 36 - 2-1/2" Deflection of Vertical Member L2U2, Truss 1, Span 6

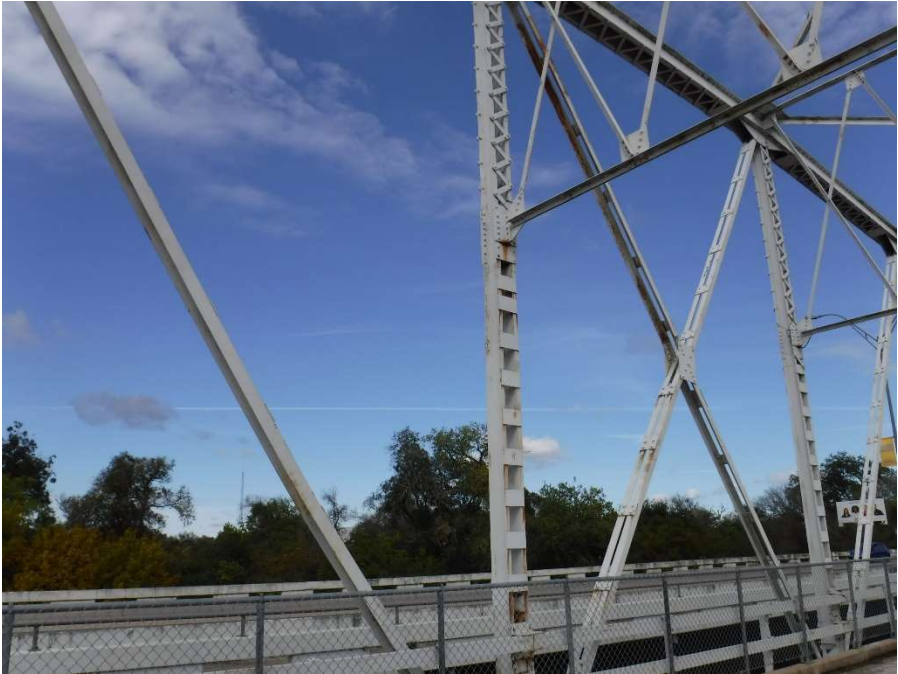
Photo 37 - Lower Half Replacement of Members L4U4 and L5U5 in Truss 2, Span 4

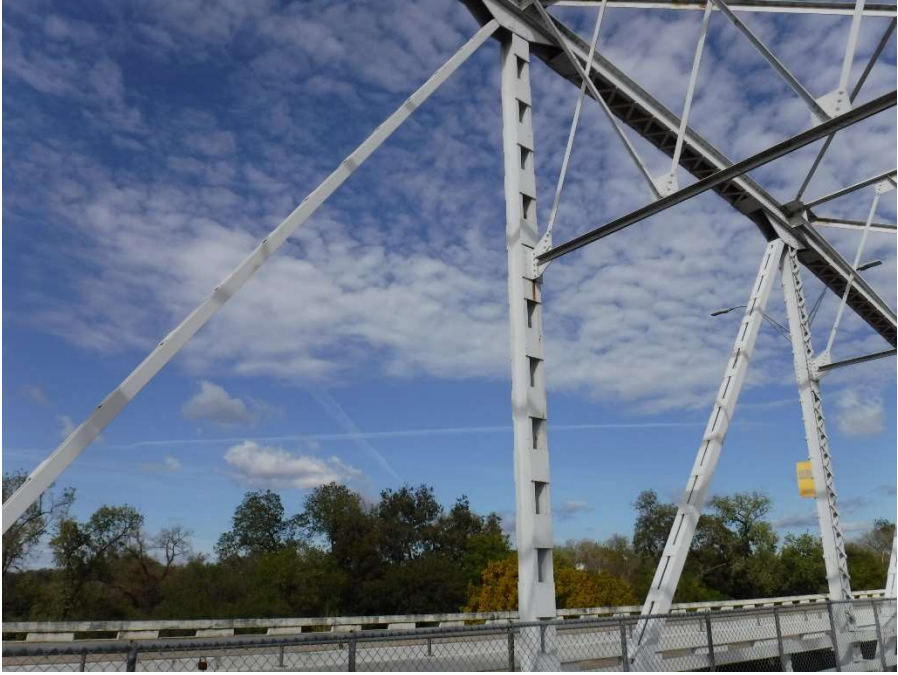
Photo 38 - Full Length Replacement of Member L6U6, Truss 2, Span 4

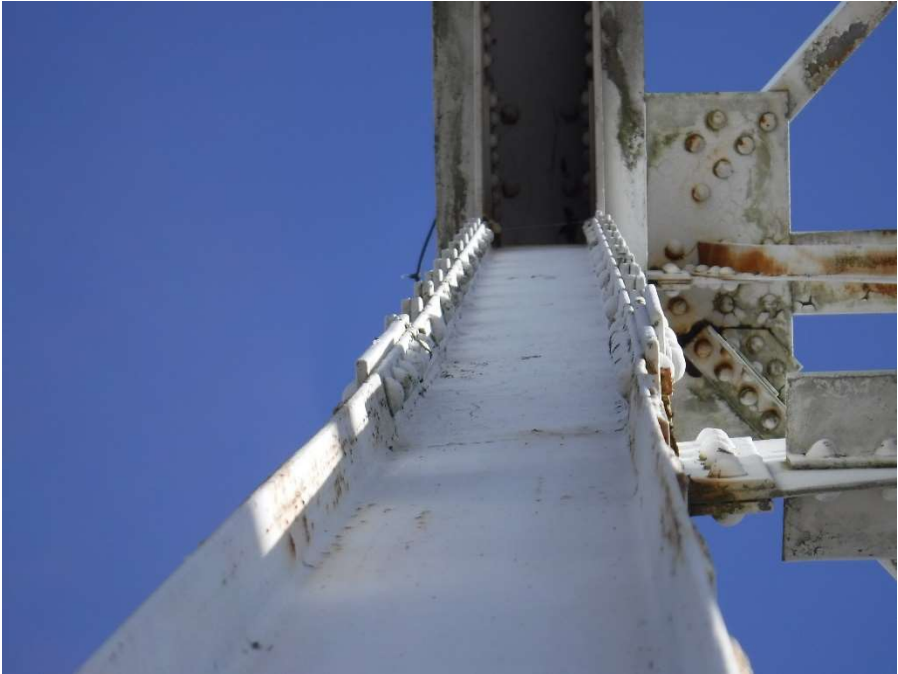
Photo 39 - Butt Weld Joint at Repaired Member L4U4, Truss 2, Span 4

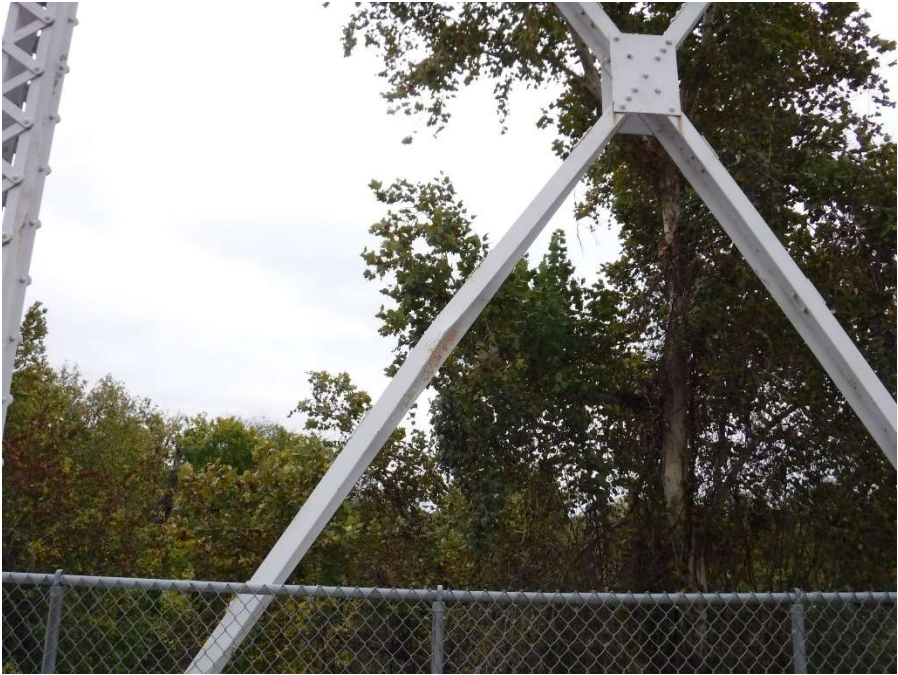
Photo 40 - Torsional Deformation on Member L5U4, Truss 1, Span 6

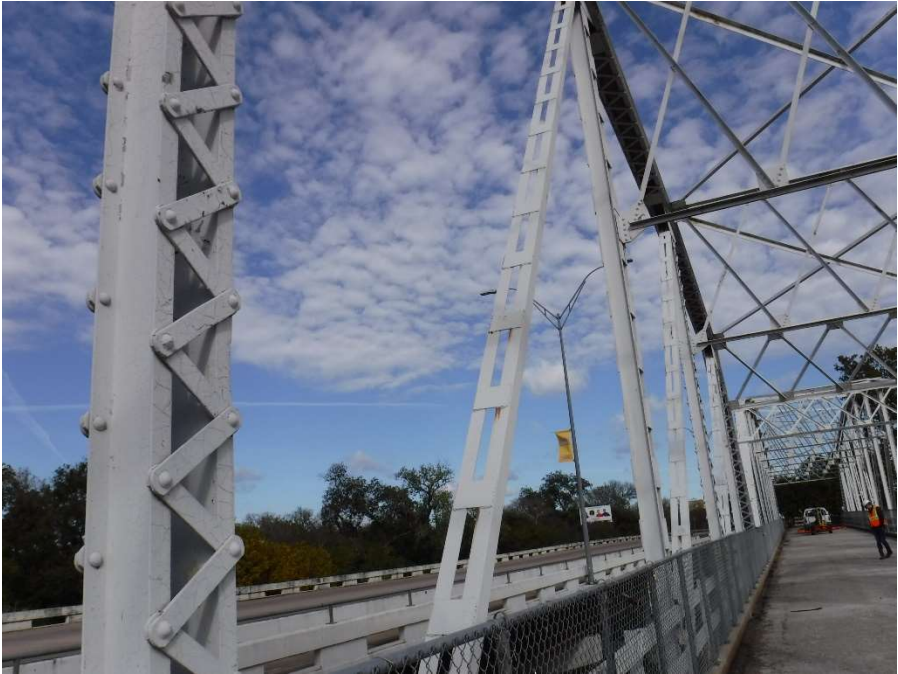
Photo 41 - Full Length Replacement of Diagonal Members L5U6 and L6U7, Truss 2, Span 5

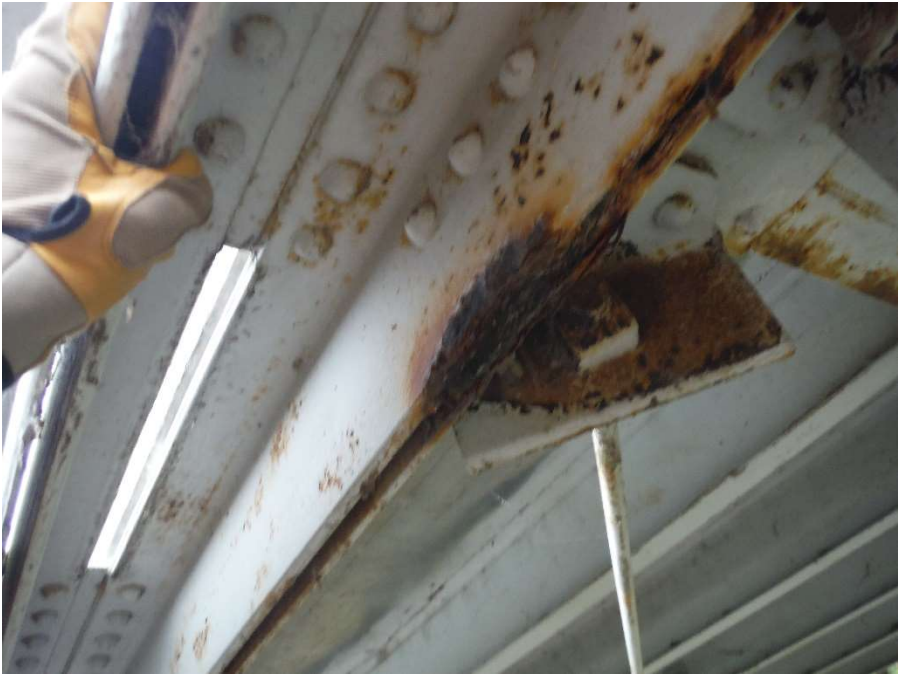
Photo 42 - Typical Pack Rust, Corrosion, and Section Loss on Lower Chord

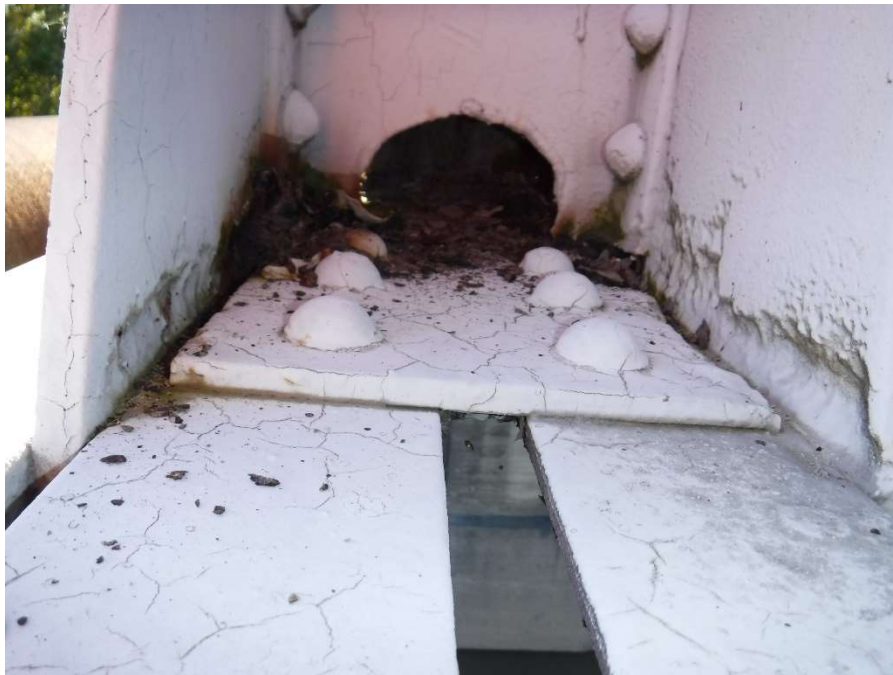
Photo 43 - Typical Gusset Plate Section Loss at Joints L2 through L7 in all Trusses

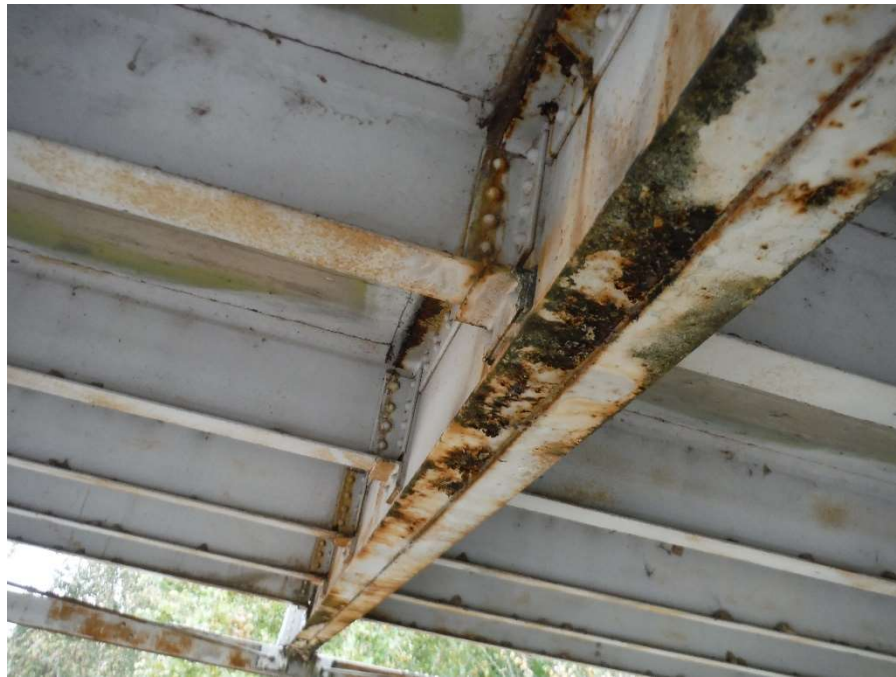
Photo 47 - Typical Interior Floorbeam Condition

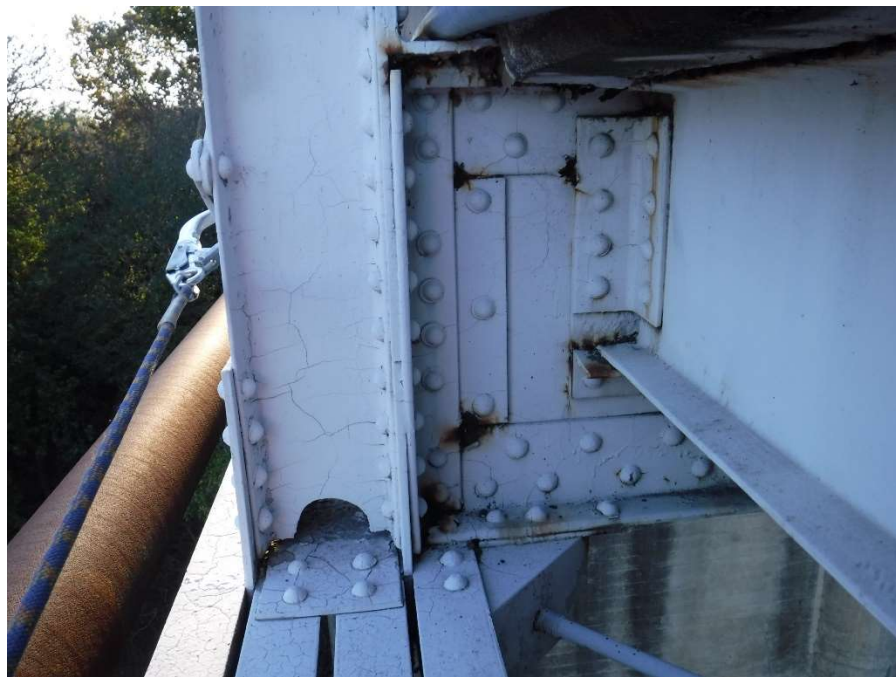
Photo 48 - Typical Localized Pack Rust at Ends of Interior Floorbeam

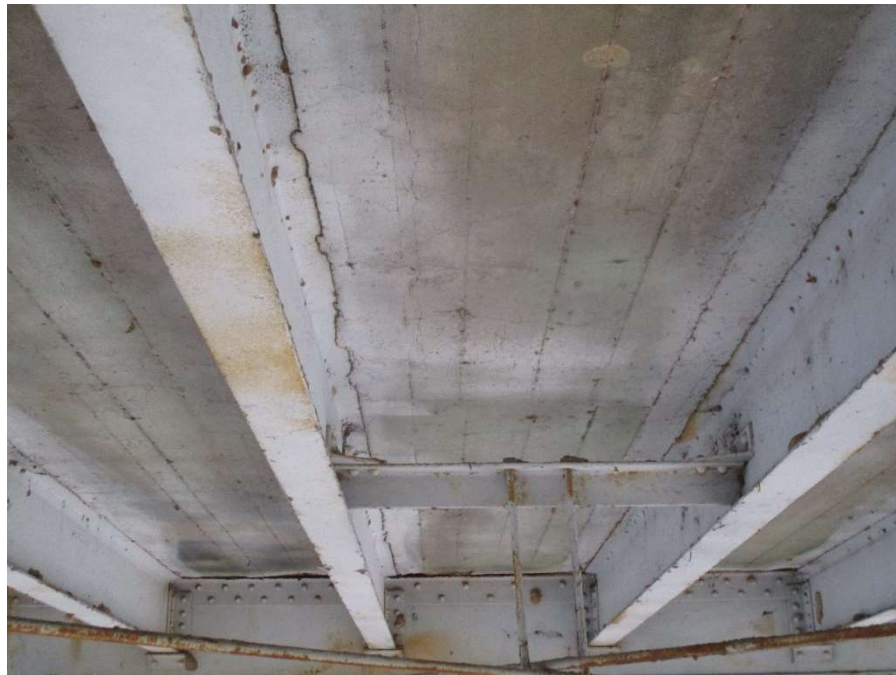
Photo 49 - Typical Section Loss along Stringer Top Flanges

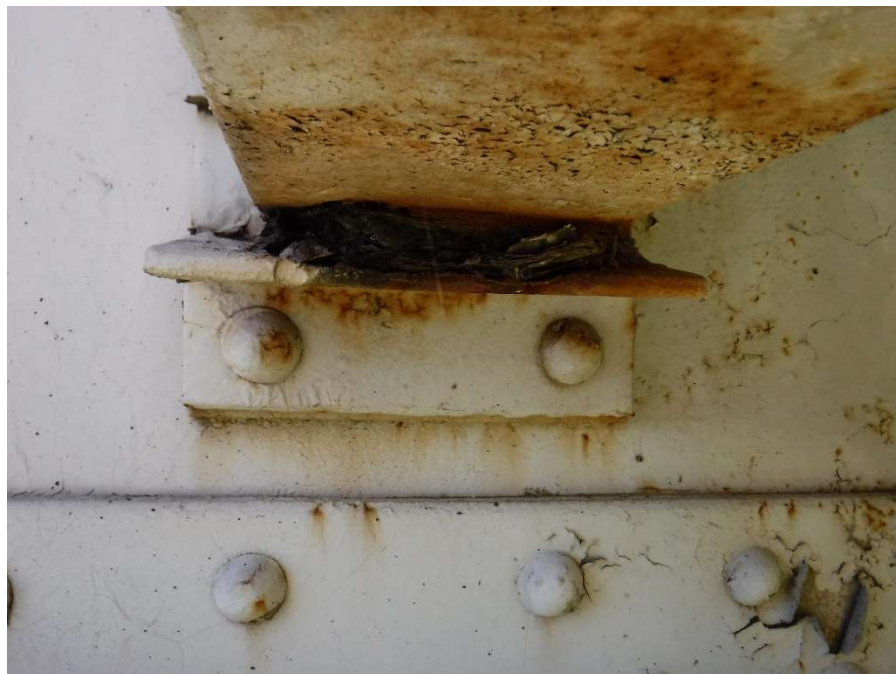
Photo 50 - Typical Pack Rust Condition at Exterior Stringer Bearing Seat

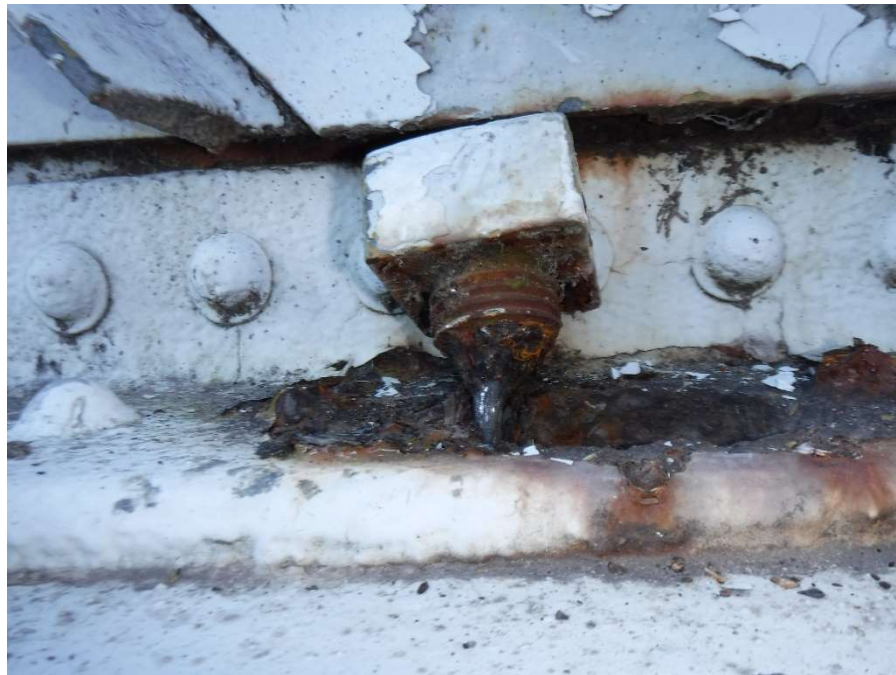
Photo 51 - Section Loss on Exterior Anchor Bolt at Joint L9, Truss 2, Span 5

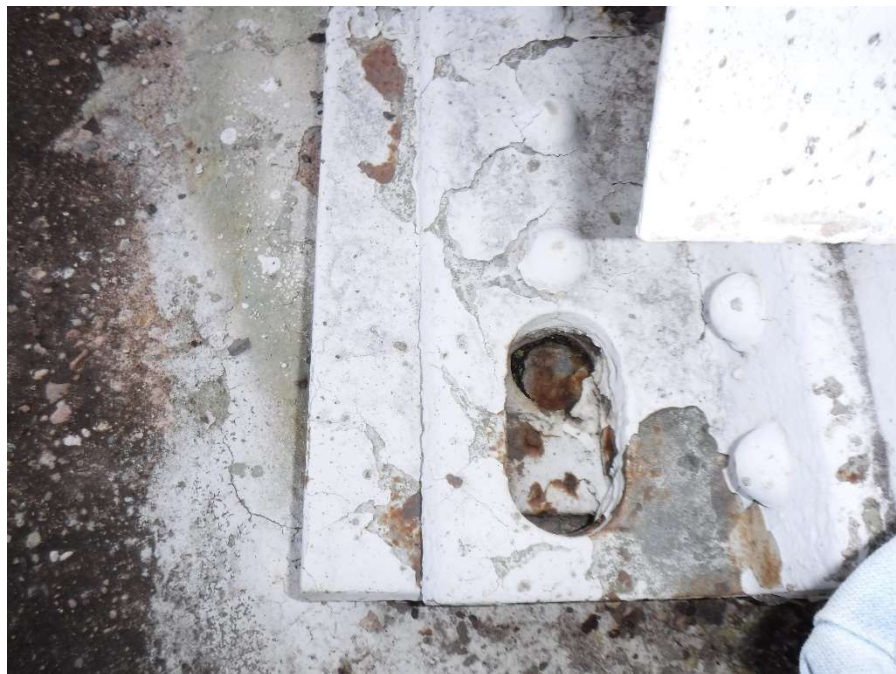
Photo 52 - Failed Anchor Bolt at Joint L9, Truss 2, Span 6
