Rehabilitation Evaluation Report  
for the  
Chestnut Street (S.H. 150) Pedestrian Bridge Over the  
Colorado River in Bastrop, Texas

Prepared for:

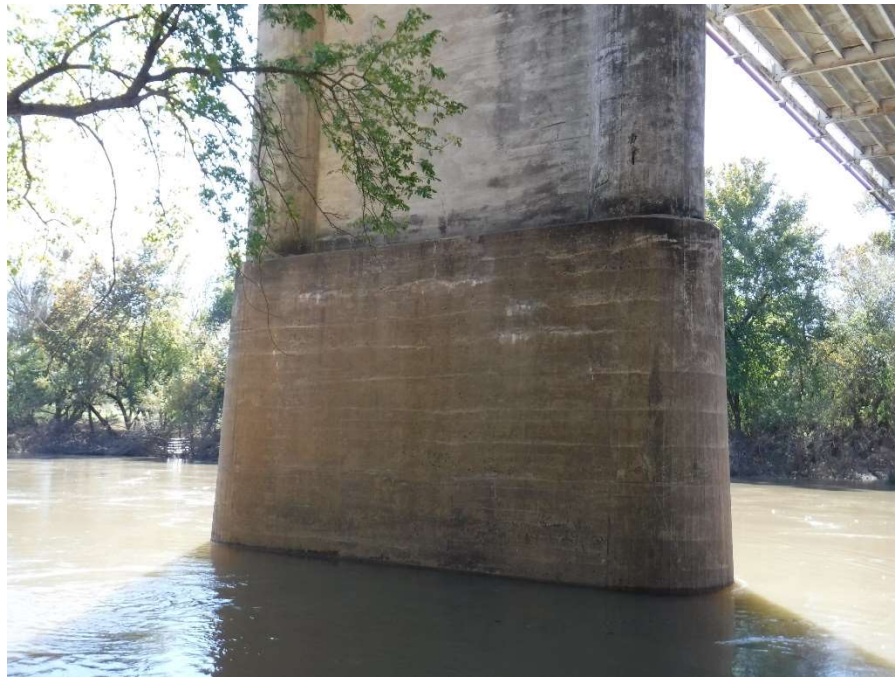
Photo 53 - Horizontal Cracking and Efflorescence on East Face of Pier 5

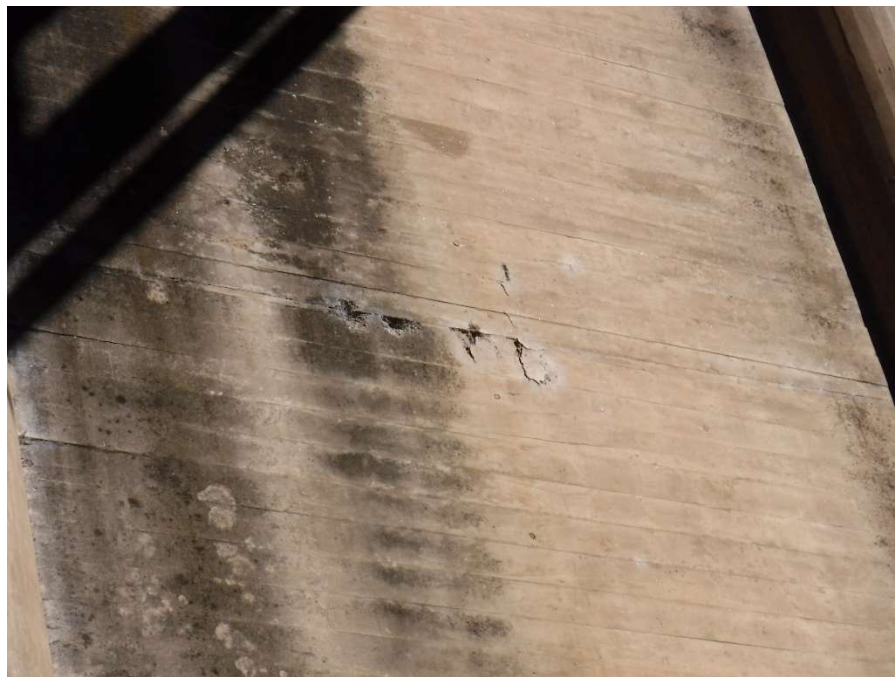
Photo 54 - Localized Delamination and Spalling at Construction Joint on West Face of Pier 6

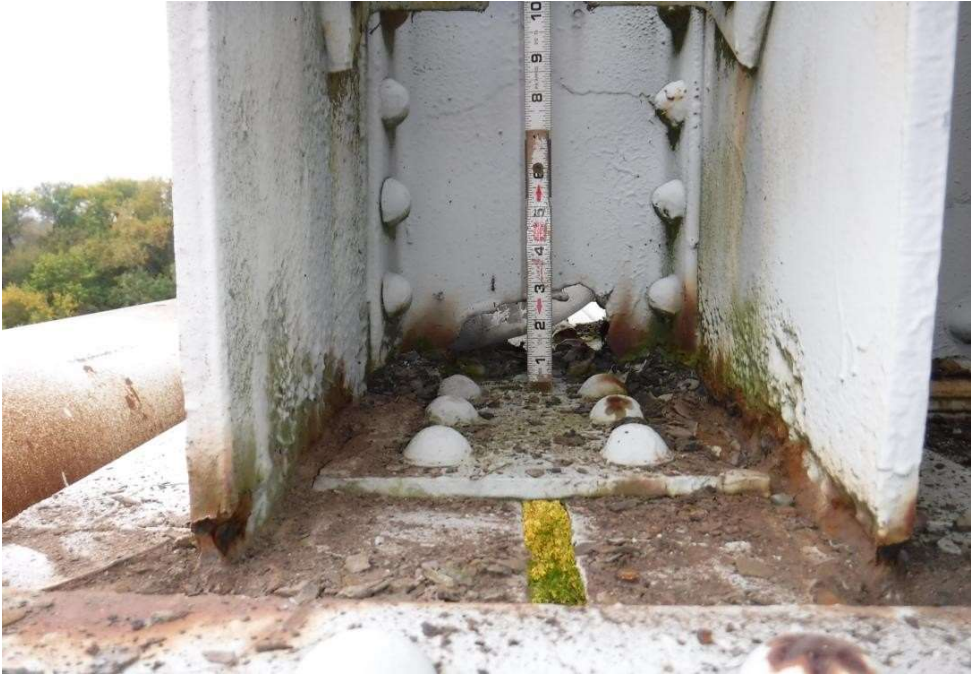
Photo 55 - Lower chord gusset plate condition at Joint L4, Truss 1, Span 4

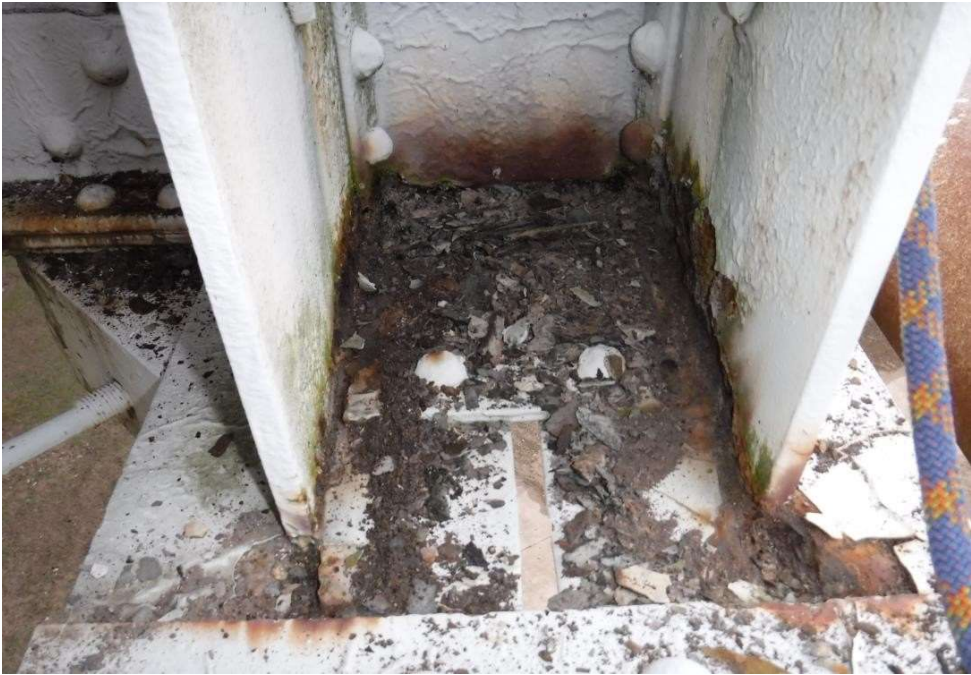
Photo 56 - Lower chord gusset plate condition at Joint L5, Truss 1, Span 4

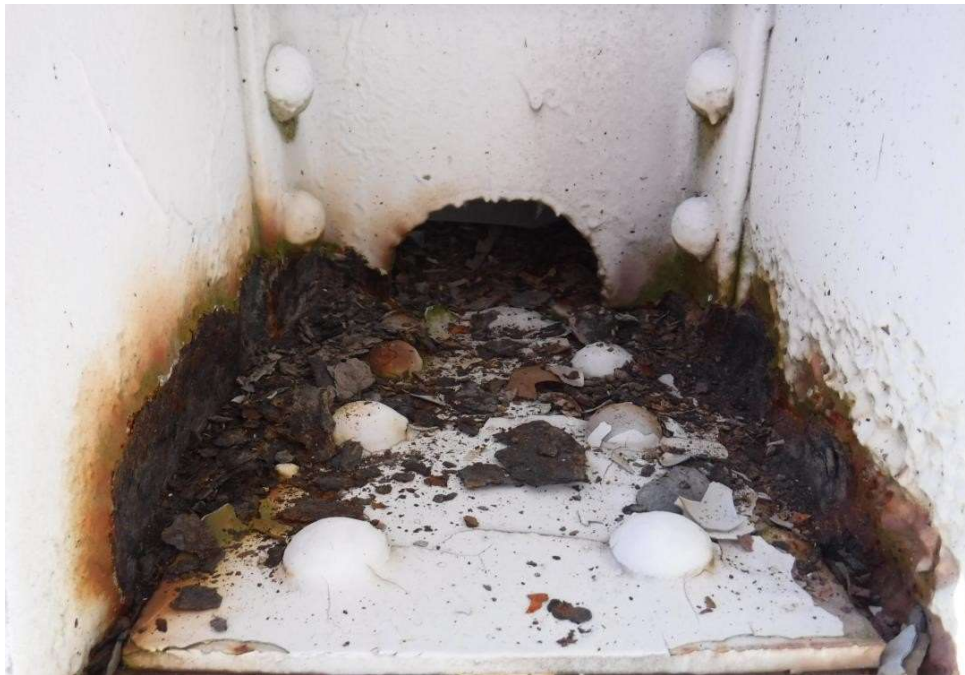
Photo 57 - Horizontal Cracking and Efflorescence on East Face of Pier 5

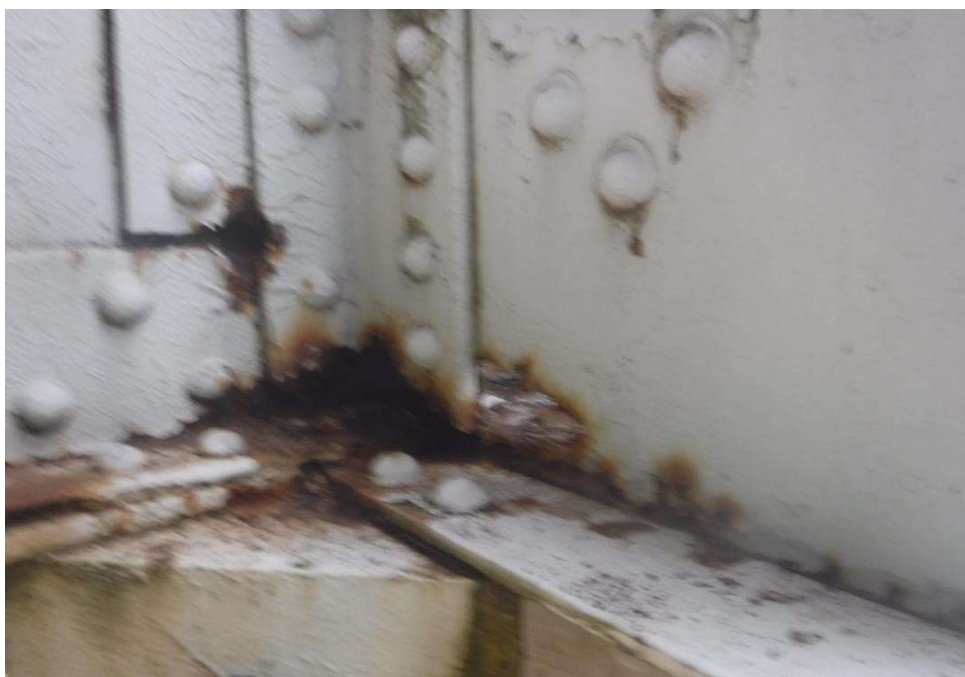
Photo 58 - Lower chord gusset plate condition at Joint L3, Truss 2, Span 4

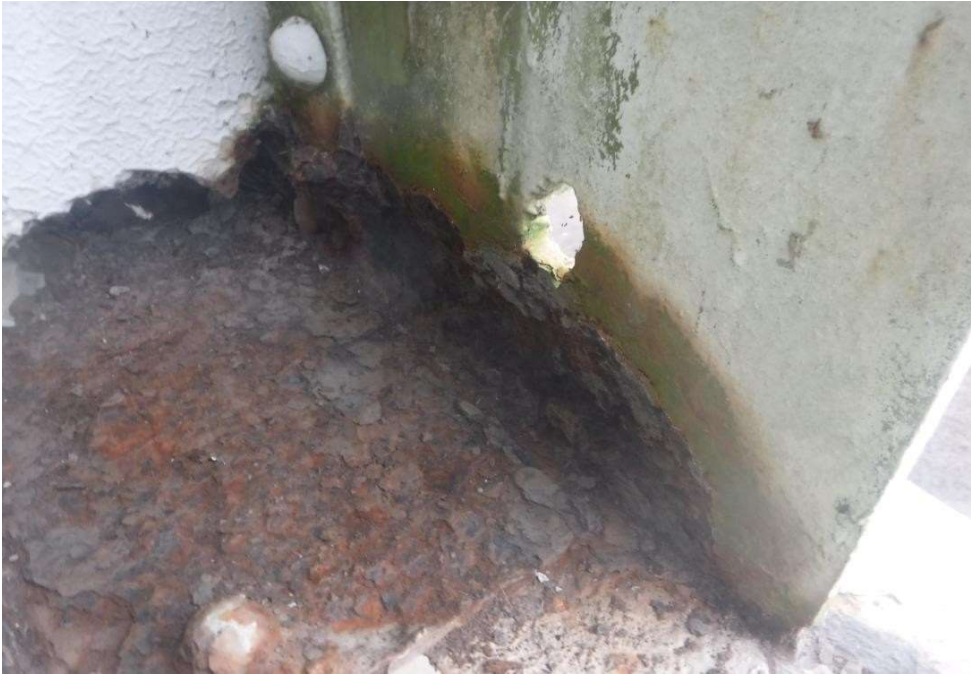
Photo 59 - Lower chord gusset plate condition at Joint L4, Truss 2, Span 4

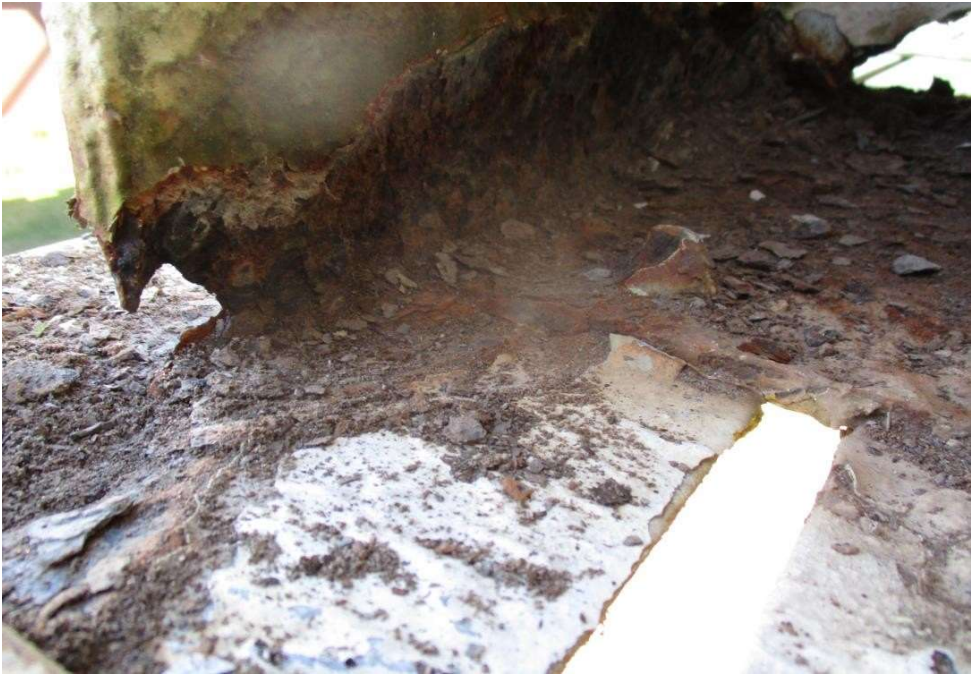
Photo 60 - Lower chord gusset plate condition at Joint L5, Truss 2, Span 4

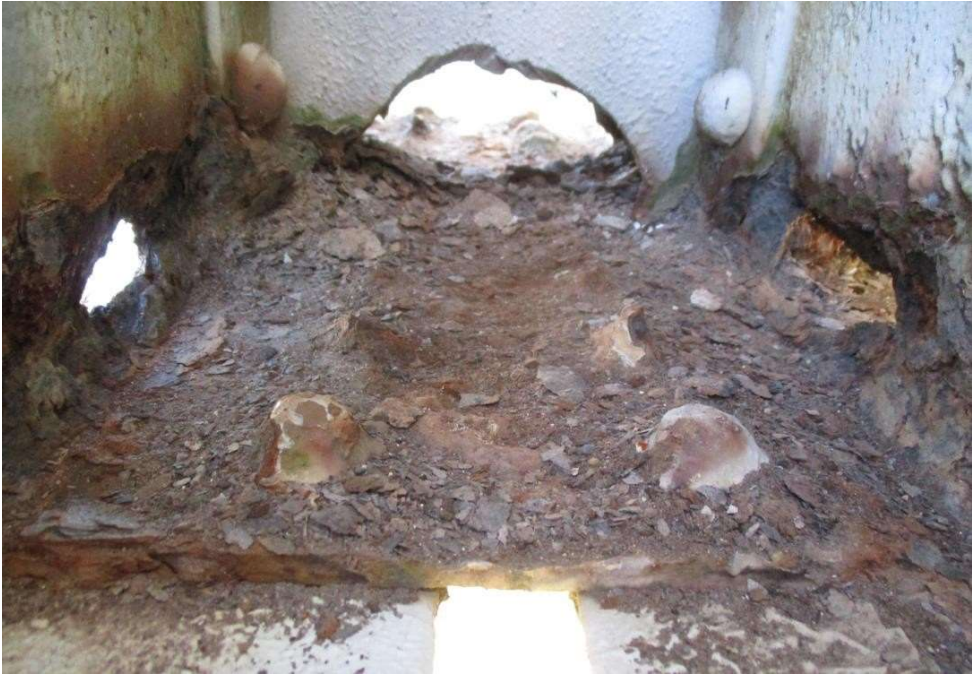
Photo 61 - Lower chord gusset plate condition at Joint L6, Truss 2, Span 4

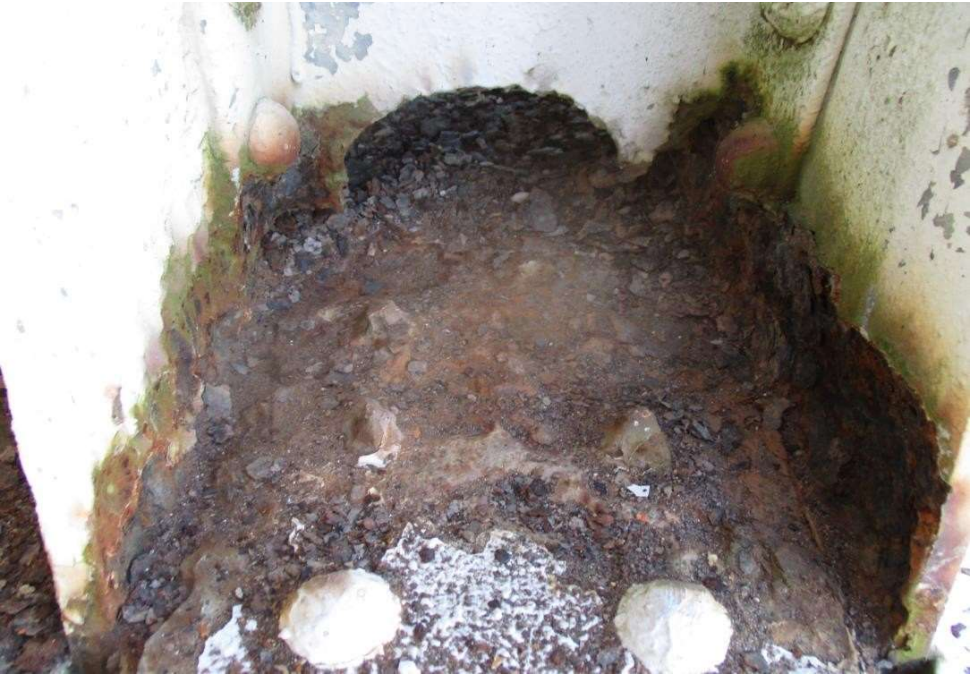
Photo 62 - Lower chord gusset plate condition at Joint L7, Truss 2, Span 4

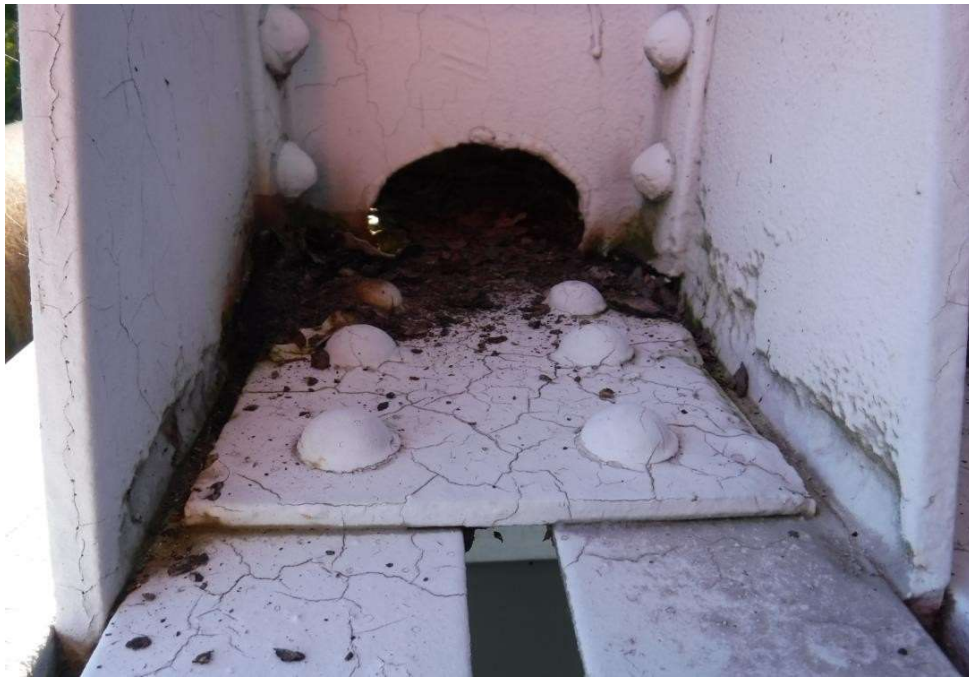
Photo 63 - Lower chord gusset plate condition at Joint L6, Truss 1, Span 5

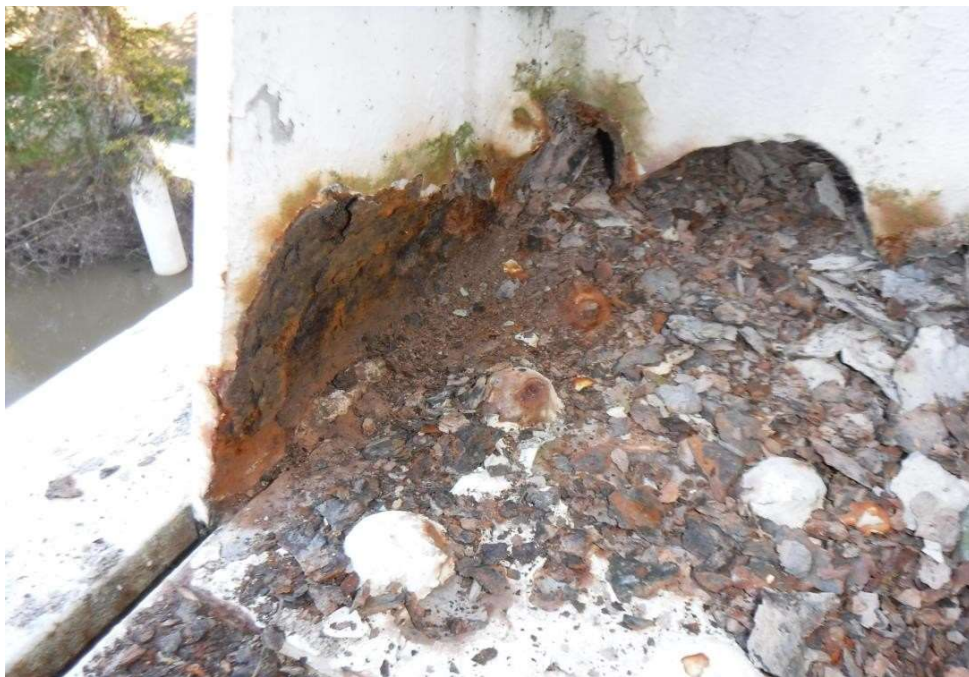
Photo 64 - Lower chord gusset plate condition at Joint L2, Truss 2, Span 5

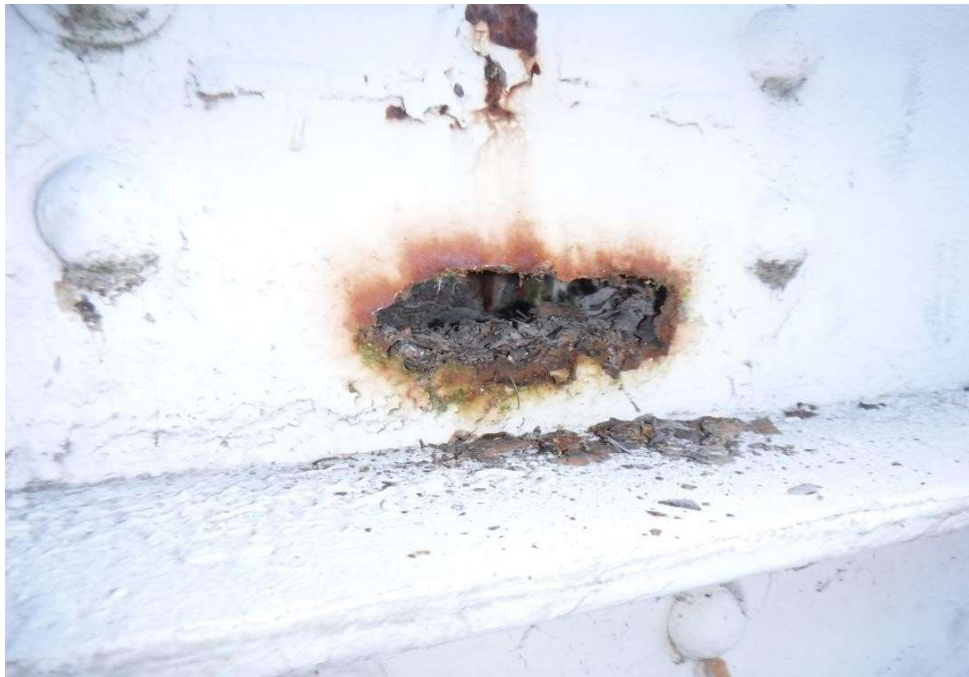
Photo 65 - Lower chord gusset plate condition at Joint L5, Truss 2, Span 5

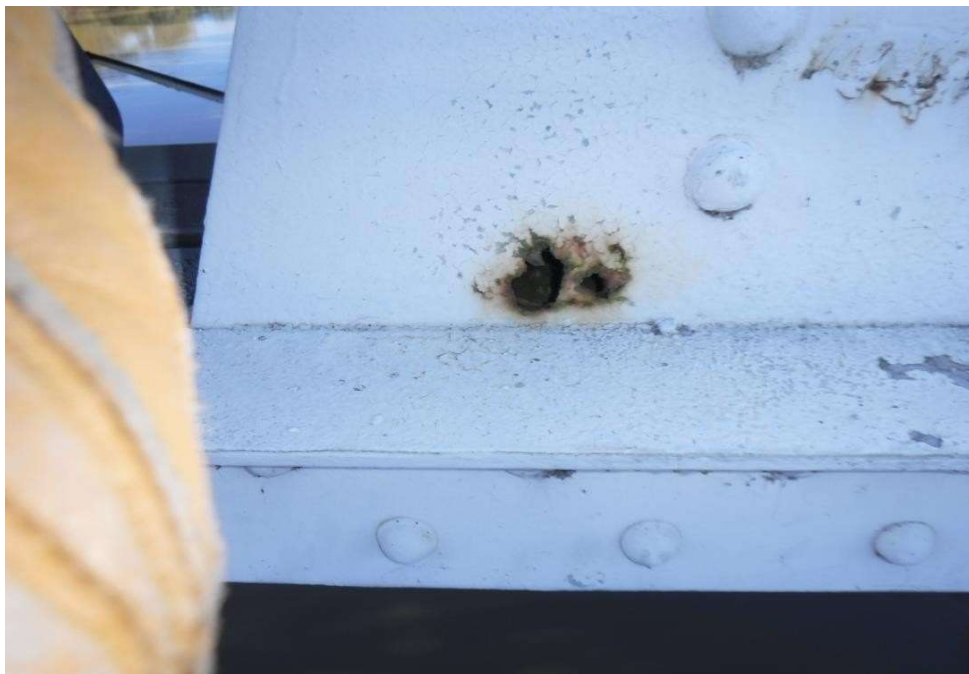
Photo 66 - Lower chord gusset plate condition at Joint L6, Truss 2, Span 5

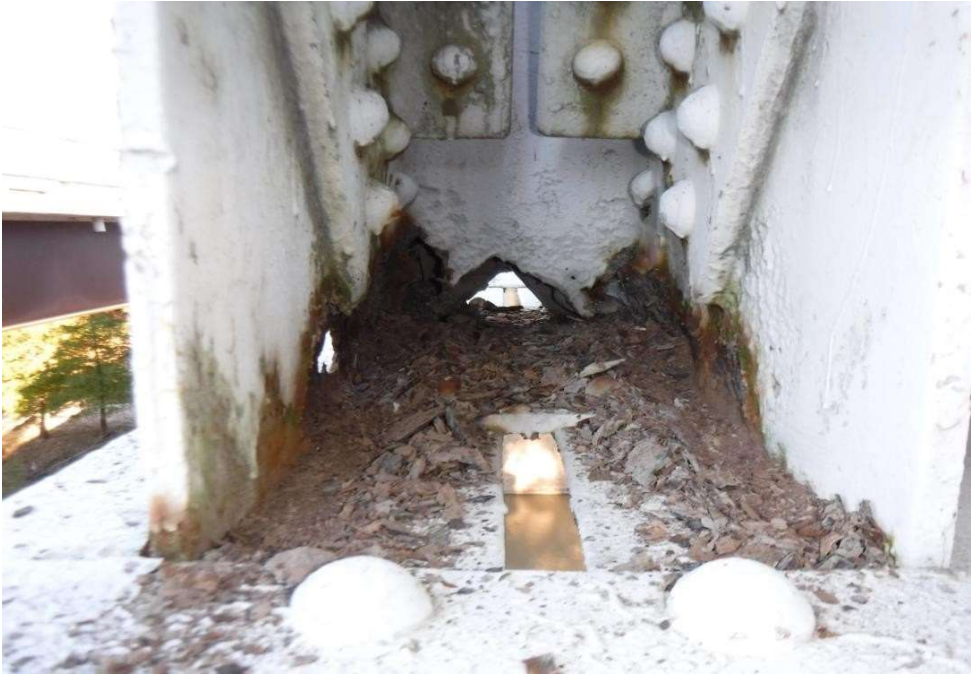
Photo 67 - Lower chord gusset plate condition at Joint L7, Truss 2, Span 5

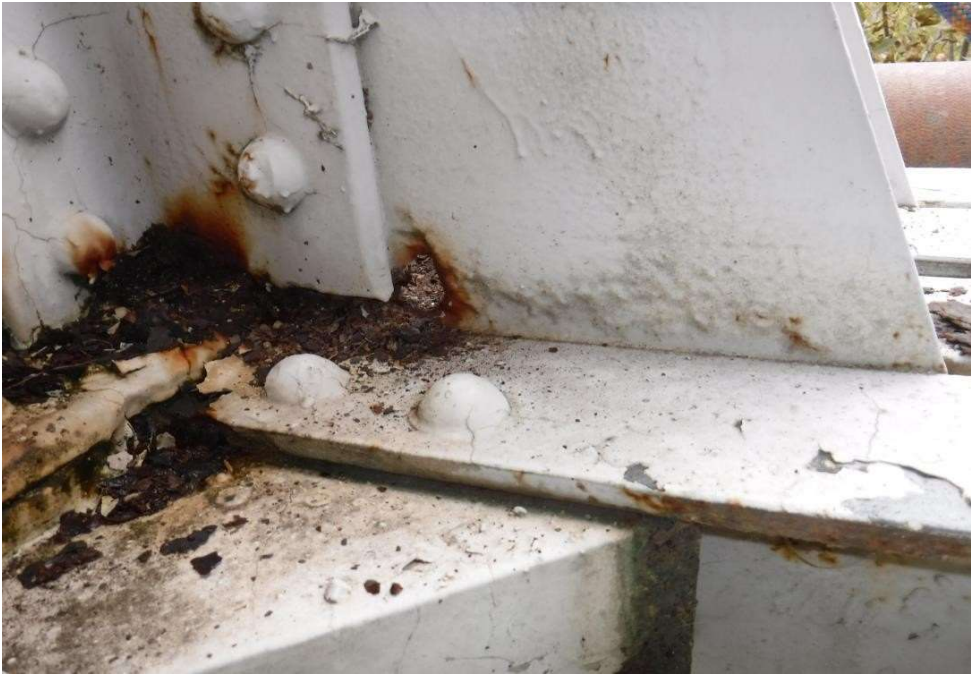
Photo 68 - Lower chord gusset plate condition at Joint L3, Truss 1, Span 6

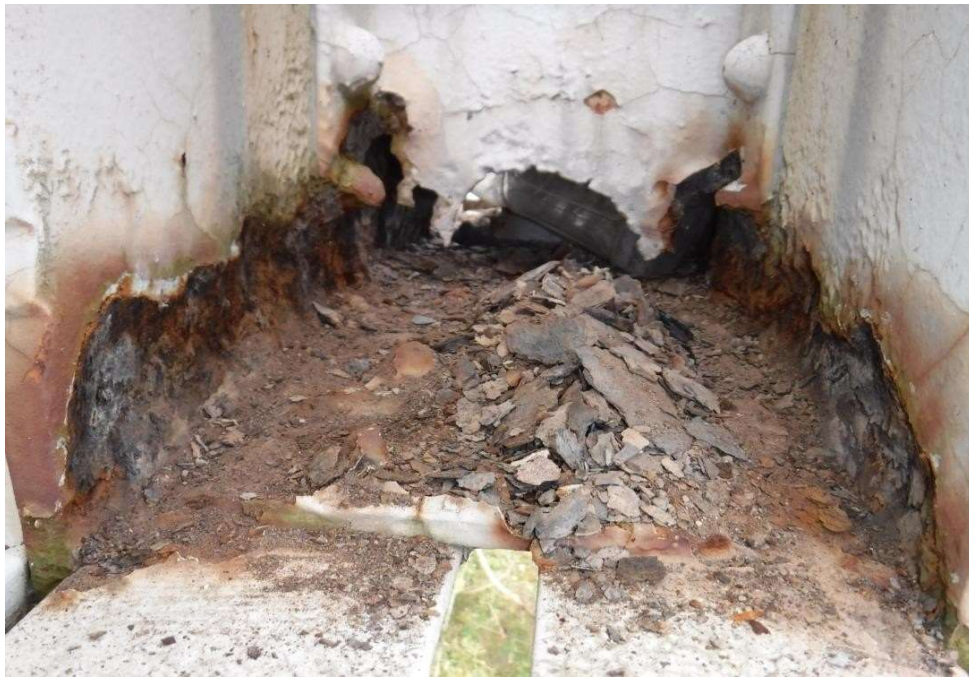
Photo 69 - Lower chord gusset plate condition at Joint L4, Truss 1, Span 6

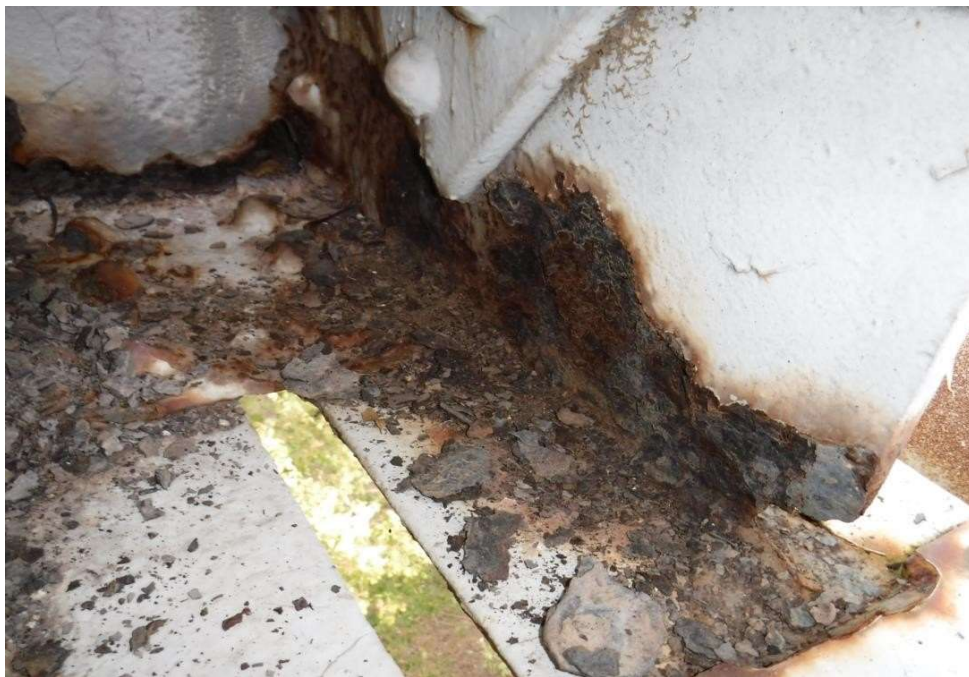
Photo 70 - Lower chord gusset plate condition at Joint L7, Truss 1, Span 6

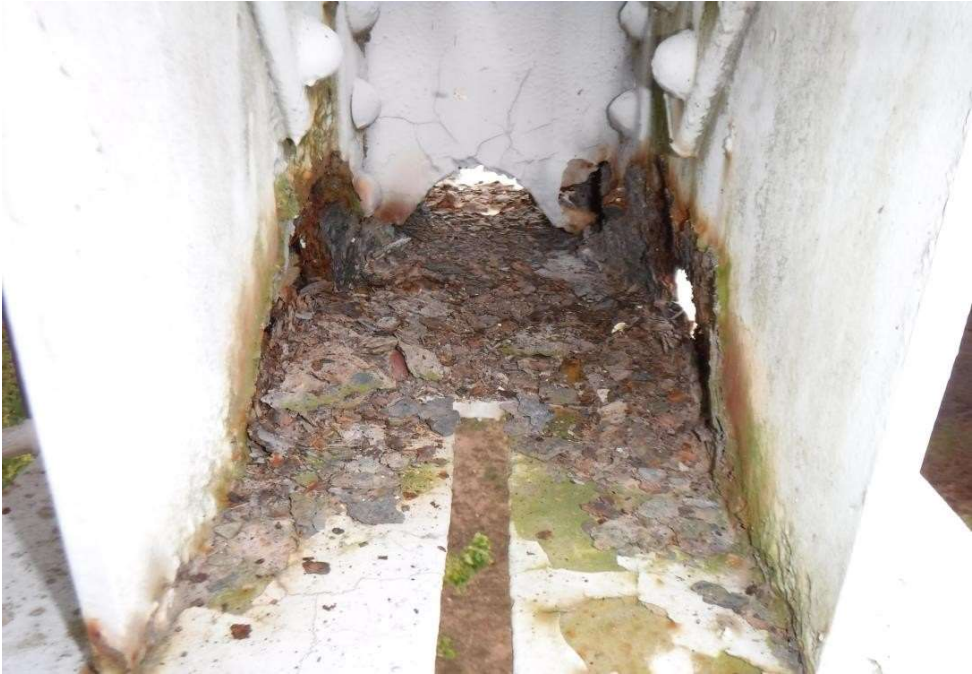
Photo 71 - Lower chord gusset plate condition at Joint L3, Truss 2, Span 6

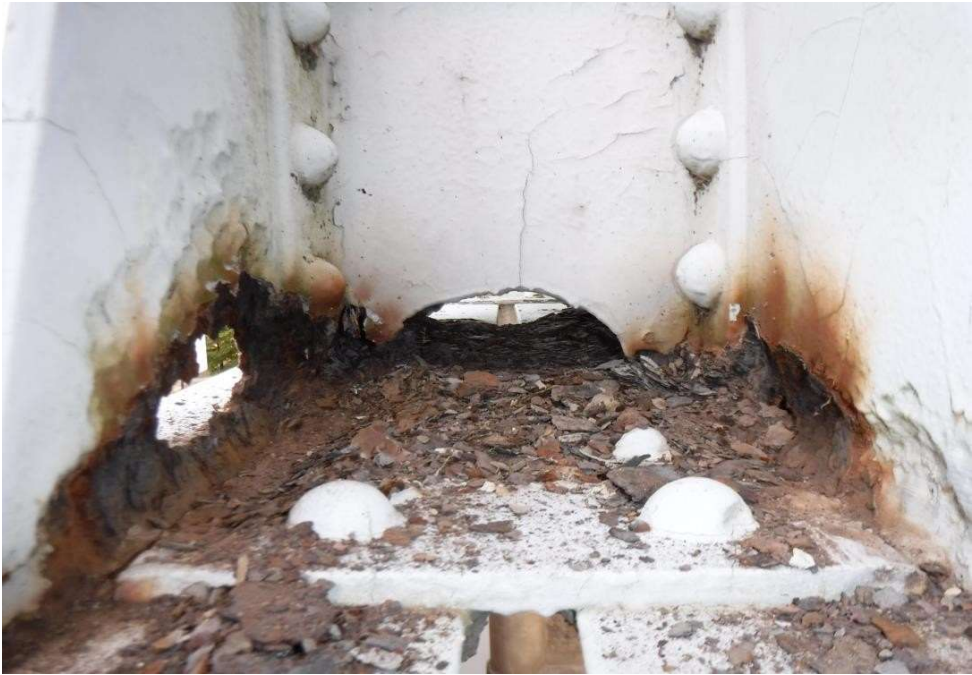
Photo 72 - Lower chord gusset plate condition at Joint L3, Truss 2, Span 6

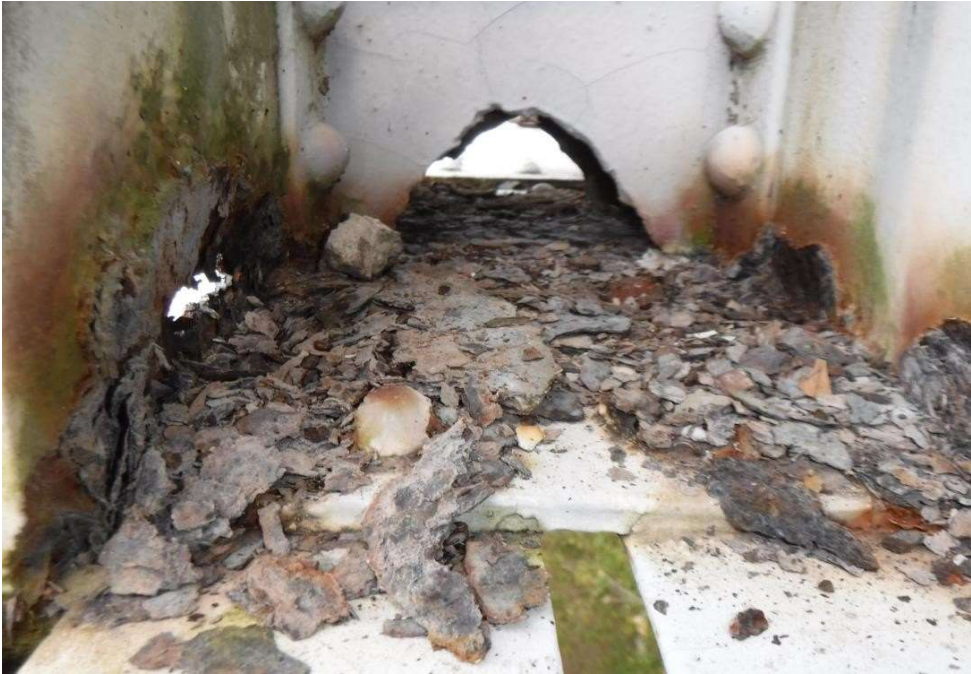
Photo 73 - Lower chord gusset plate condition at Joint L4, Truss 2, Span 6

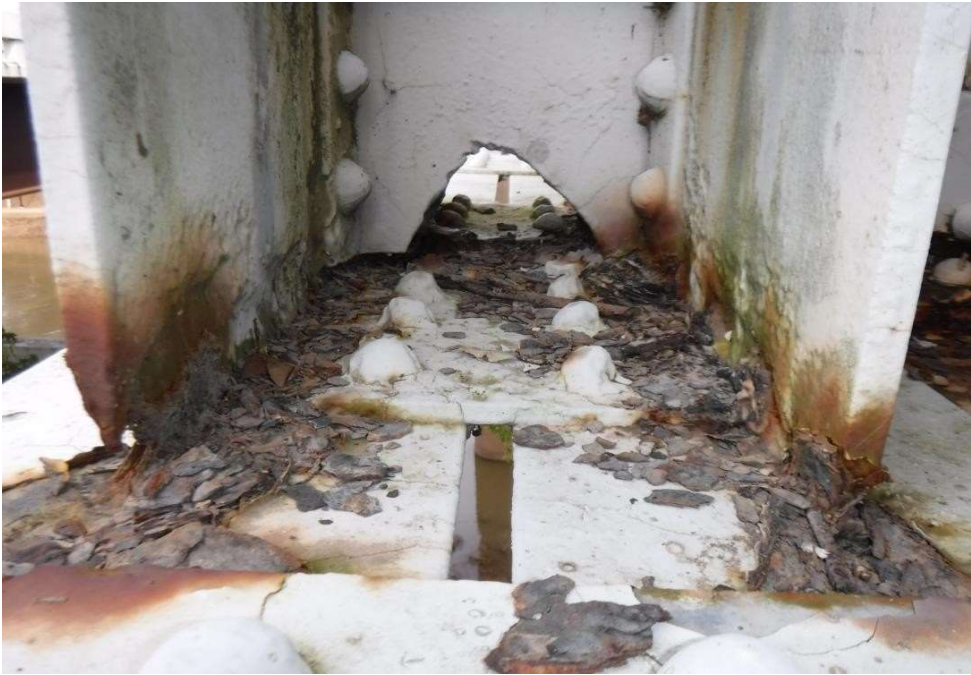
Photo 74 - Lower chord gusset plate condition at Joint L5, Truss 2, Span 6

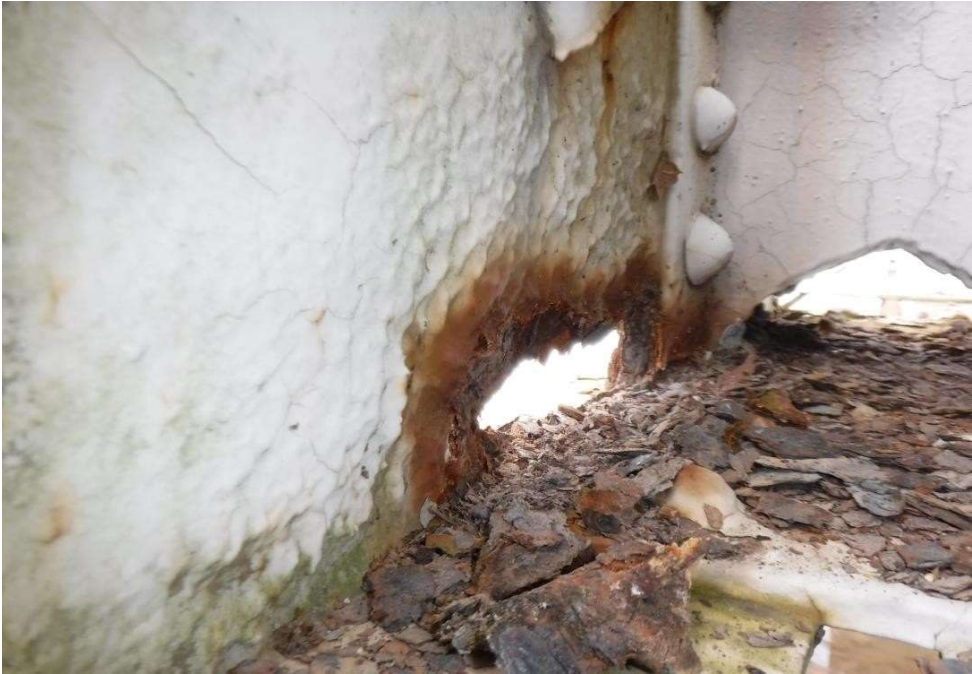
Photo 75 - Lower chord gusset plate condition at Joint L6, Truss 2, Span 6

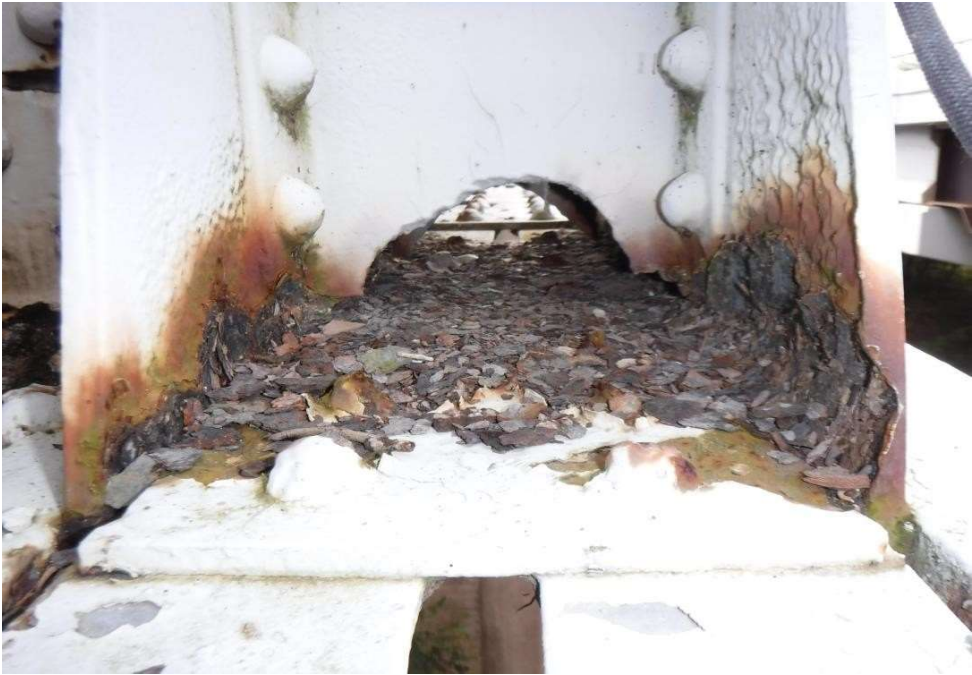
Photo 76 - Lower chord gusset plate condition at Joint L7, Truss 2, Span 6

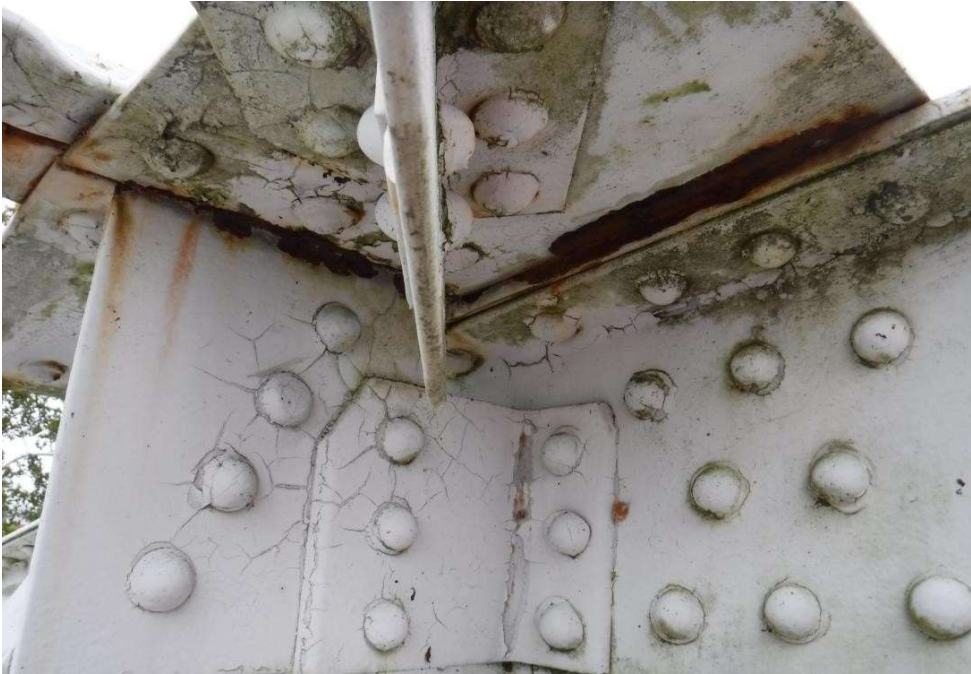
Photo 77 - Upper chord gusset plate condition at Joint U2, Truss 1, Span 4

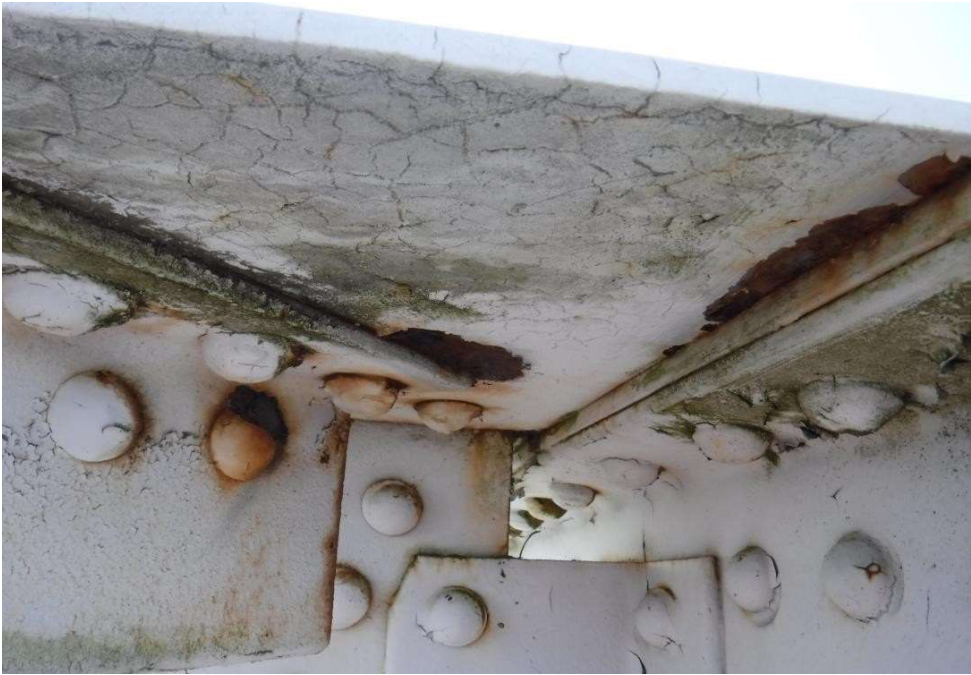
Photo 78 - Upper chord gusset plate condition at Joint U5, Truss 1, Span 4

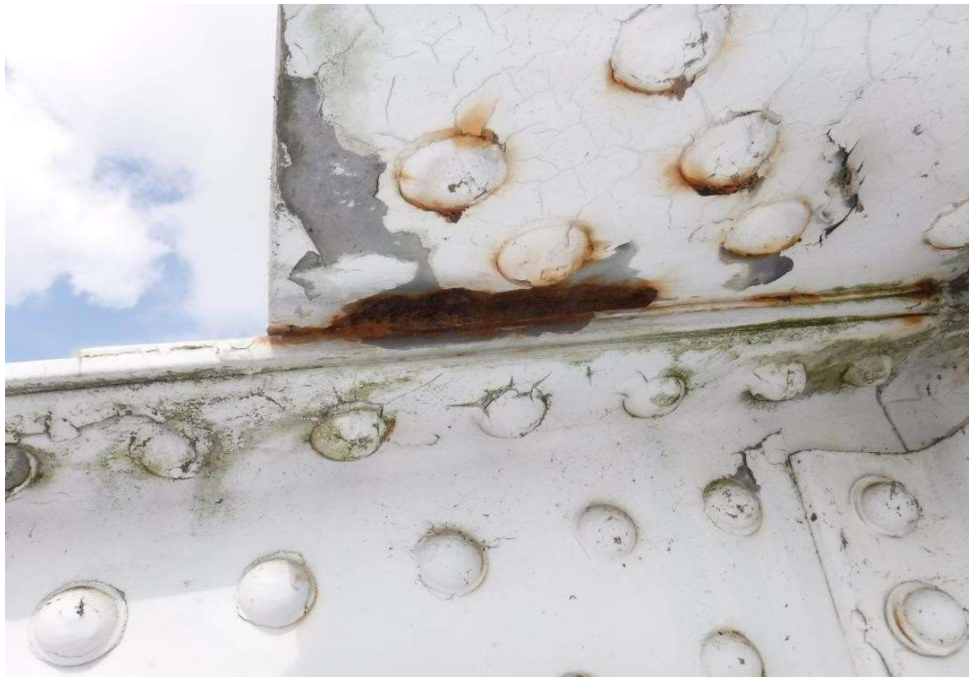
Photo 79 - Upper chord gusset plate condition at Joint U7, Truss 2, Span 4

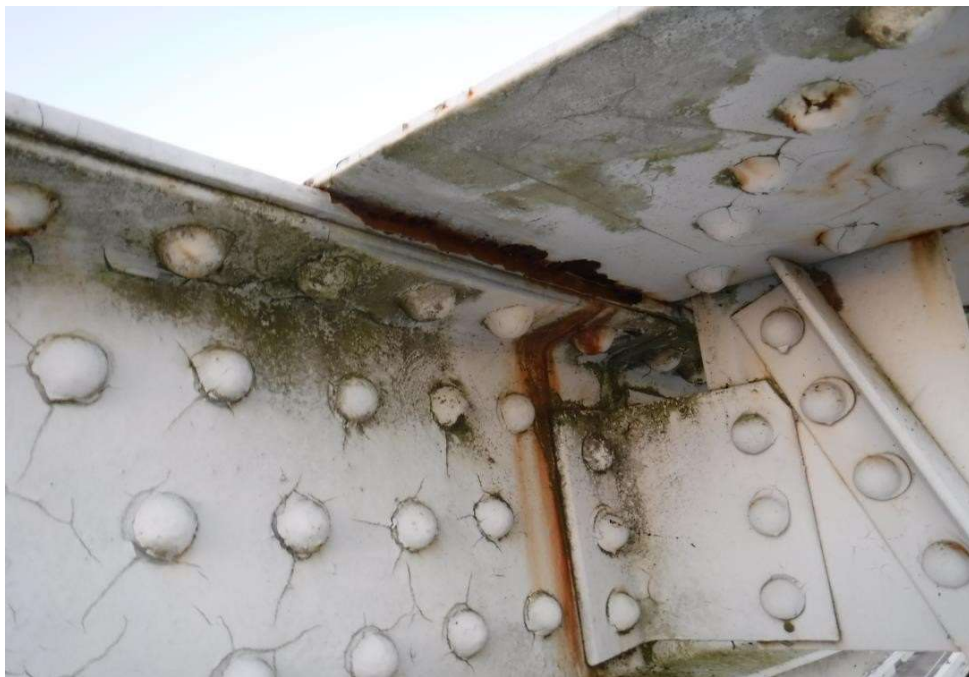
Photo 80 - Upper chord gusset plate condition at Joint U5, Truss 2, Span 6

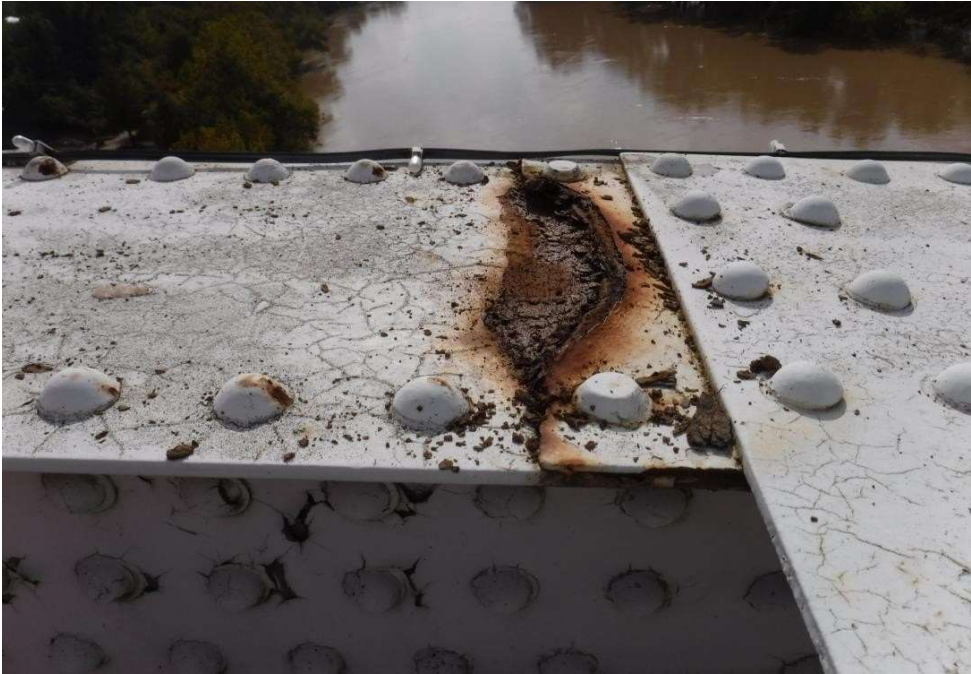
Photo 81 - Upper chord filler plate condition at Joint U8, Truss 1, Span 4

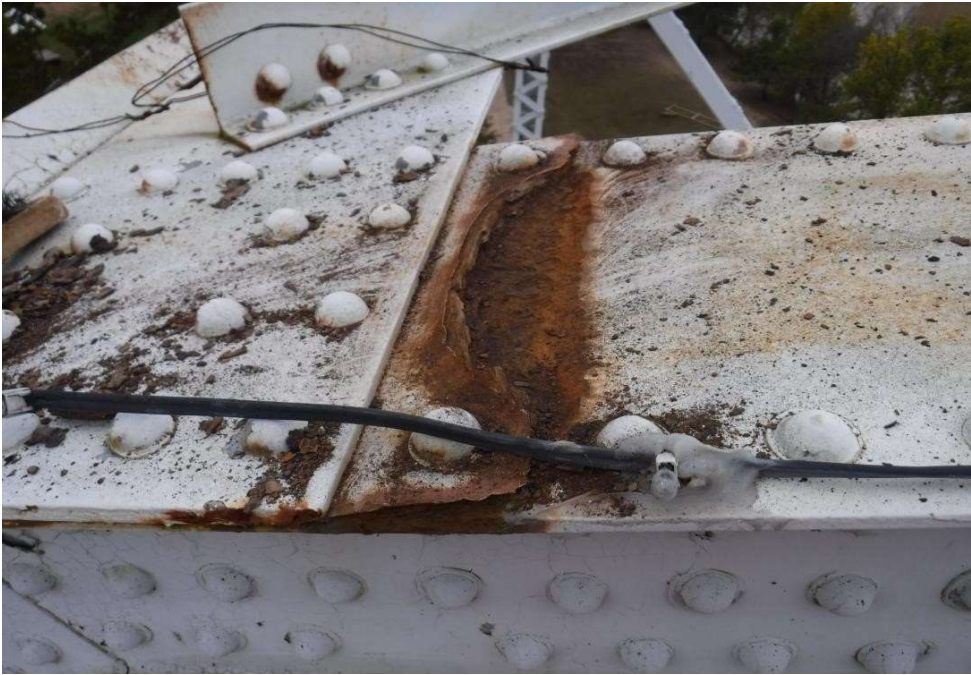
Photo 82 - Upper chord filler plate condition at Joint U1, Truss 2, Span 4

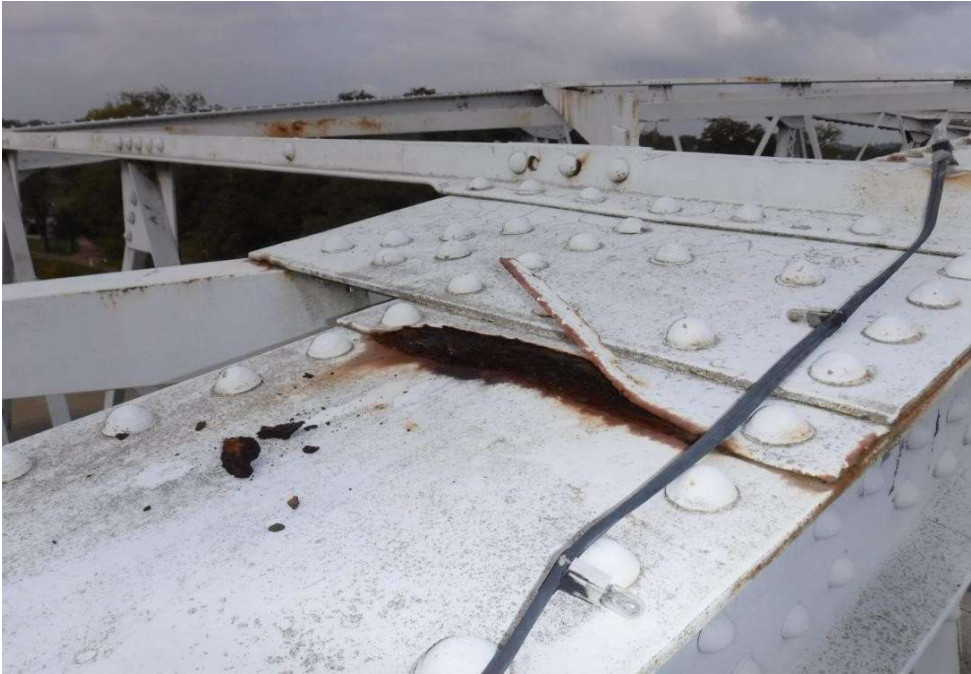
Photo 83 - Upper chord filler plate condition at Joint U7, Truss 1, Span 5

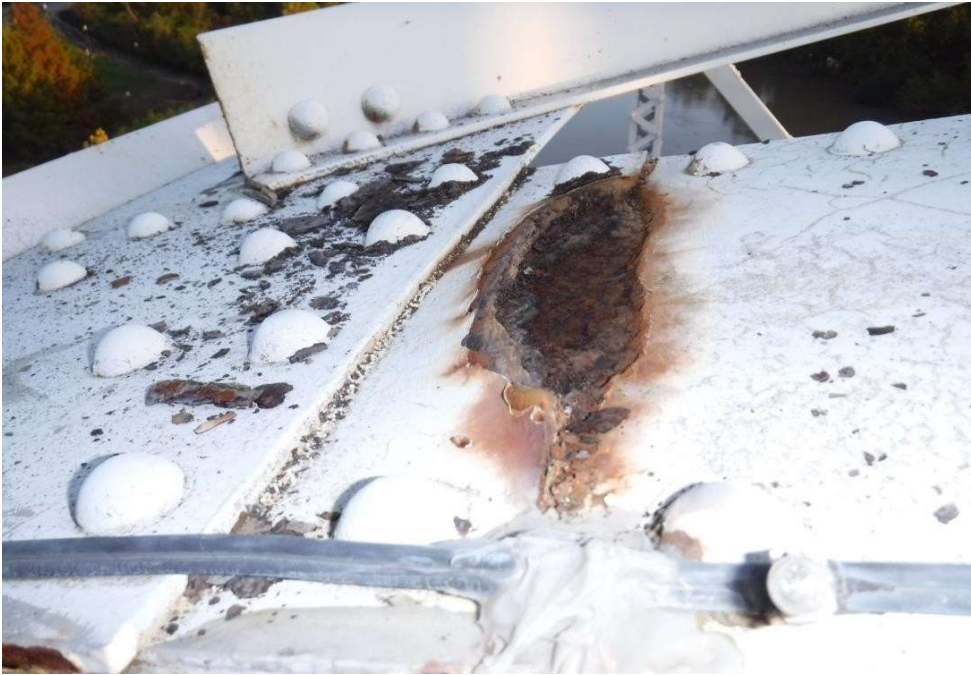
Photo 84 - Upper chord filler plate condition at Joint U1, Truss 2, Span 5

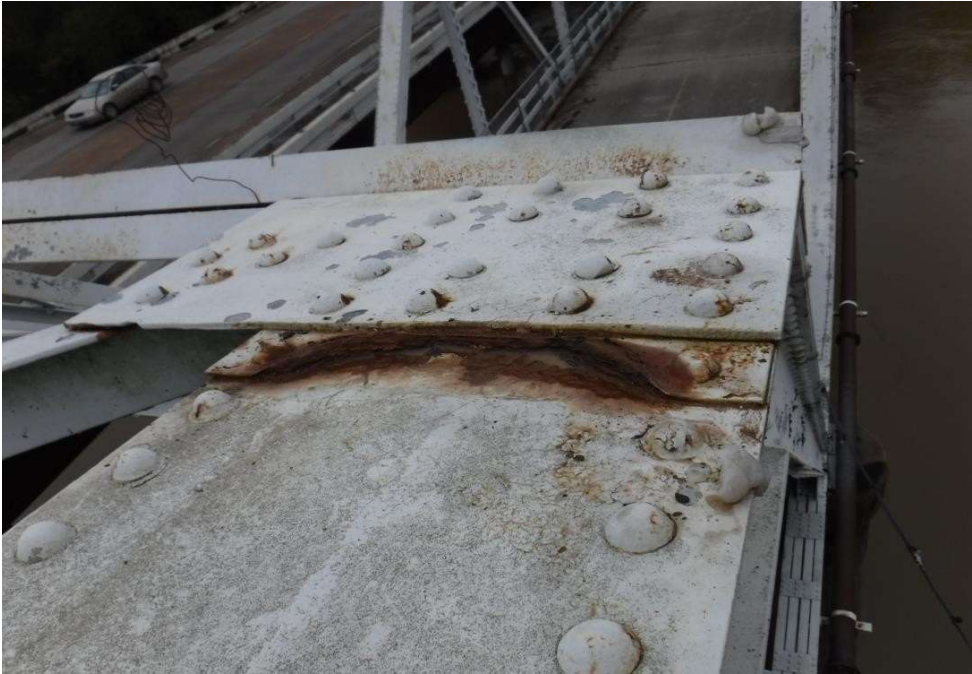
Photo 85 - Upper chord filler plate condition at Joint U1, Truss 1, Span 6

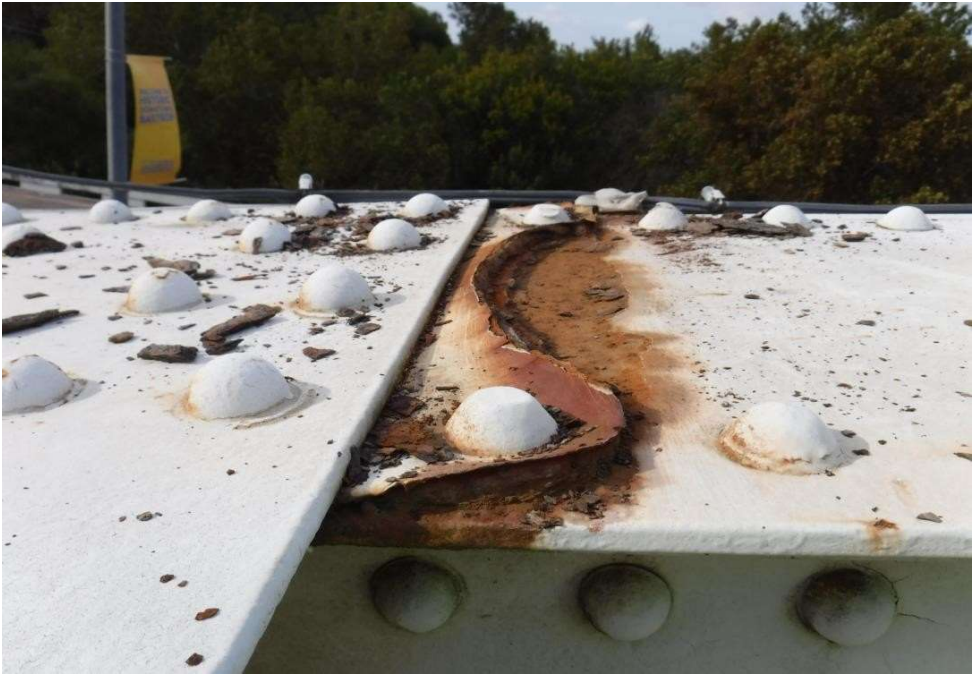
Photo 86 - Upper chord filler plate condition at Joint U8, Truss 2, Span 6
