Rehabilitation Evaluation Report  
for the  
Chestnut Street (S.H. 150) Pedestrian Bridge Over the  
Colorado River in Bastrop, Texas

Prepared for:

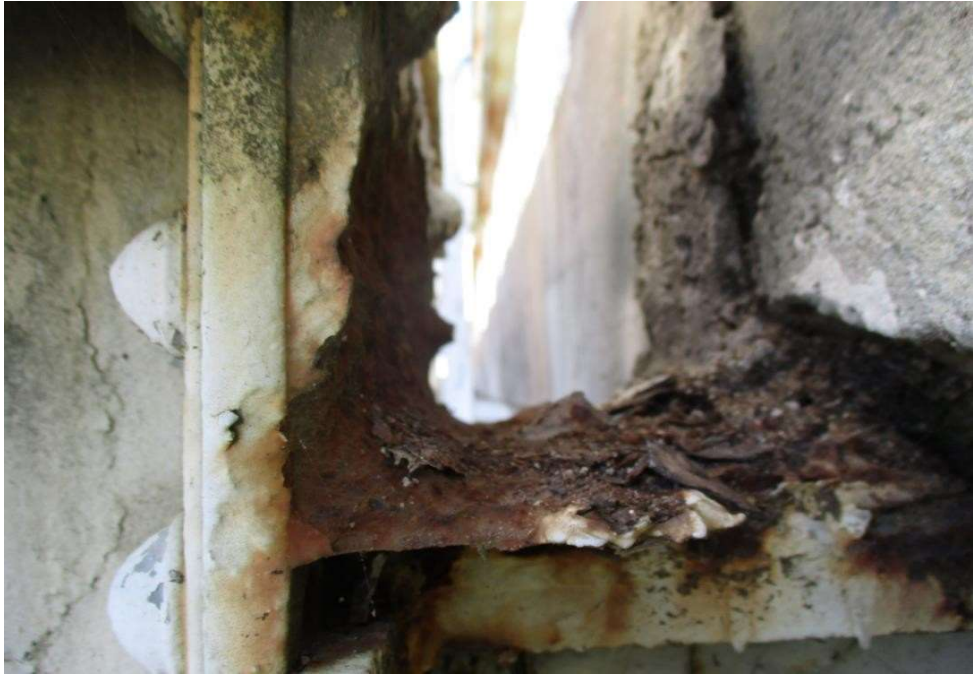
Photo 87 - Floorbeam to vertical connection angle condition at Joint L5, Truss 2, Span 4

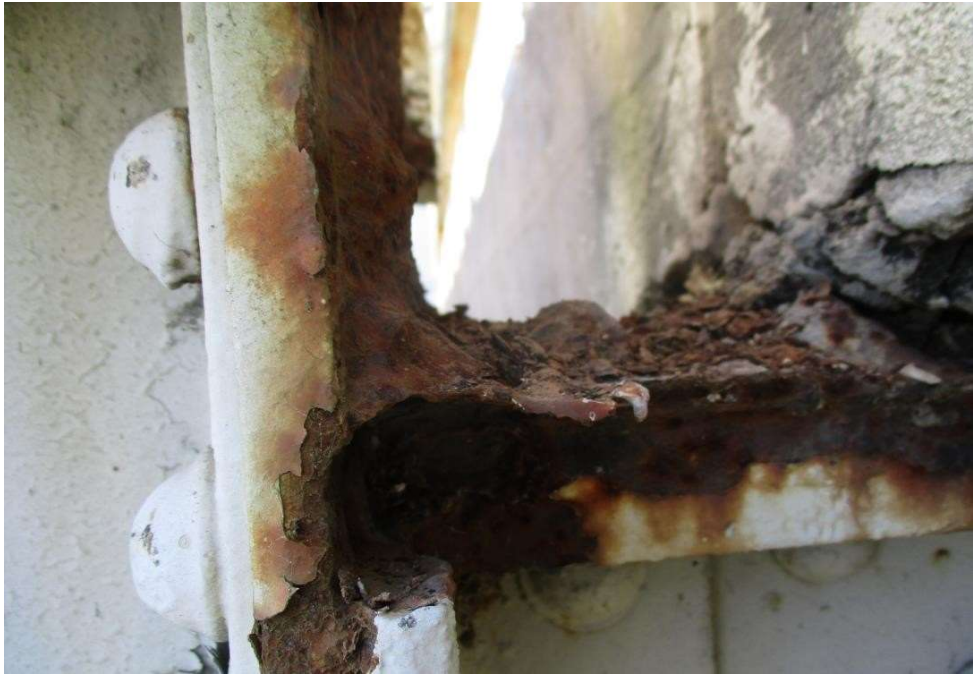
Photo 88 - Floorbeam to vertical connection angle condition at Joint L6, Truss 2, Span 4

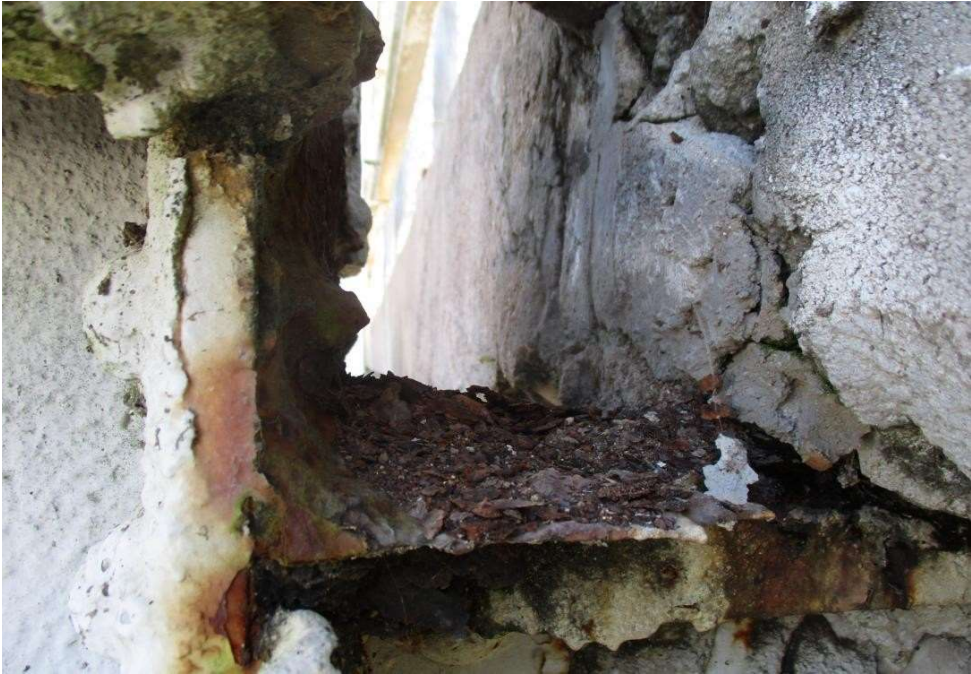
Photo 89 - Floorbeam to vertical connection angle condition at Joint L7, Truss 2, Span 4

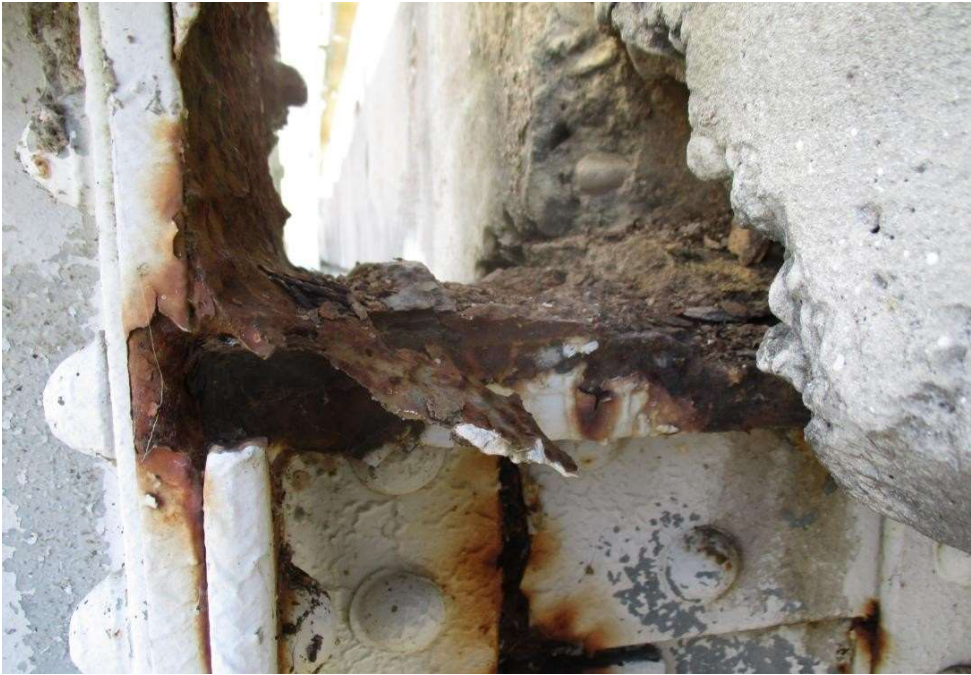
Photo 90 - Floorbeam to vertical connection angle condition at Joint L8, Truss 2, Span 4

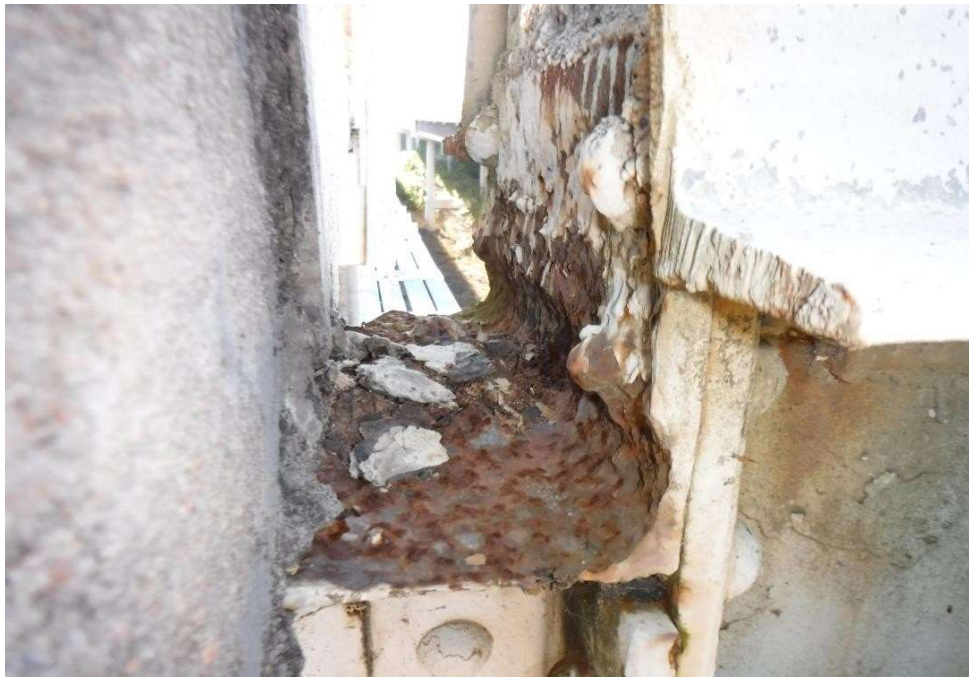
Photo 91 - Floorbeam to vertical connection angle condition at Joint L3, Truss 2, Span 5

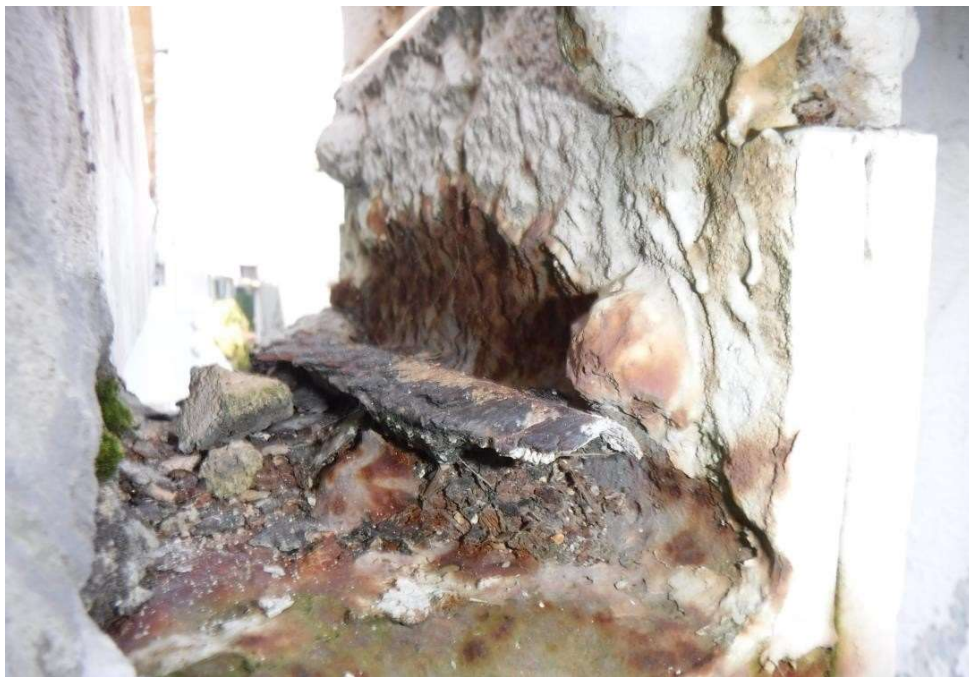
Photo 92 - Floorbeam to vertical connection angle condition at Joint L6, Truss 2, Span 5

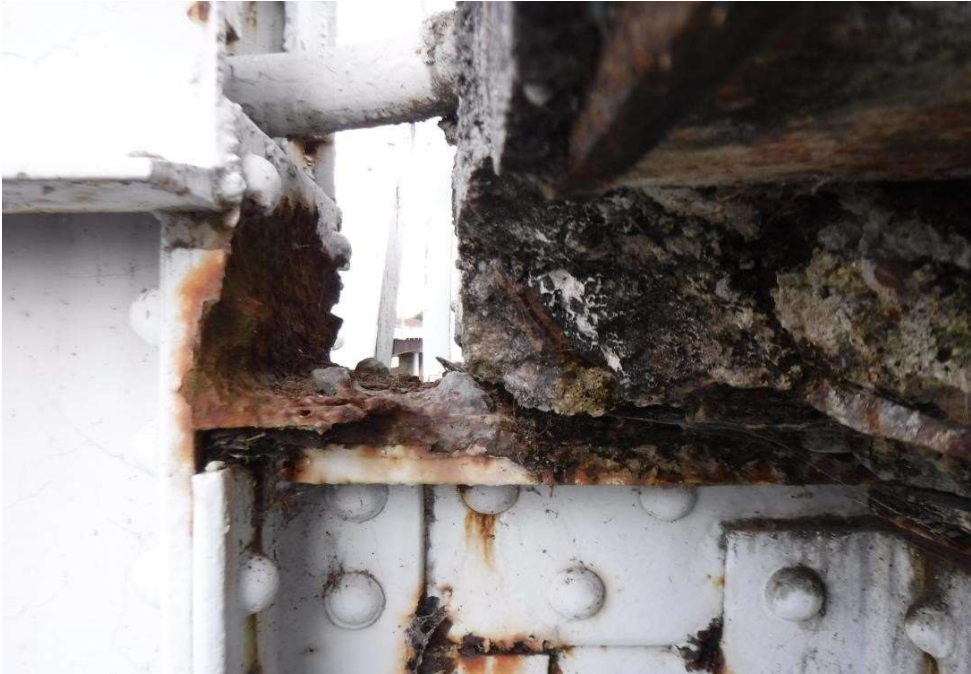
Photo 93 - Floorbeam to vertical connection angle condition at Joint L2, Truss 2, Span 6

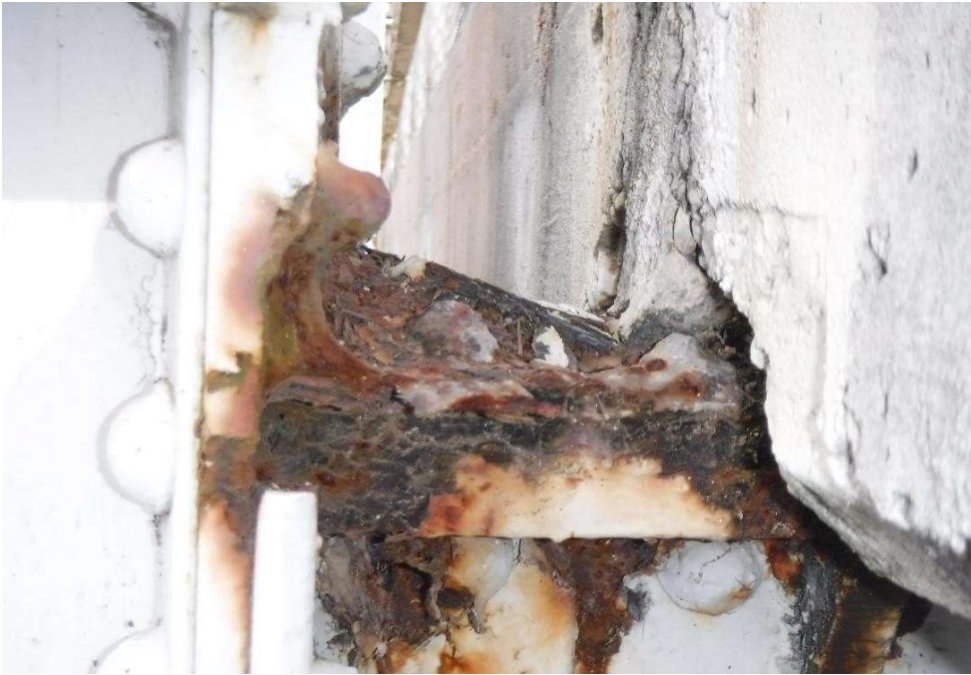
Photo 94 - Floorbeam to vertical connection angle condition at Joint L5, Truss 2, Span 6

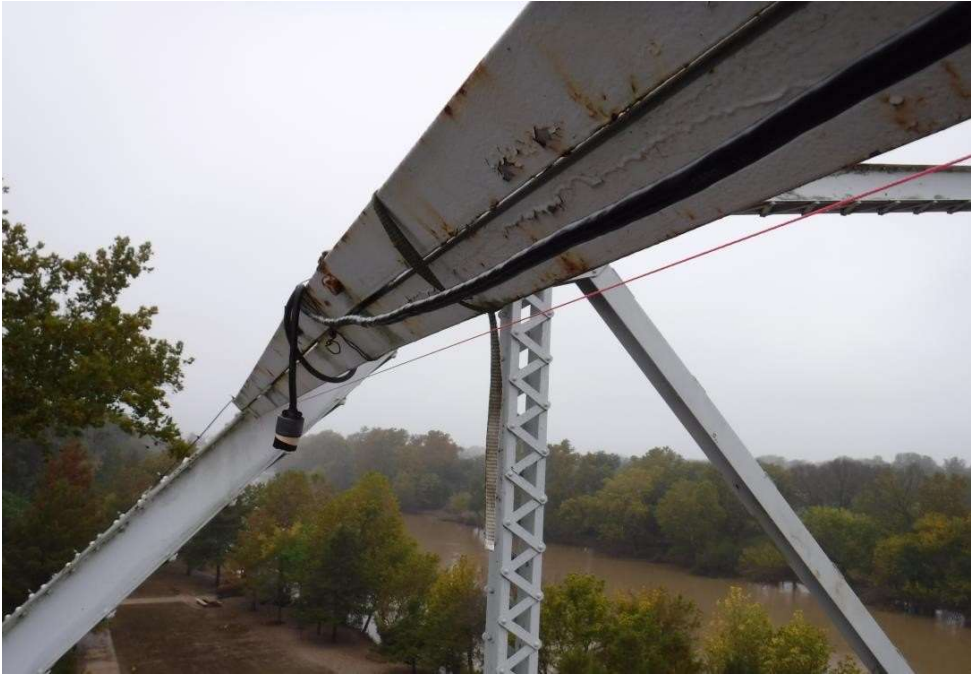
Photo 95 – Cross frame lower chord deformation at Joint U1, Span 4

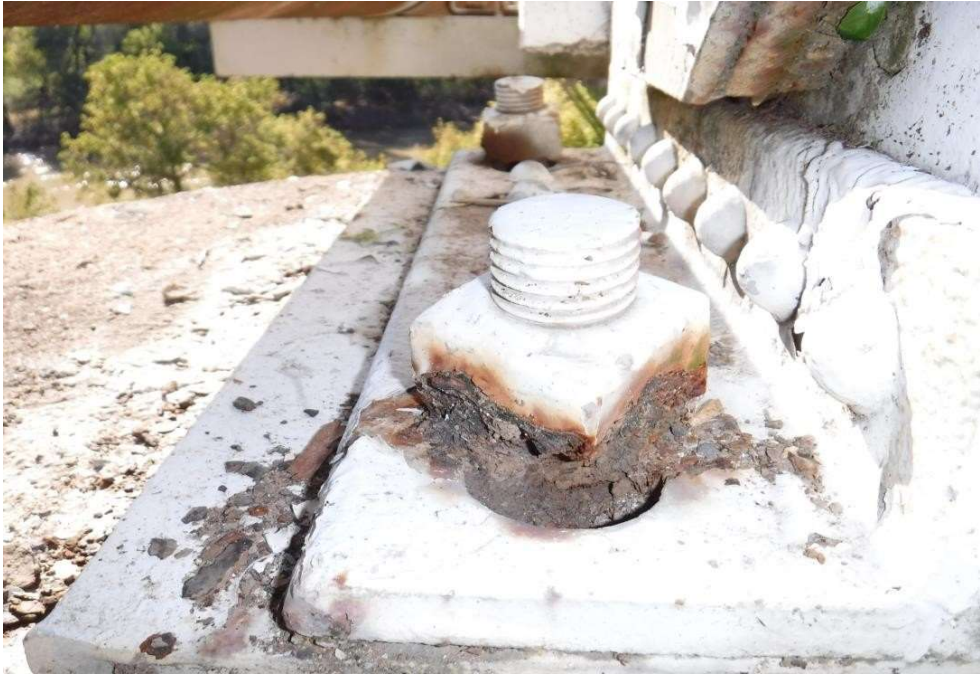
Photo 101 - Exterior anchor bolt condition at Joint L0, Truss 1, Span 4

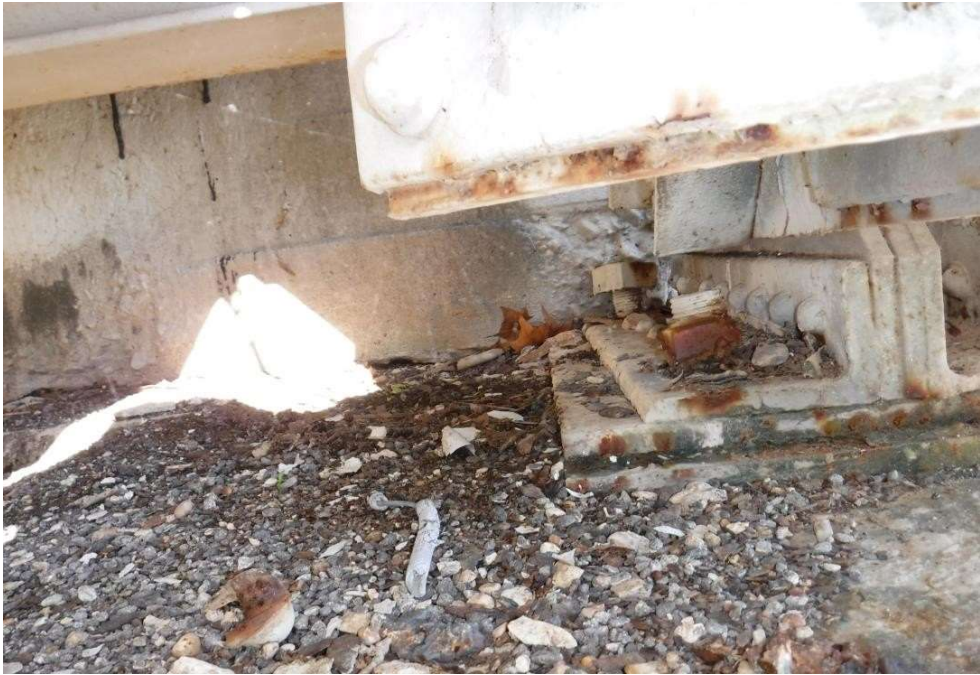
Photo 102 – Interior anchor bolt condition at Joint L0, Truss 1, Span 4

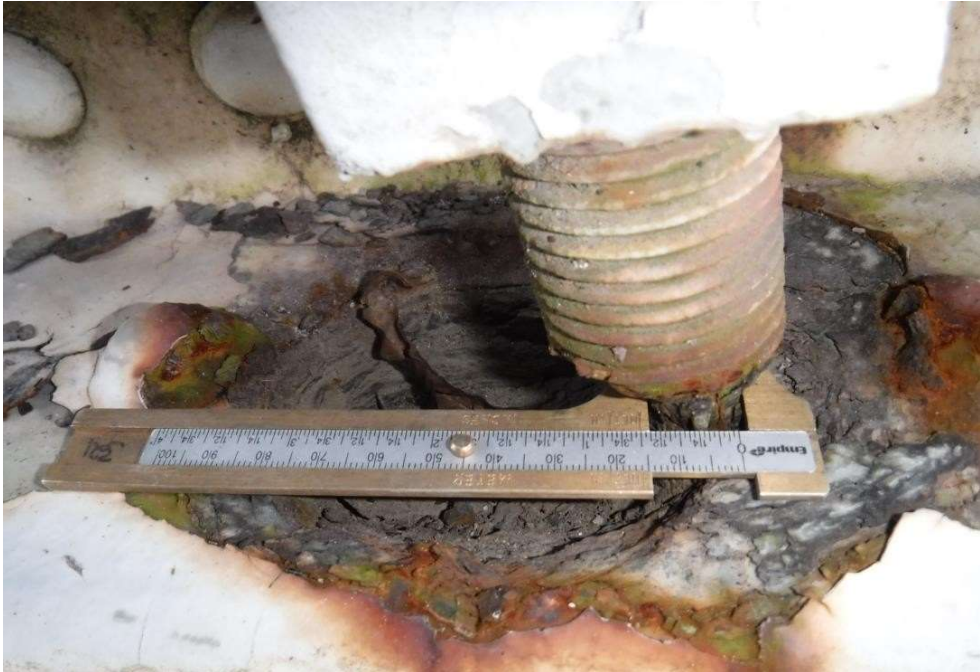
Photo 103 - Exterior anchor bolt condition at Joint L9, Truss 1, Span 5

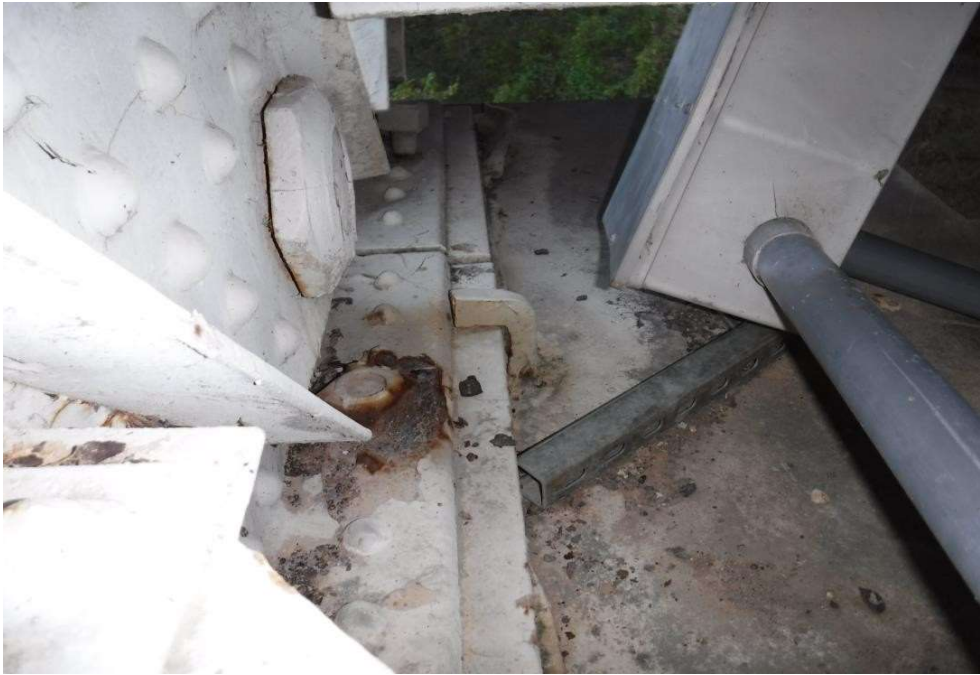
Photo 104 - Interior anchor bolt condition at Joint L9, Truss 1, Span 5

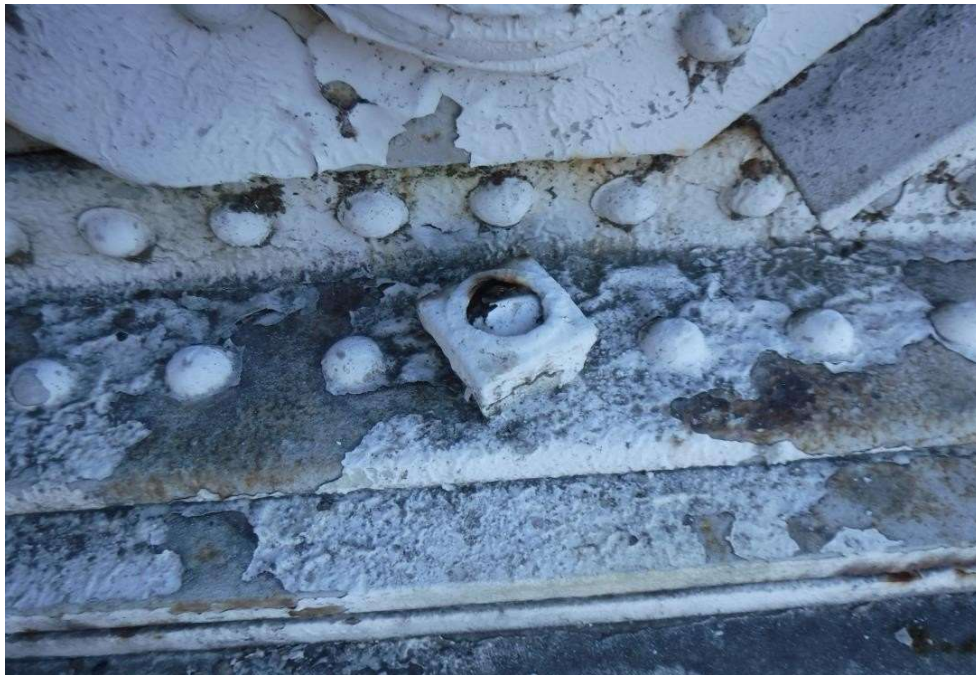
Photo 105 - Exterior anchor bolt condition at Joint L0, Truss 2, Span 5

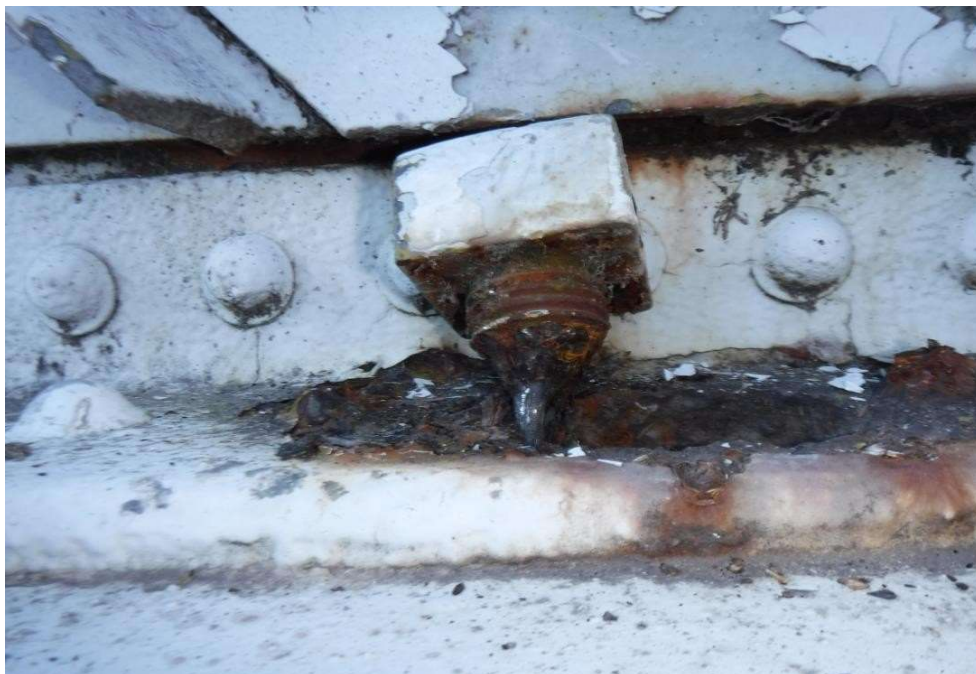
Photo 106 - Exterior anchor bolt condition at Joint L9, Truss 2, Span 5

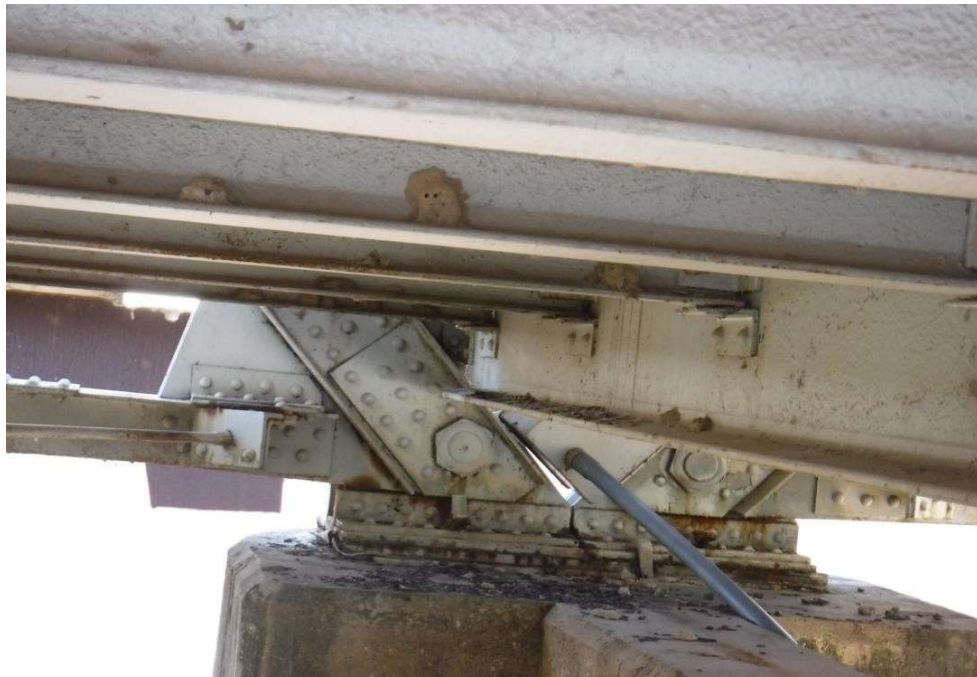
Photo 107 - Interior anchor bolt condition at Joint L9, Truss 2, Span 5

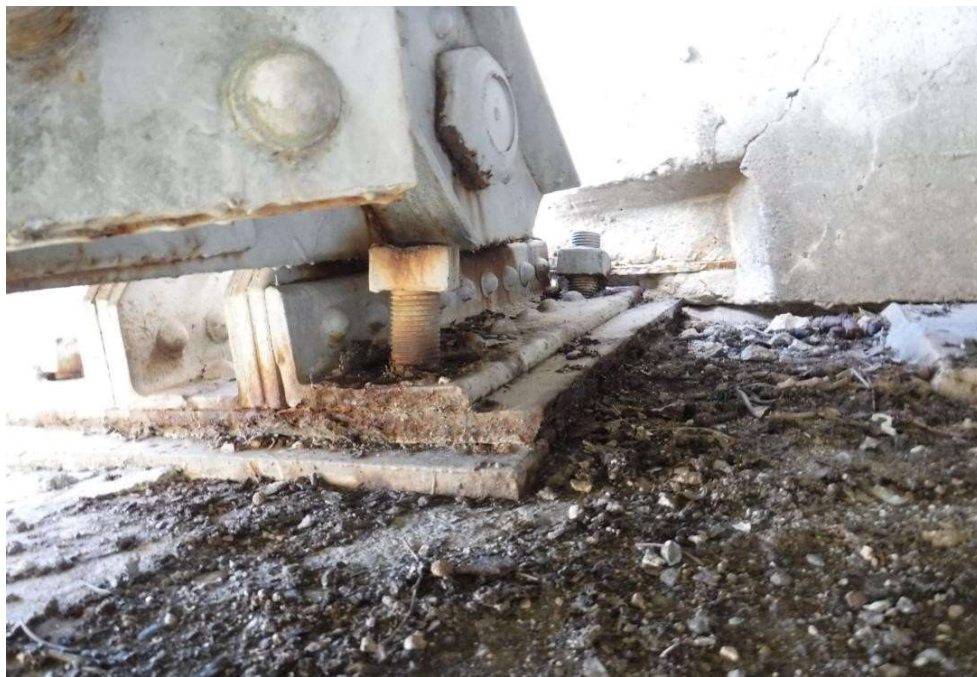
Photo 108 - Interior anchor bolt condition at Joint L9, Truss 1, Span 6

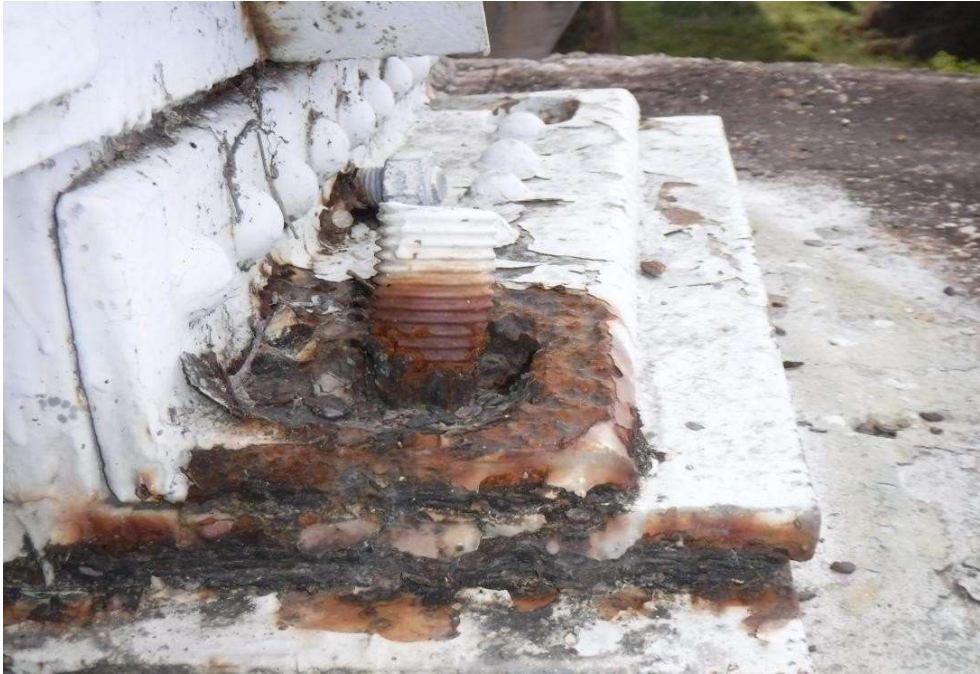
Photo 109 - Exterior anchor bolt condition, missing fastener, missing bolt, at Joint L9, Truss 2, Span 6

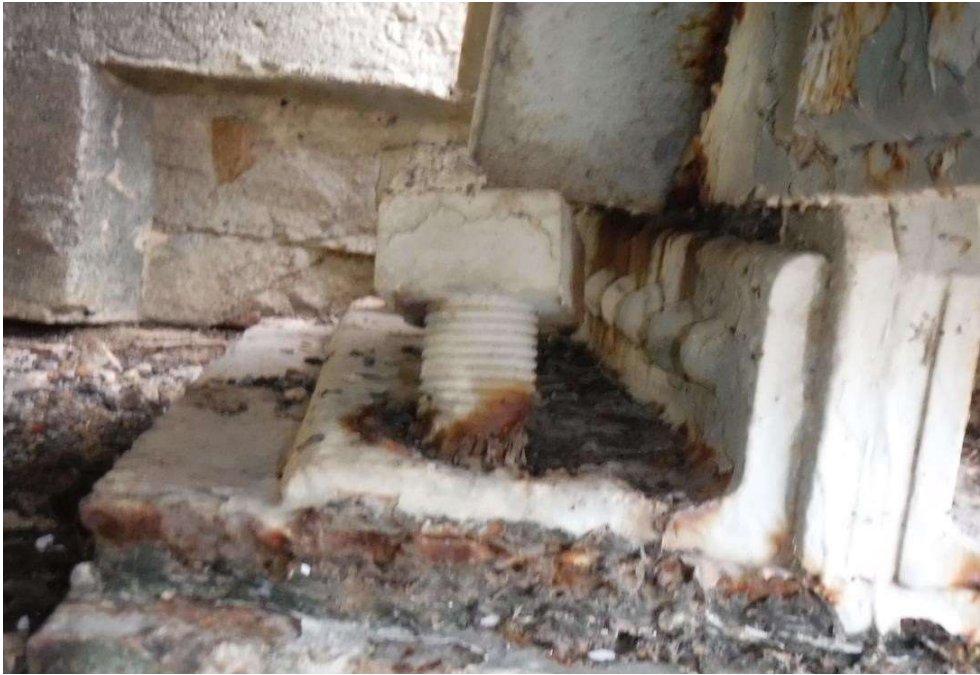
Photo 110 - Interior anchor bolt condition at Joint L9, Truss 2, Span 6

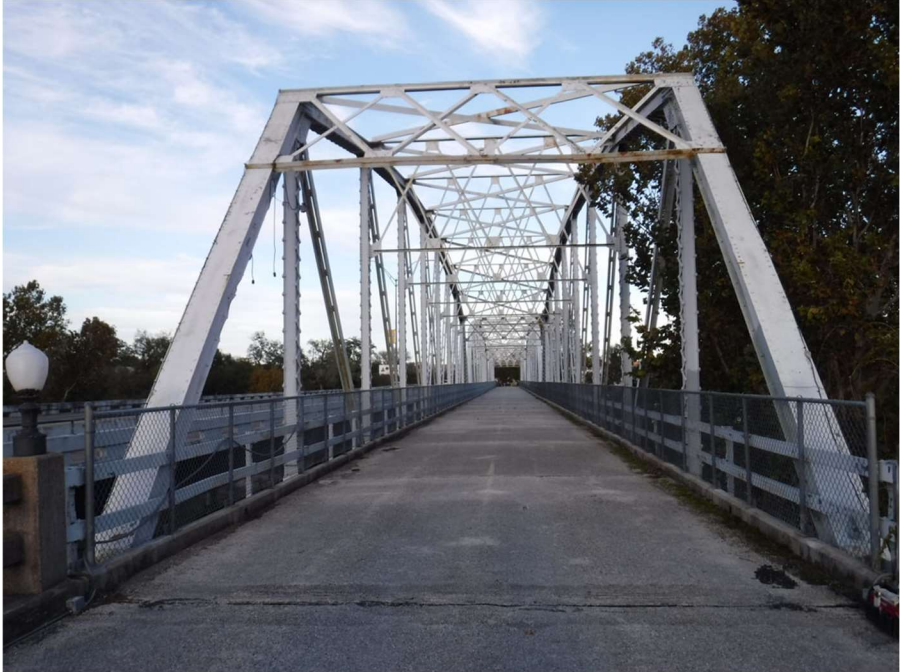
Photo 111 – Roadway over bridge

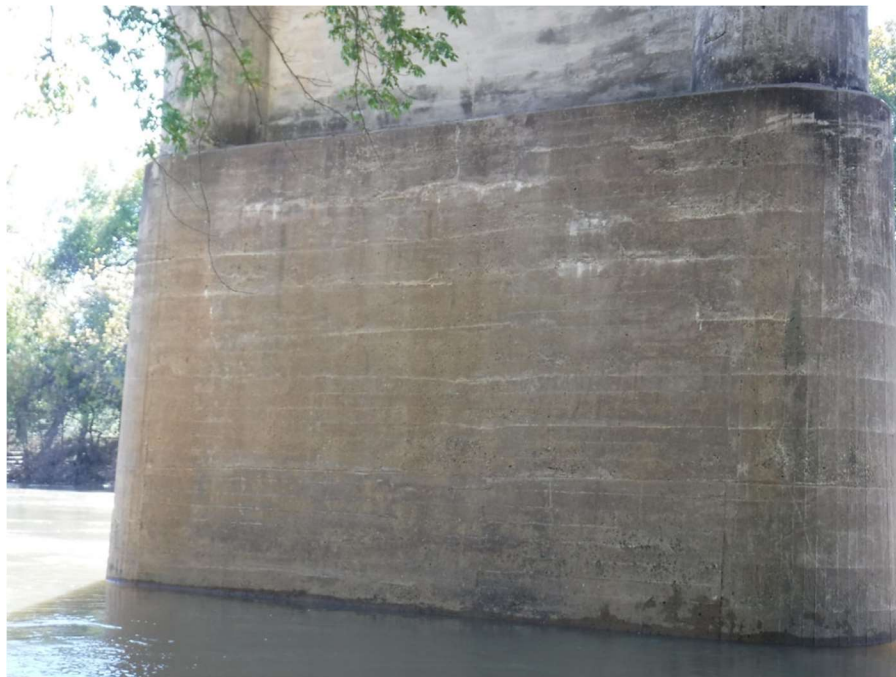
Photo 116 – General condition of concrete bents above water. Heavier abrasion below water level.

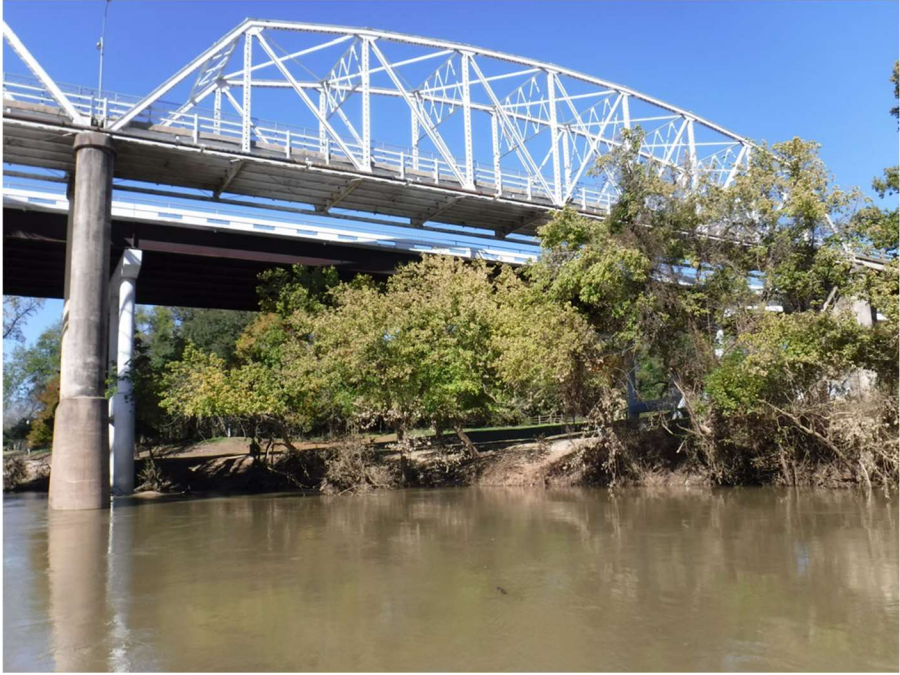
Photo 117 – Erosion of east channel bank through Chestnut St. bridges

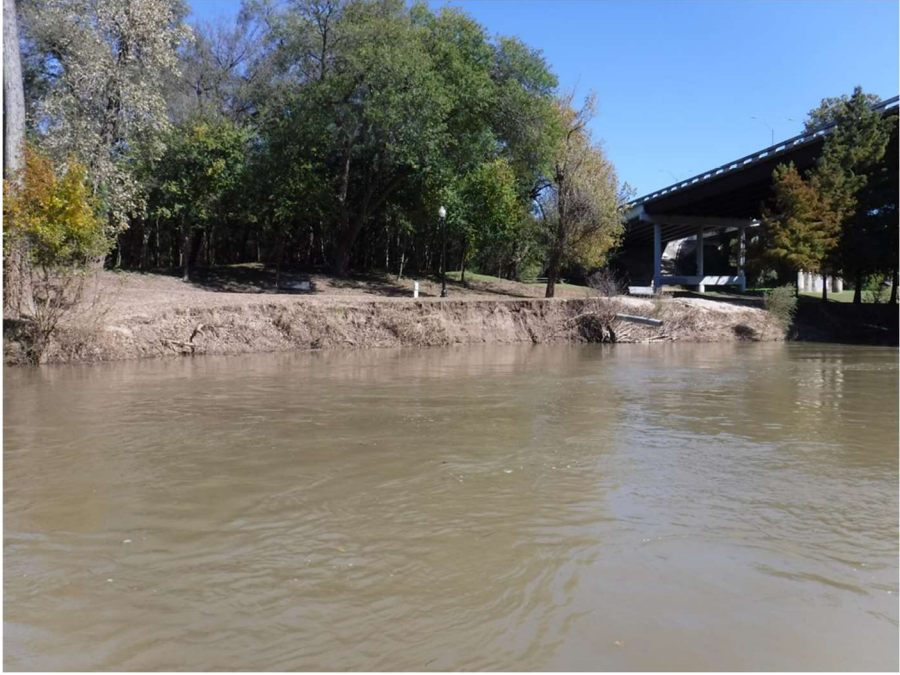
Photo 118 – Erosion of east channel bank upstream of Chestnut St. bridges
