## MEMORANDUM

DATE: December 12, 2019

SUBJECT: Bastrop Corridor Study – Analysis of Safety Performance

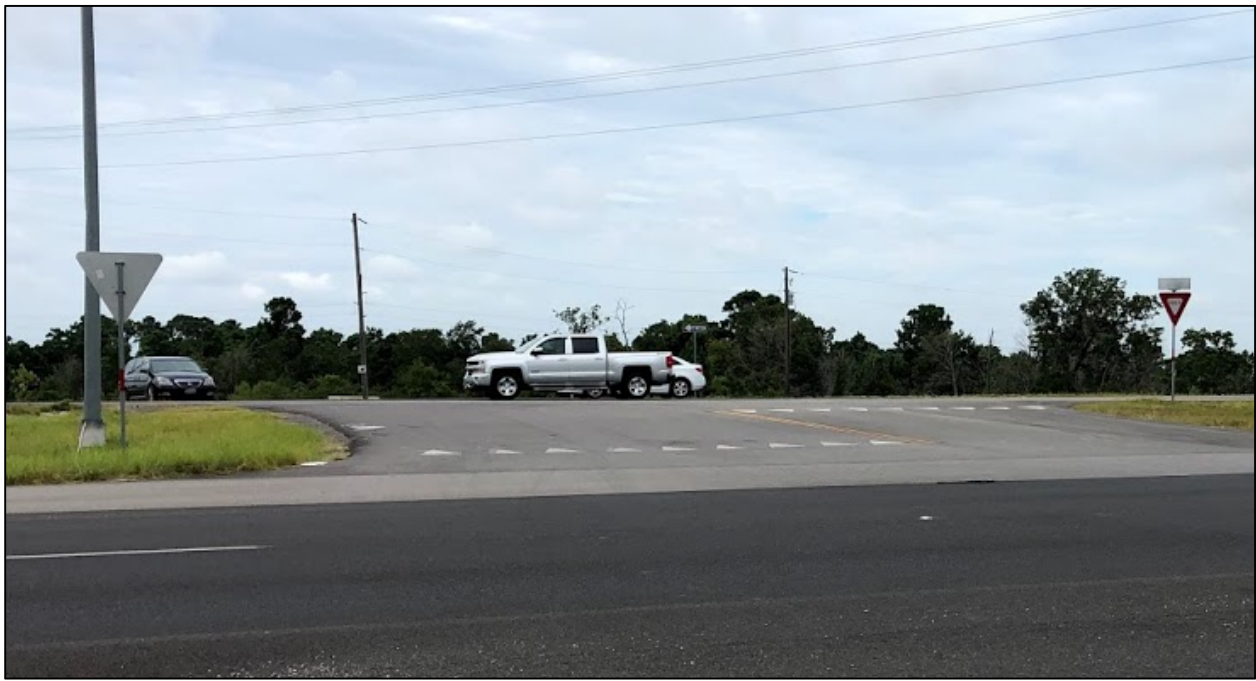
- Two ONE WAY (R6-1) signs appear to be missing below the Yield signs within the median. Refer to **Figure 3** for a photo at this location and **Figure 5** in the next section for the TMUTCD standard sign package.
- The DO NOT ENTER (R5-1) signs for McAllister Road motorists looking left along SH 71 are faded (see **Figure 4**).
- Both side street approaches have potential sight distance issues based on the vertical curve and current 75 mph posted speed limit of SH 71 (see **Figure 4**). Current TxDOT Roadway Design Manual standards require 820 feet of design stopping sight distance at 75 mph.<sup>5</sup>

**Figure 3. Existing signs at the SH 71 & McAllister Rd intersection**

- Install street name sign at SH 71 / McAllister Road intersection
- Install/replace ONE WAY signing for divided highways in accordance with TMUTCD per **Figure 5**. Utilize larger ONE WAY signs (54" x 18") due to the distance from the intersection to the median and approach speeds along SH 71.

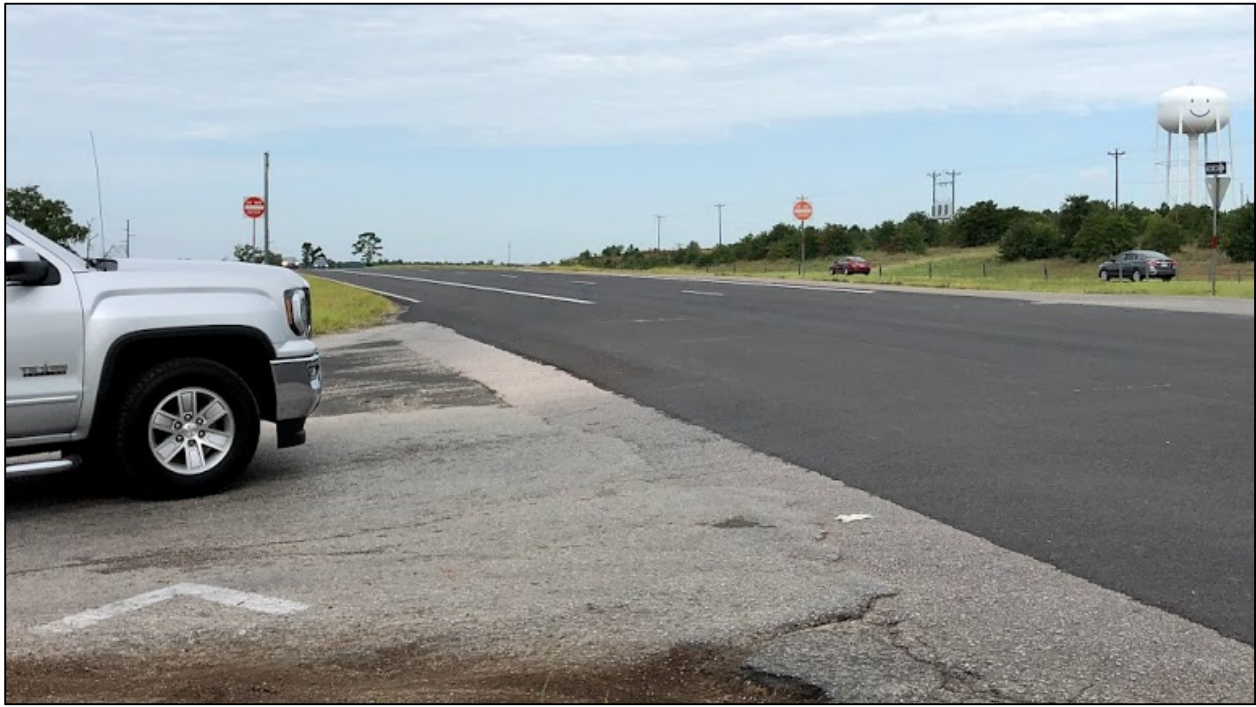
**Figure 4.** View looking left/west from NB McAllister Rd approach to SH 71 showing faded DO NOT ENTER signs, deceleration area striped into the previous 10' shoulder (leaving no shoulder), and sight distance limitation.

Eastbound mainline traffic on SH 71 emerges from a combined vertical/horizontal curve as it approaches the intersection. Vehicles are not visible from McAllister Road until they emerge from the curve along SH 71 eastbound. A field-observed count of 8 to 10 seconds was made for most vehicles approaching the intersection from the west as they became visible at approximately 750-800 feet. Additionally, leading to the McAllister Road intersection, eastbound traffic does have a deceleration area where the shoulder should be, per TxDOT's RDM. The existing deceleration area is 10' wide, 600' long, with a 150' taper and no shoulder, which falls below the guidelines set forth in Table 3-13 of the TxDOT RDM, which require a 950' long lane at 12' wide with a 4' shoulder.

Northbound traffic at the STOP sign is stopped on older pavement and loose gravel with a slight vertical grade. The team observed some motorists struggling for traction, causing tires to spin as they attempted to enter the roadway and avoid oncoming traffic on SH 71.

- Install additional intersection illumination for eastbound and westbound approaches along SH 71 to improve visibility in dark conditions.
- Reconstruct existing eastbound deceleration area to full deceleration lane (12') with shoulder (4')

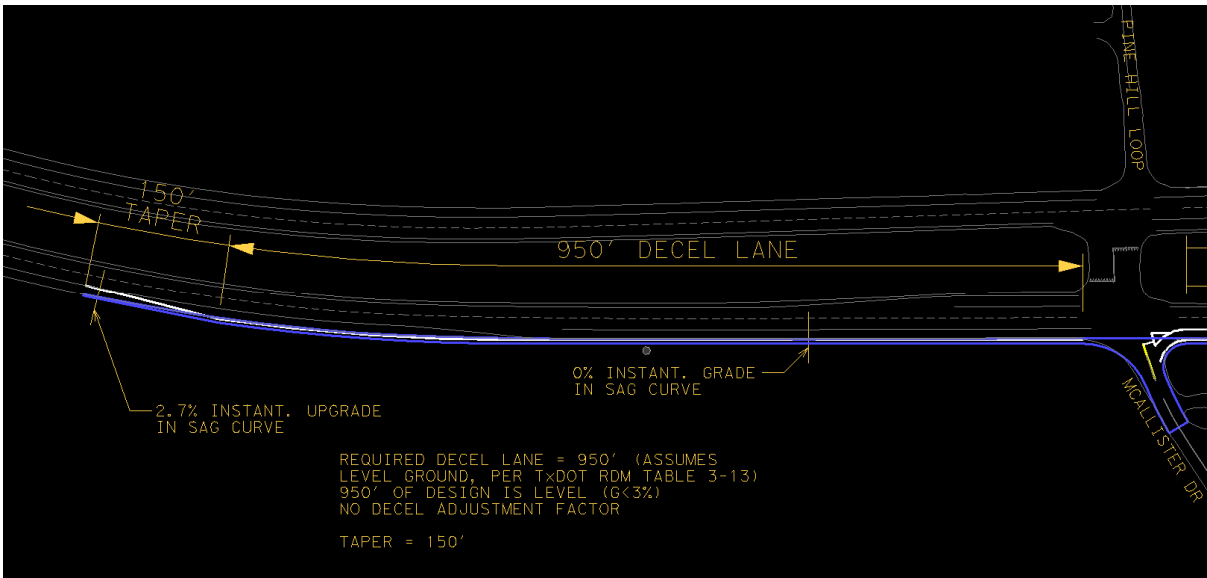
**Figure 6: Eastbound SH 71 to southbound McAllister Road deceleration lane**

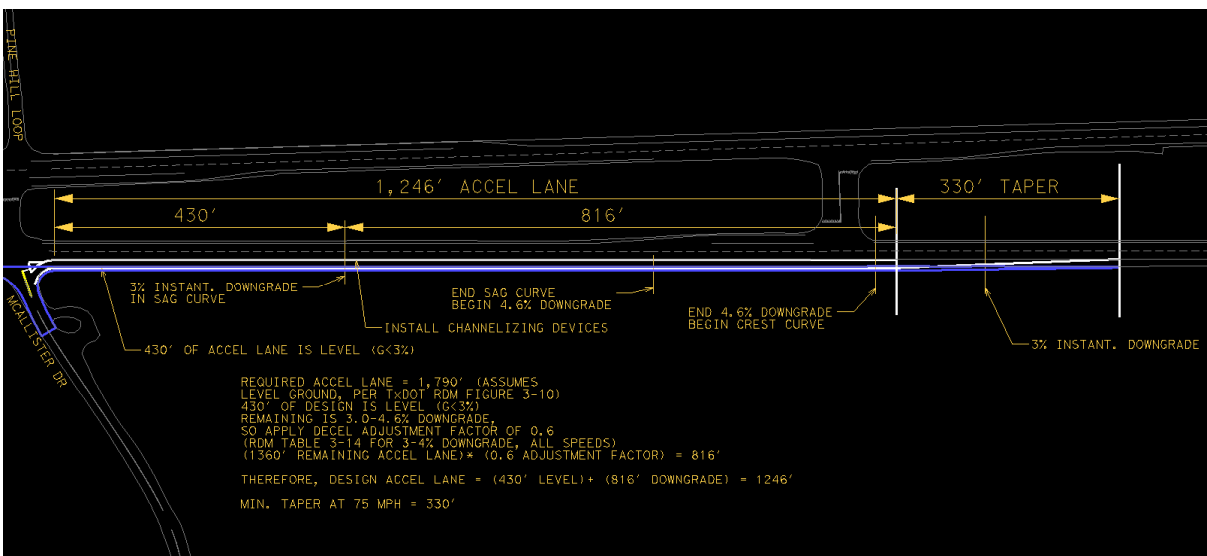
**Figure 7: Northbound McAllister Road to eastbound SH 71 acceleration lane**

- Construct northbound to eastbound acceleration lane with 4' shoulder.
  - Recommend installing channelizing devices along acceleration lane to prevent unsafe weaving operations to adjacent median opening.

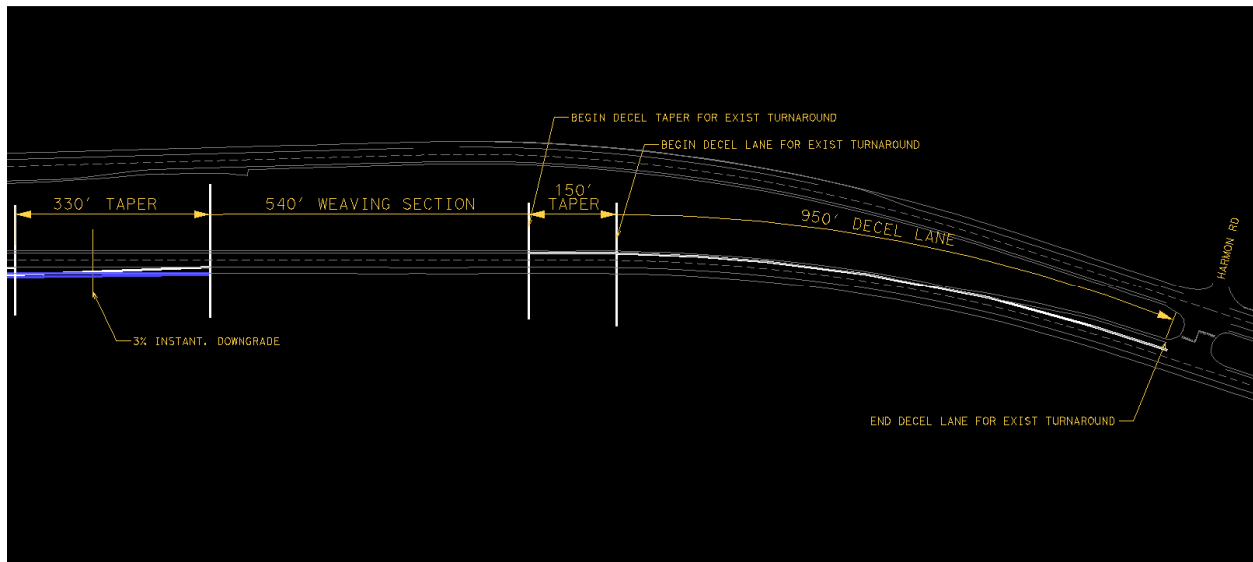
**Figure 8: Weaving Section between eastbound acceleration lane and Harmon Rd deceleration lane**

- Reconstruct the existing eastbound left-turn deceleration lane and taper at the Harmon Rd median opening to meet Current TxDOT RDM design standards. This improvement combined with eastbound acceleration lane at McAllister Road would result in approximately 540' weaving distance between the end of the eastbound acceleration lane and beginning of the eastbound deceleration lane taper, as shown in **Figure 8**, below, which is sufficient to accommodate a lane change maneuver, and will therefore not preclude the J-turn Medium-term solution described below

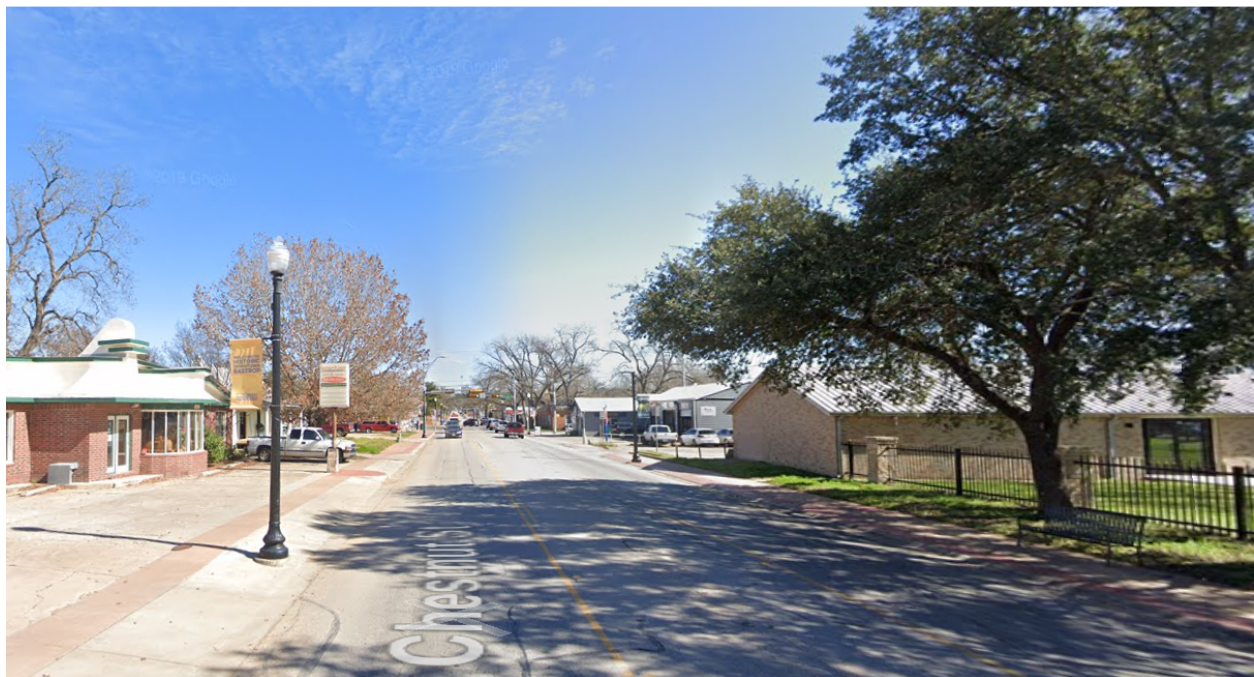
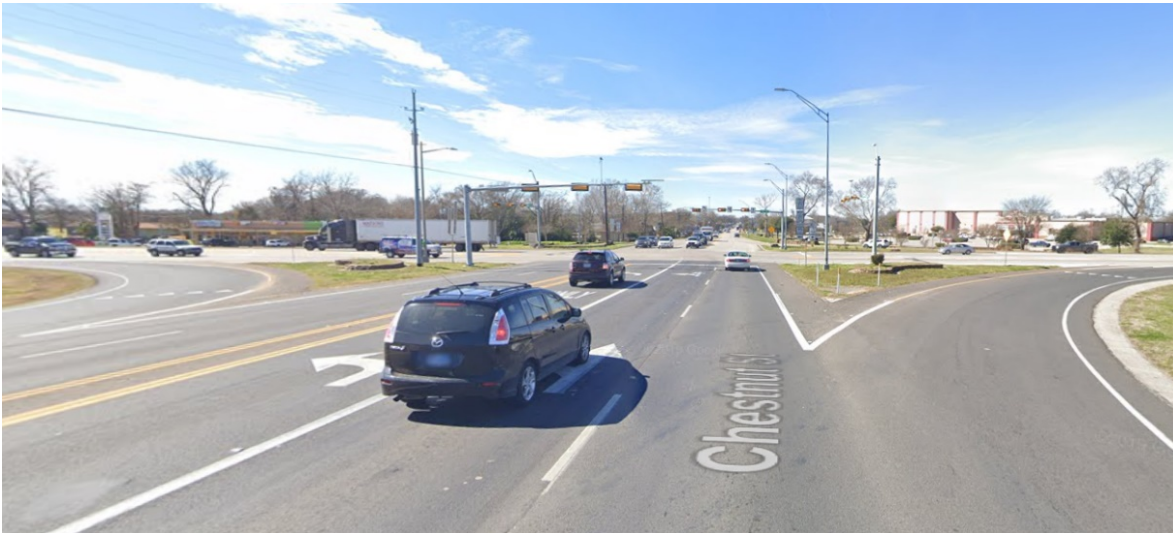
This segment's characteristics differ from the others in this safety study. In particular, the western half of SL150 is a lower speed city arterial with a high number of intersections and private entrances serving commercial properties (see **Figure 13**).

**Figure 13. Typical cross section of SL 150 through Bastrop (Google Maps)**

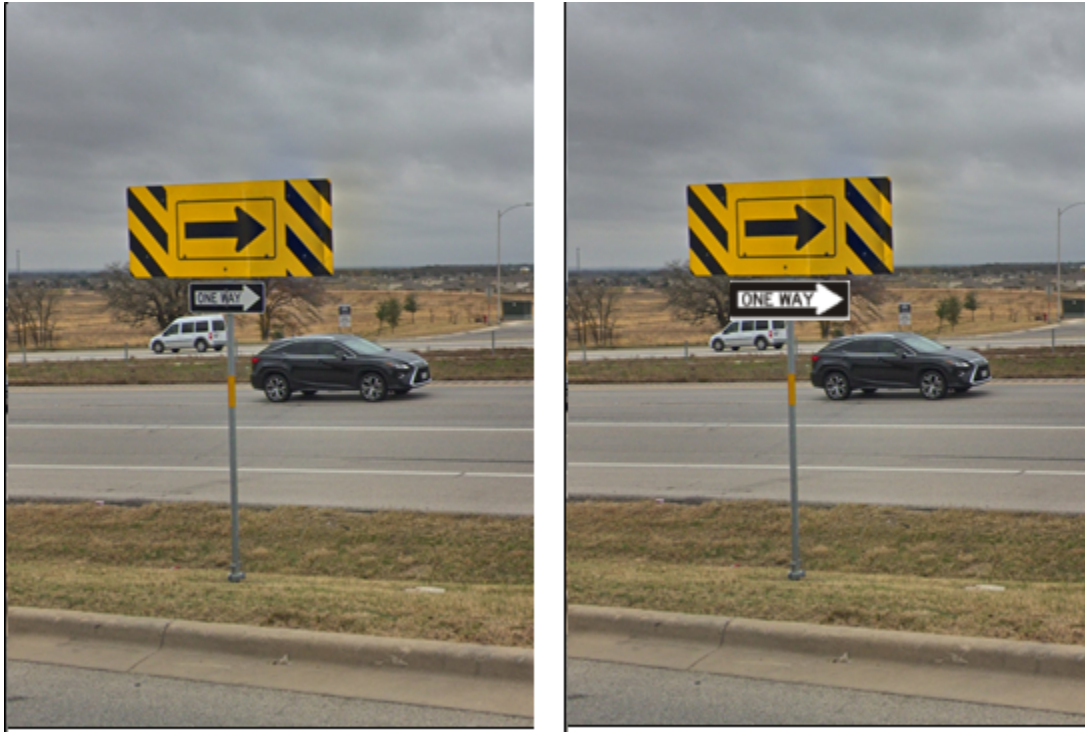
Researchers reviewed the FM 969 approach at SH 21 during their field observations on July 22, 2019. In general, signing and pavement marking appeared consistent with the TMUTCD and TxDOT RDM. However, due to the oversizing of certain regulatory and warning signs, the existing standard sized ONE WAY appeared small in comparison as shown in **Figure 22**.

**Figure 22: Left – FM 969 at SH 21 (Google Maps, 2018). Right – Artist rendition of oversized ONE-WAY sign**

| Treatment | Crash Reduction Factor and type affected <sup>25</sup> | Estimated Implementation Cost <sup>26</sup> |
|---|--|---|
| Replace existing ONE-WAY sign | Unknown | \$600 |

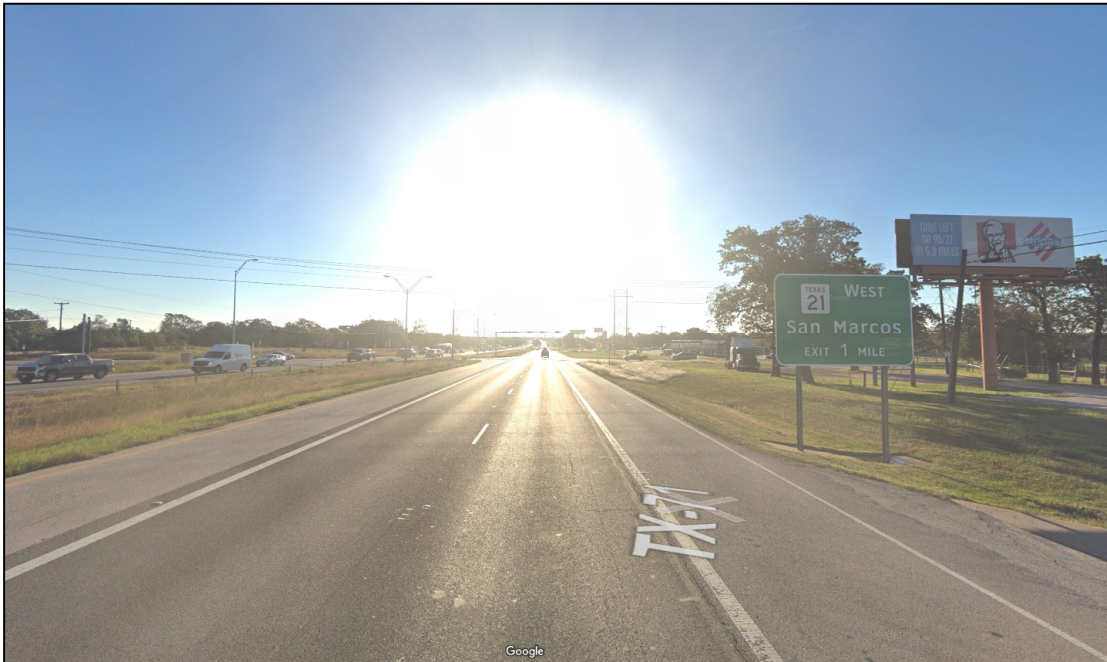
The research team conducted a field observation at this location. There appeared to be no sight distance issues for motorists traveling eastbound and westbound on SH 71. Depicted in Figure 25 below, the sun may cause blinding making it hard to see the traffic signal. There are also advanced traffic signal warning signs with flashing beacons eastbound and westbound on SH 71. The speed limit of this segment is 70 mph.

Figure 25: FM 1209 and SH 71 West (Google Maps, 2018)
