Mid Year Budget Workshop

History of Today's Icon

Bridge Inspection 2014

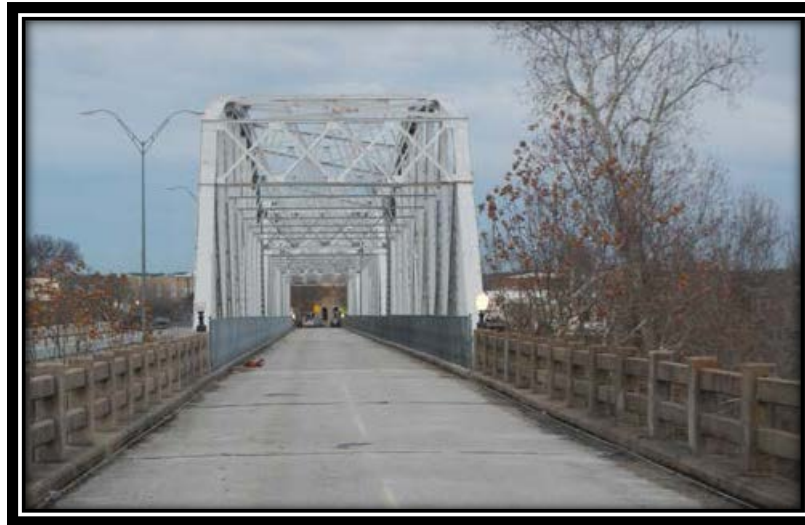
End view looking east.

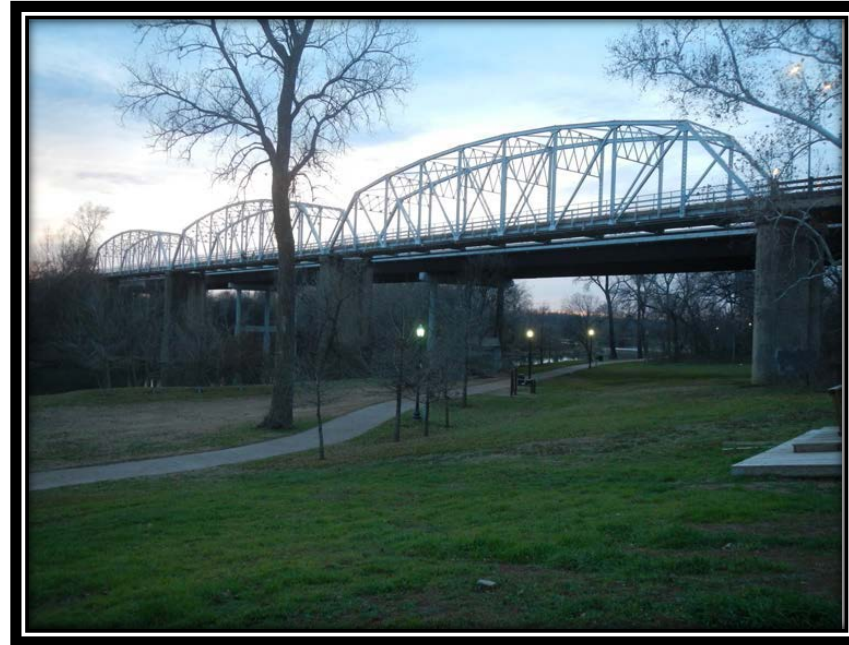
Elevation looking northwest.

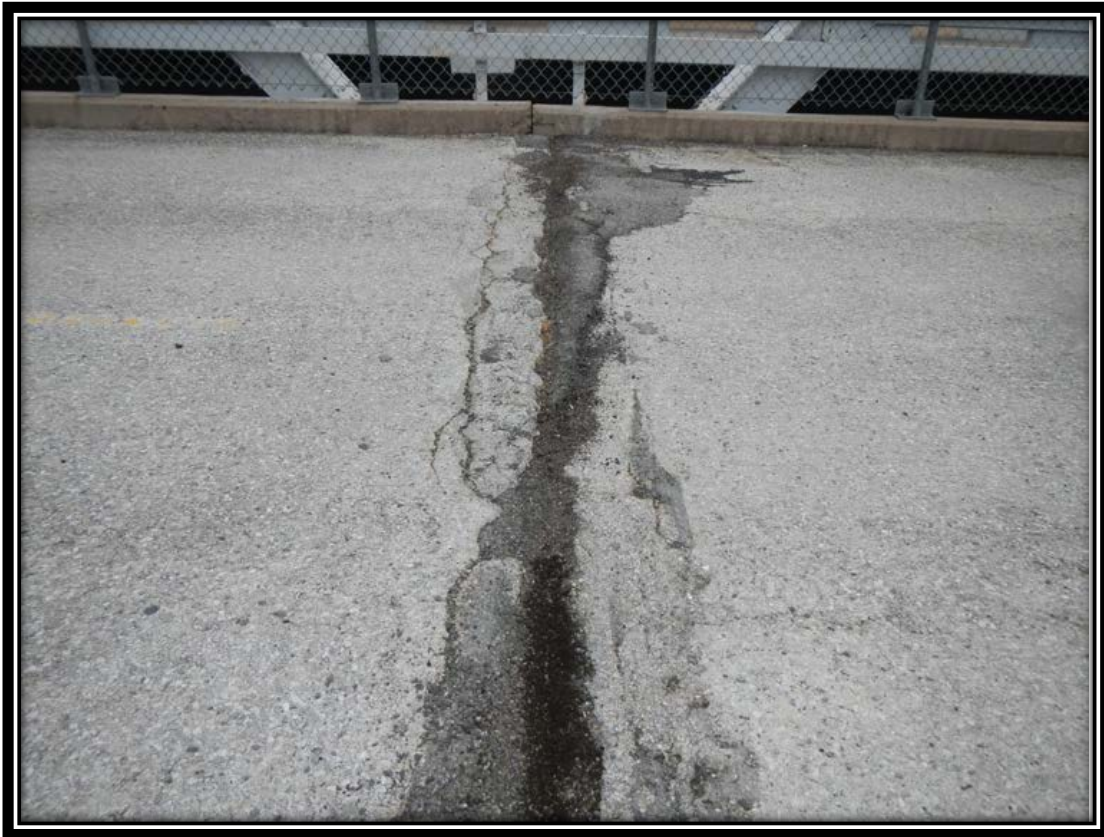
Looking north at the asphalt wearing surface over pier 17 between spans 17 and 18.
Note: the asphalt patch is loose and deteriorated.

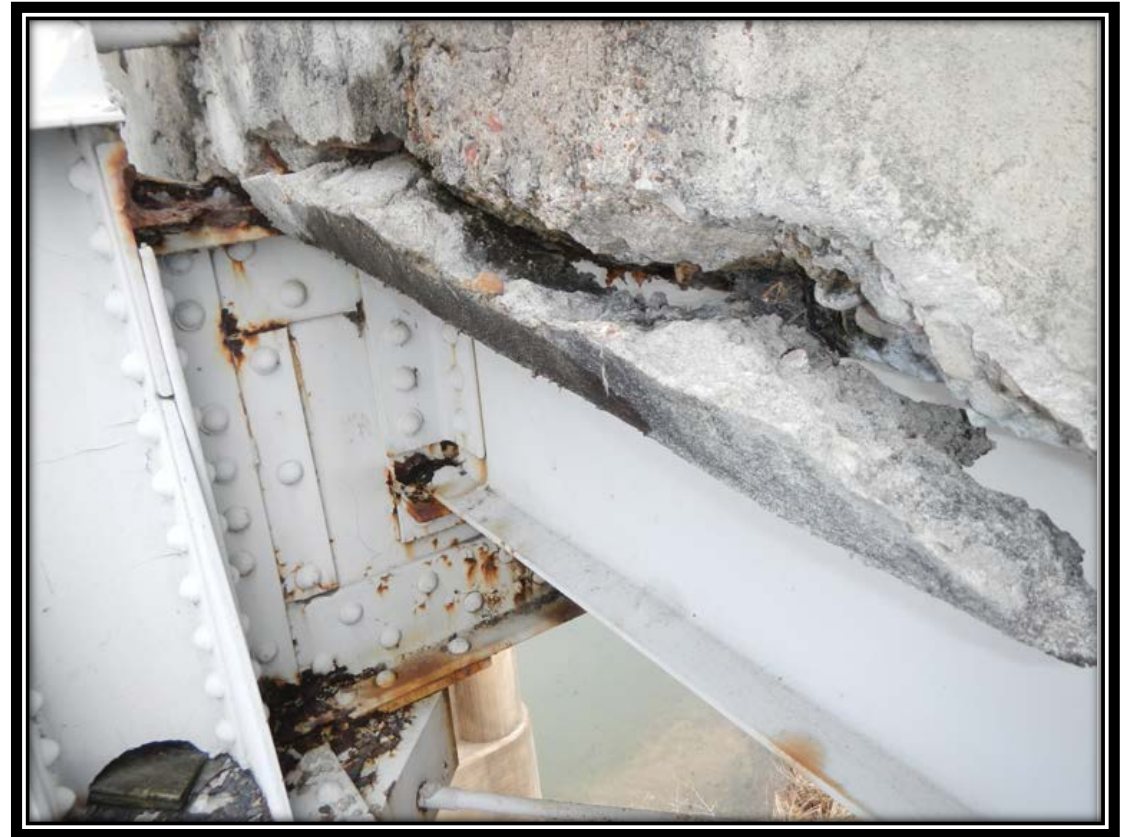
Looking southeast at the north edge of the deck at panel point 7 in span 16. Note: 3-foot long spall in the edge of the deck with exposed reinforcing steel.

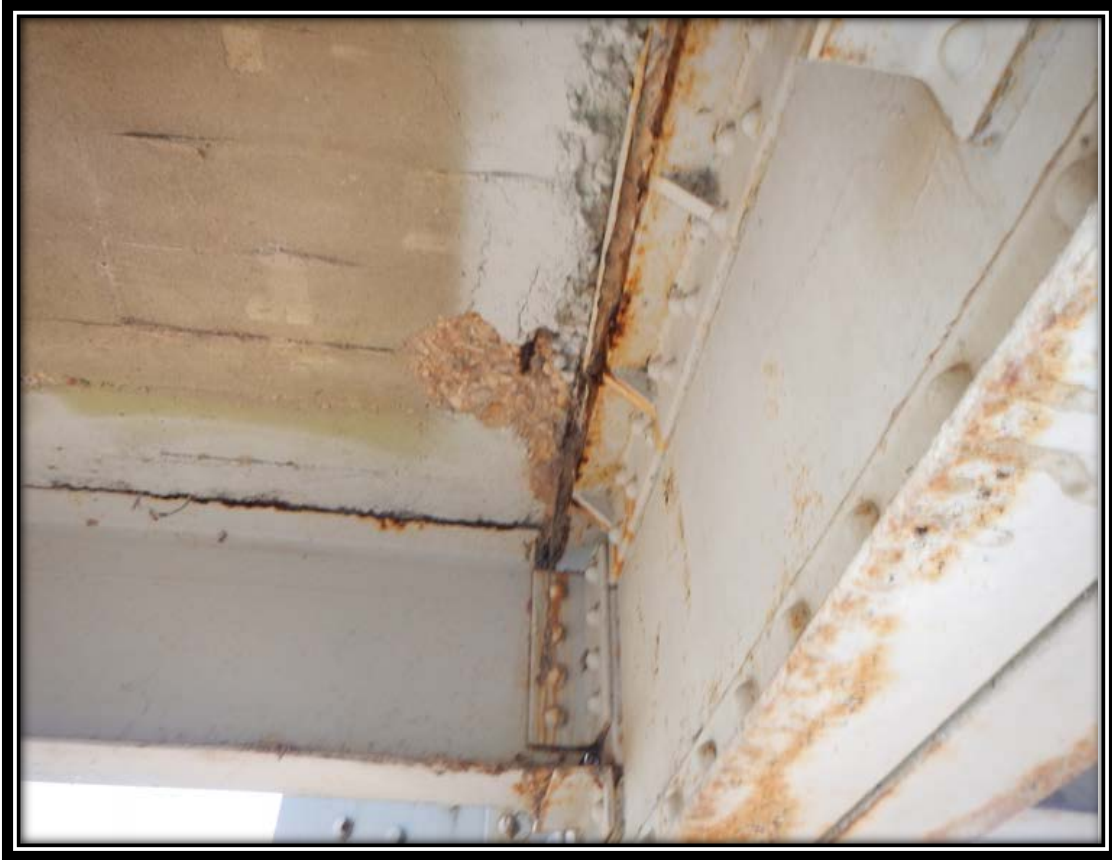
Looking north at the underside of the deck at floor beam 3 in span 16. Note: spall in deck underside with exposed reinforcing steel adjacent to floor beam top flange.

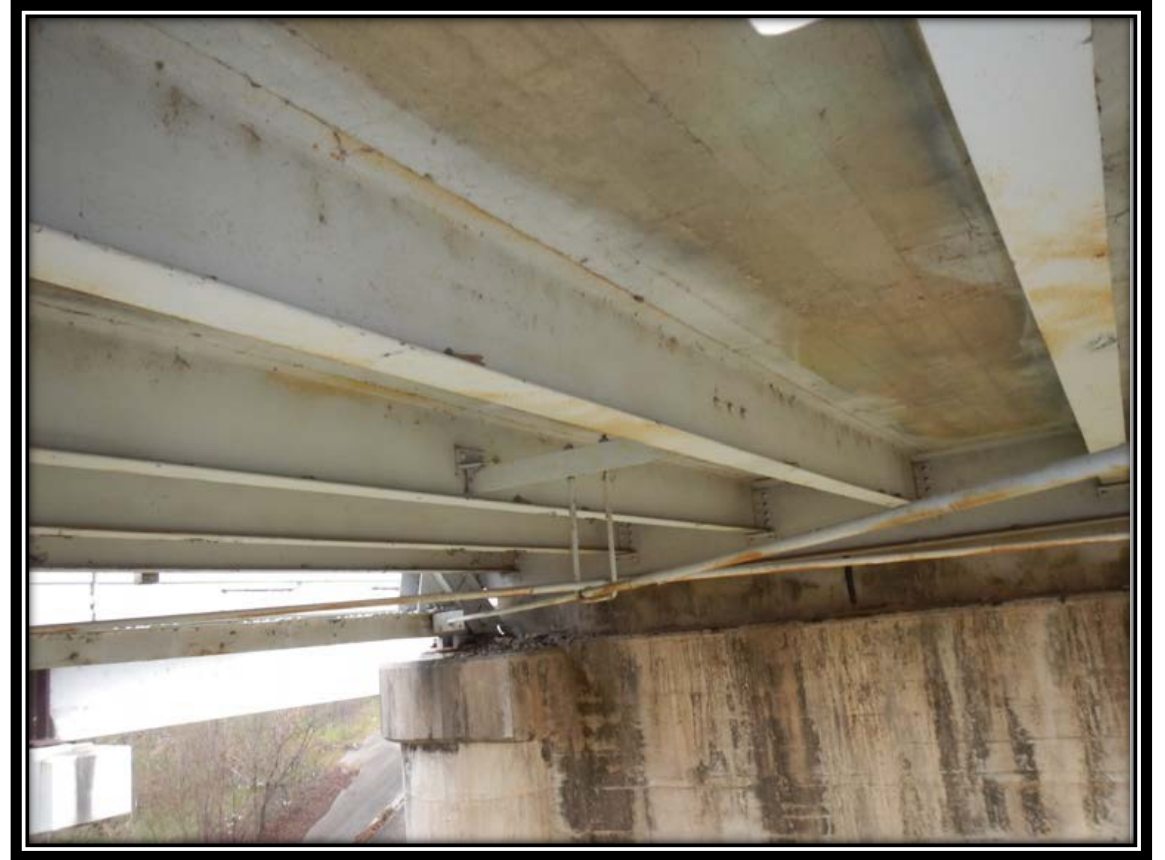
Looking northeast at the stringers at floor beam 8. Note: typical stringer condition with minor surface corrosion on the webs and flanges.

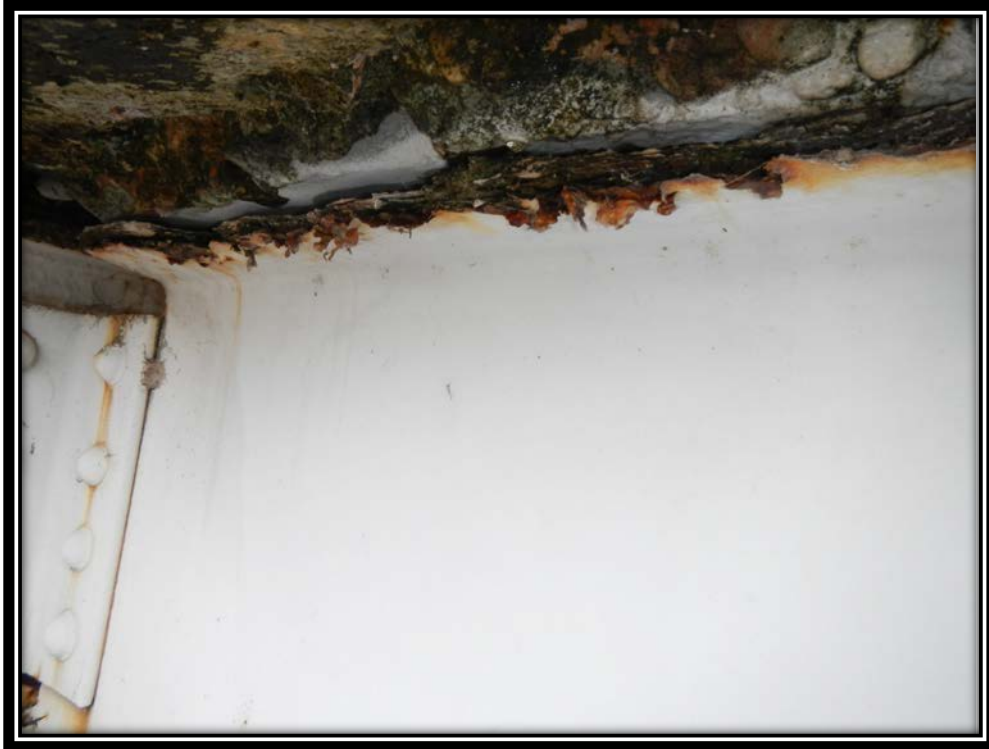
Looking southeast at stringer 1, span 16 at floor beam 7. Note: 1-inch wide knife edge section loss to the stringer top flange for 10-feet of stringer length.

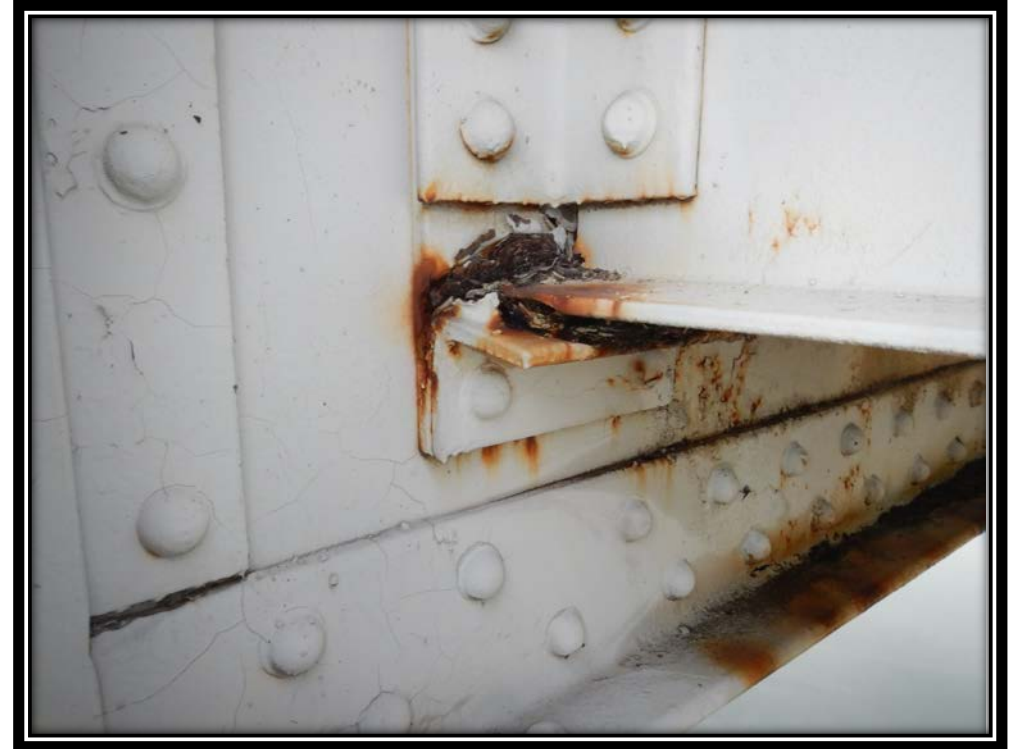
Looking northwest at stringer 6 connection to floor beam 3 in span 17. Note: heavy pack rust between stringer bottom flange and seat angle.

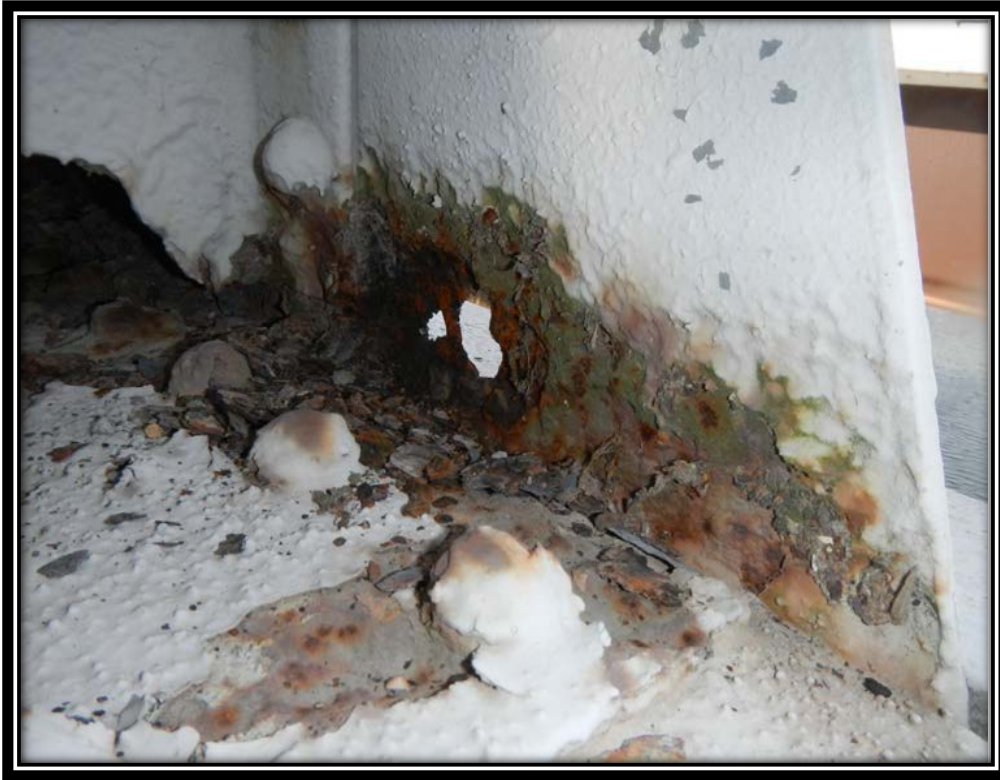
Looking northwest at the outboard gusset plate at L2, span 17, north truss. Note: 1-inch diameter corrosion hole through the gusset plate along the horizontal shear plane.

- Additionally, during the inspection, heavy and active section loss was noted on many lower chord gusset plates including through holes. Some locations of section loss were greater than **50%** of the original area. These gusset plates were rated for horizontal shear (by the Load Factor Method) since the section loss occurred nearly exclusively along the top of the lower chord. The gusset plates were rated for a combination of truck and pedestrian live load.

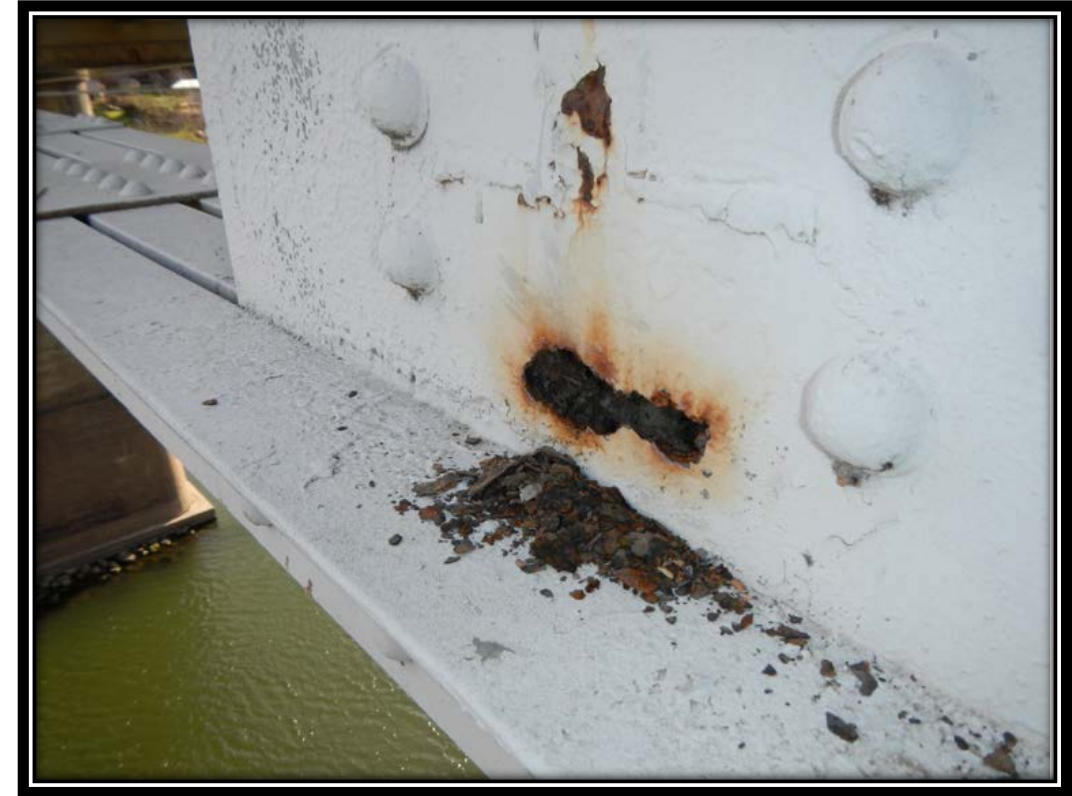
Looking southeast at the outboard gusset plate at L4, span 17, north truss. Note: 3 1/2-inch horizontal by 1-inch vertical corrosion hole through the gusset plate along the horizontal shear plane.

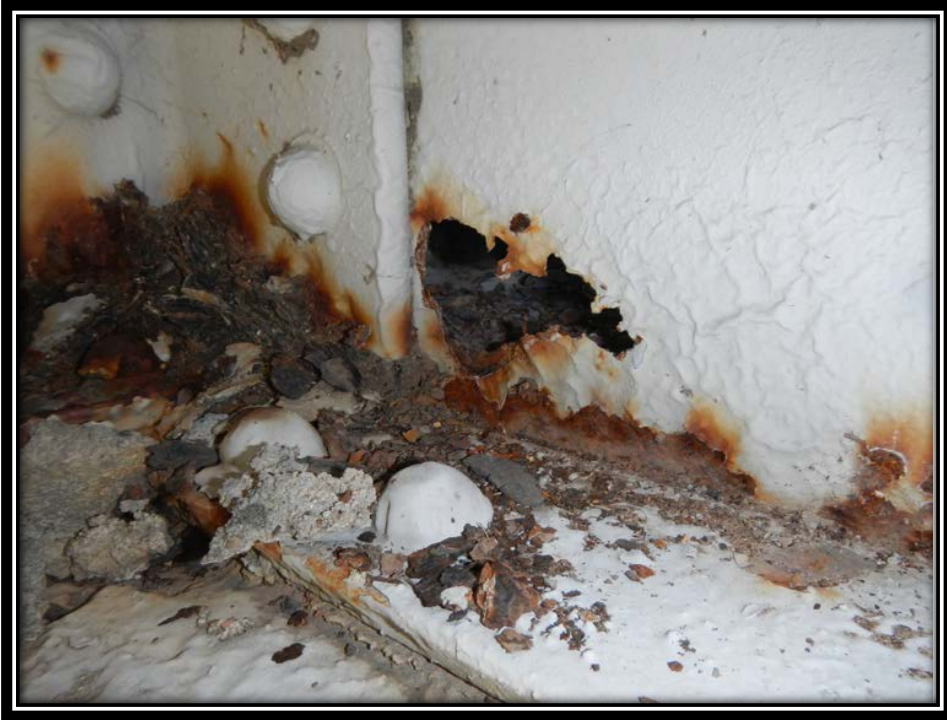
Looking northwest at the inboard gusset plate at L6, span 18, north truss. Note: 3 1/2-inch horizontal by 2 1/2-inch vertical corrosion hole through the gusset plate along the horizontal shear plane.

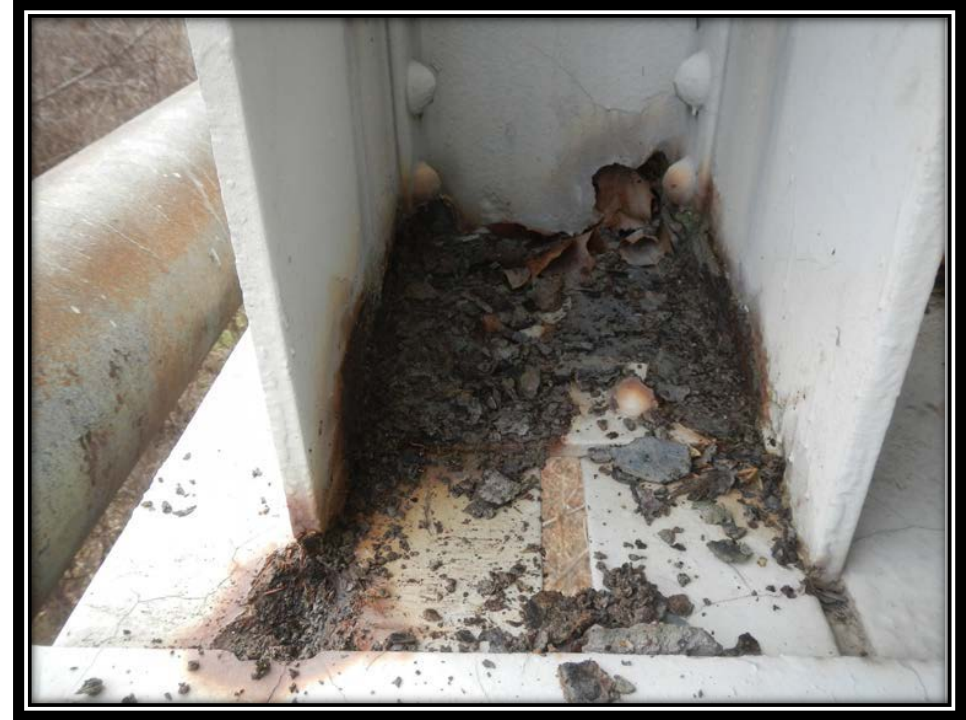
Looking west at L5L6 at L6, south truss in span 16. Note: 1/8-inch deep by 1-inch wide pitting on the top flange of the lower chord.

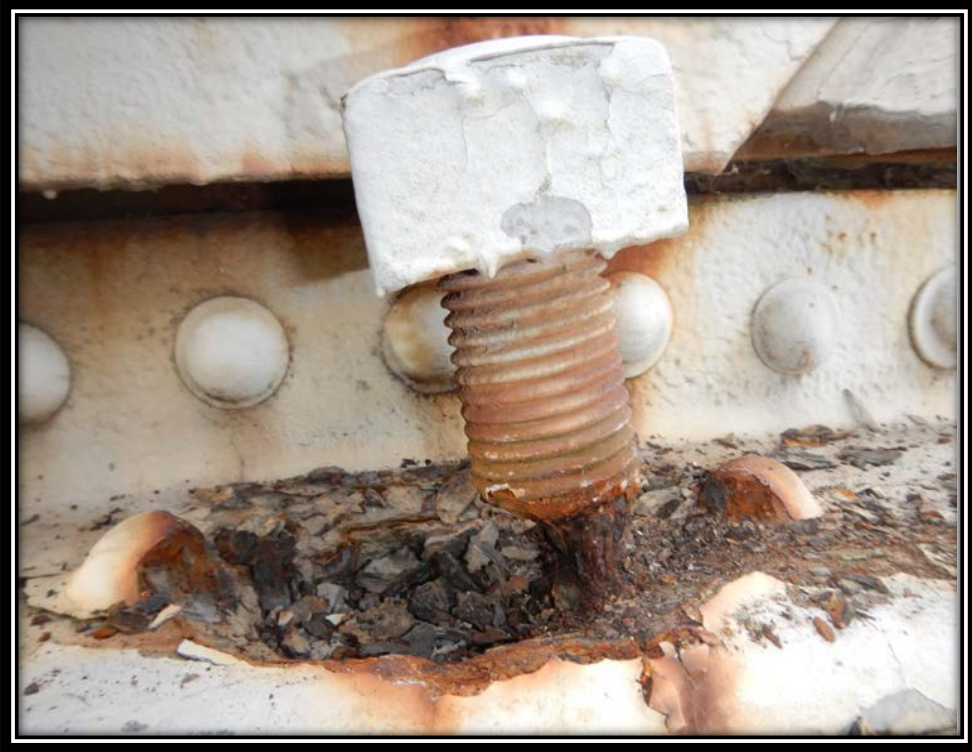
Looking north at the south truss bearing at L0, span 17. Note: 1 1/2-inch nominal diameter anchor bolt exhibits up to 75% section loss at the base of the anchor bolt.

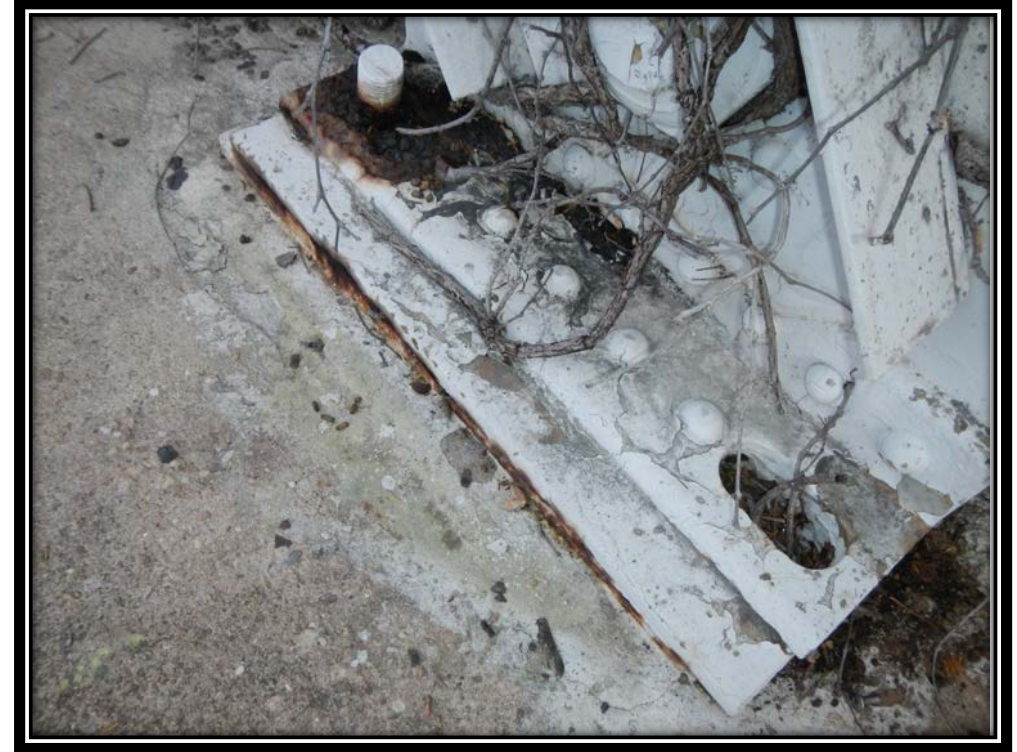
Looking southeast at the north truss bearing at L0, north truss. Note: one missing anchor bolt on outboard face of the bearing. Also note, expansion slot filled with corrosion and debris.
