Above the Flood: Elevating Your Floodprone House

FEMA 347 / May 2000

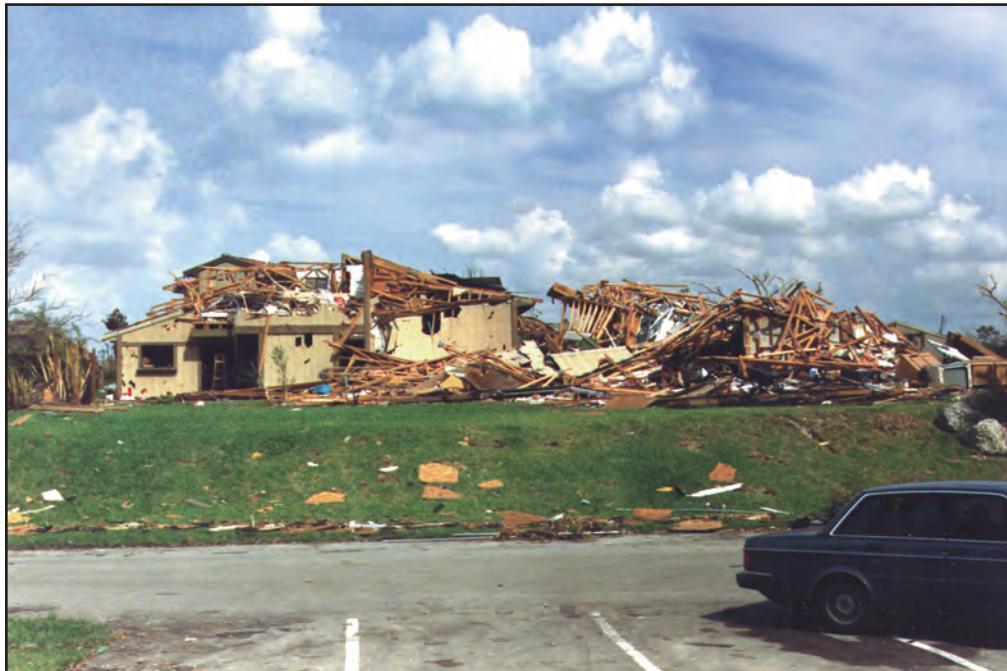
Figure 4

In low-lying areas, wind and rain damage to interior finishes and furnishings was exacerbated by flood waters.

The widespread destruction caused by Andrew was due primarily to high winds (Figure 3). However, flood waters contributed to the damage in low-lying coastal areas of central and southern Miami-Dade County (Figure 4).

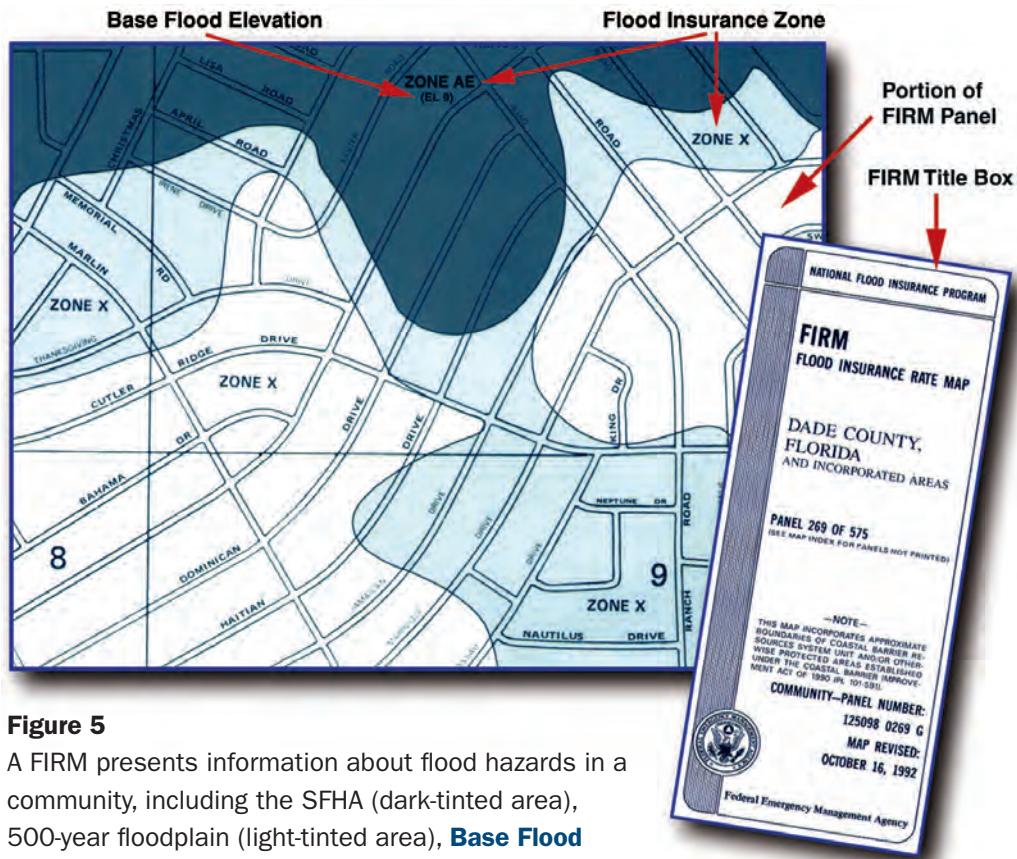
**Figure 5**

A FIRM presents information about flood hazards in a community, including the SFHA (dark-tinted area), 500-year floodplain (light-tinted area), **Base Flood Elevation (BFE)** (number in parentheses), and flood insurance zones (AE and X in this example).

Note that the SFHA in the example in Figure 5 is designated Zone AE. This zone is only one of several applied to SFHAs under the NFIP, including V, VE, V1-V30, A, AE, A1-A30, AO, and AH. These zones indicate differences in the types and severity of flood hazards in SFHAs. For the purposes of this publication, it is sufficient to focus on the basic differences between the two main types of SFHA zones—V zones and A zones. The distinction is important because regulatory requirements associated with V zones and A zones differ significantly. As explained later in this chapter, these requirements affect the types of building elevation techniques that may be used under the NFIP.

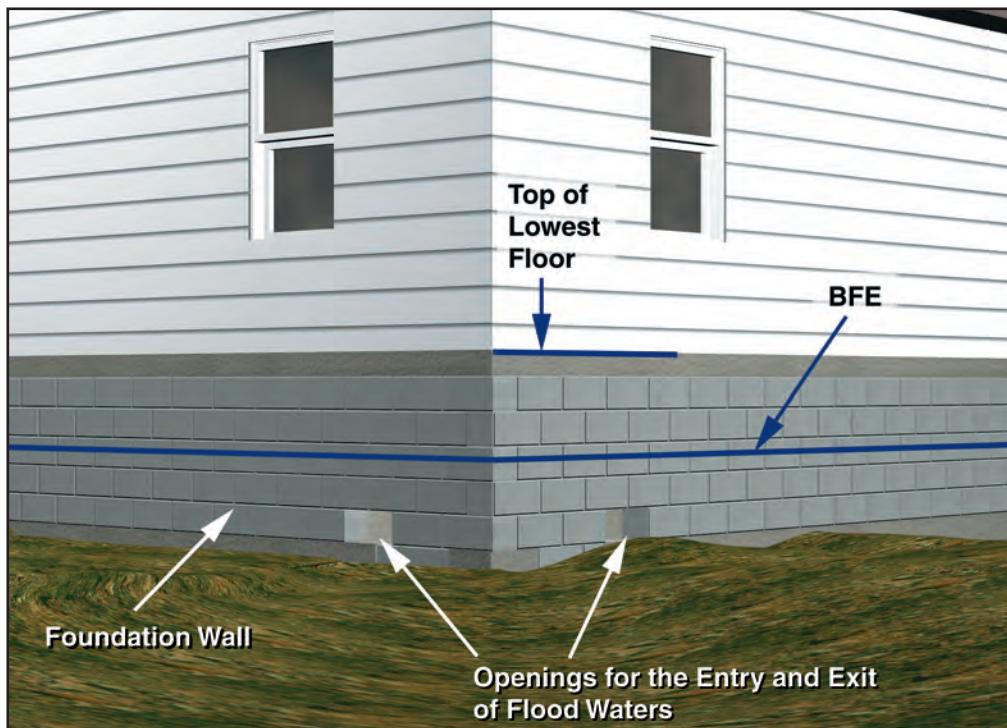
**Figure 6**

In a new, substantially improved, or substantially damaged building in an A zone, the elevation of the lowest floor must be at or above the BFE.

In A zones, where flood hazards are less severe, buildings may be elevated either on an open foundation or on continuous foundation walls below the BFE (Figure 6). Regardless of the type of foundation used, A-zone buildings must be elevated so that the **lowest floor** is at or above the BFE, as shown in Figure 6. If continuous walls are used below the BFE, they must be equipped with openings that allow flood waters to flow into and out of the area enclosed by the walls (Figure 6). Allowing the entry and exit of flood waters ensures that water pressures will be the same on both sides of the walls and reduces the likelihood that water pressure will cause the walls to fail.

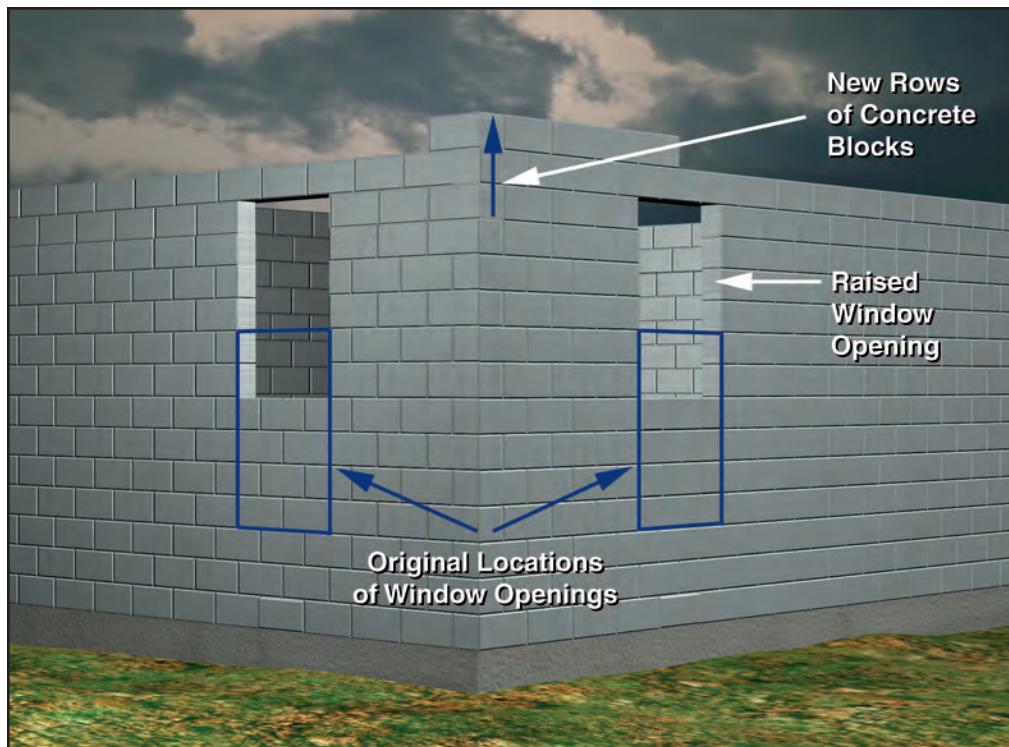
Figure 11

The tops of the walls and bottoms of the window openings are raised with concrete blocks.

After the roof, windows, and doors are removed, several courses of concrete block are added to the tops of the existing walls and to the bottoms of the window openings (Figure 11). A corresponding number of blocks are removed from the tops of the window openings so that the size of the windows will remain the same. In addition, although not shown in Figure 11, concrete bond beams are formed in place at the tops of the extended walls to provide structural reinforcement.

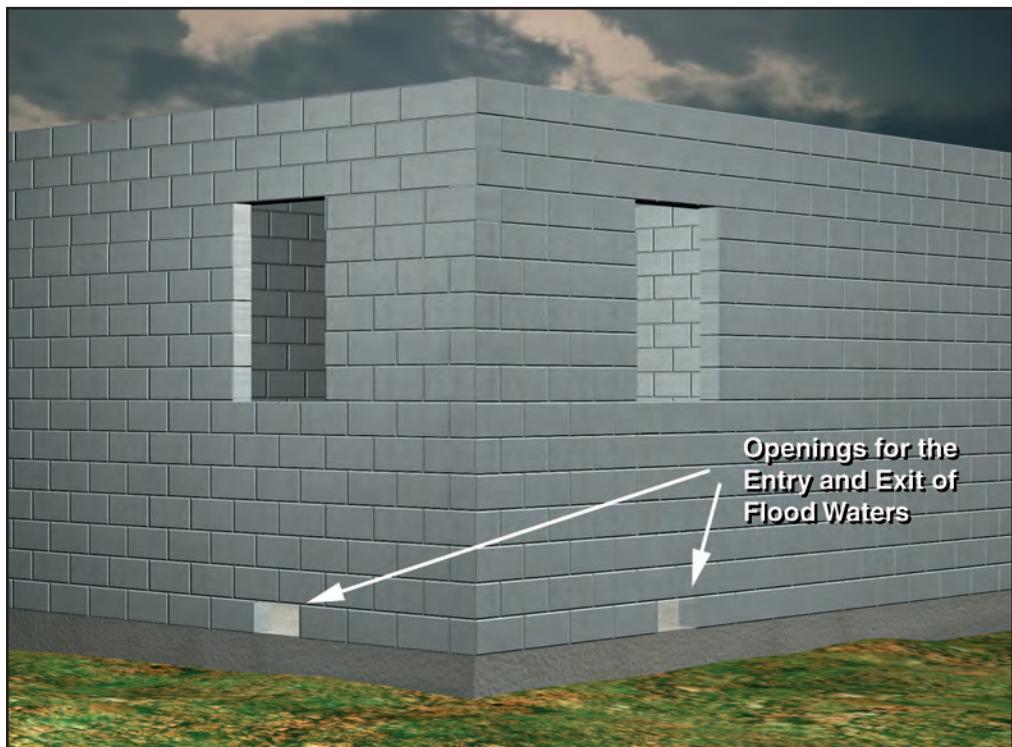
Figure 12

Openings are created in the walls near the ground.

Blocks are removed from the walls of the house at selected locations within 1 foot of the ground (Figure 12). The resulting openings will allow flood waters to flow into and out of the lower area of the house so that the water pressures on both sides of the walls will remain the same. The roof and windows are then replaced, and a new wood-frame floor is constructed above the flood level (Figure 13).

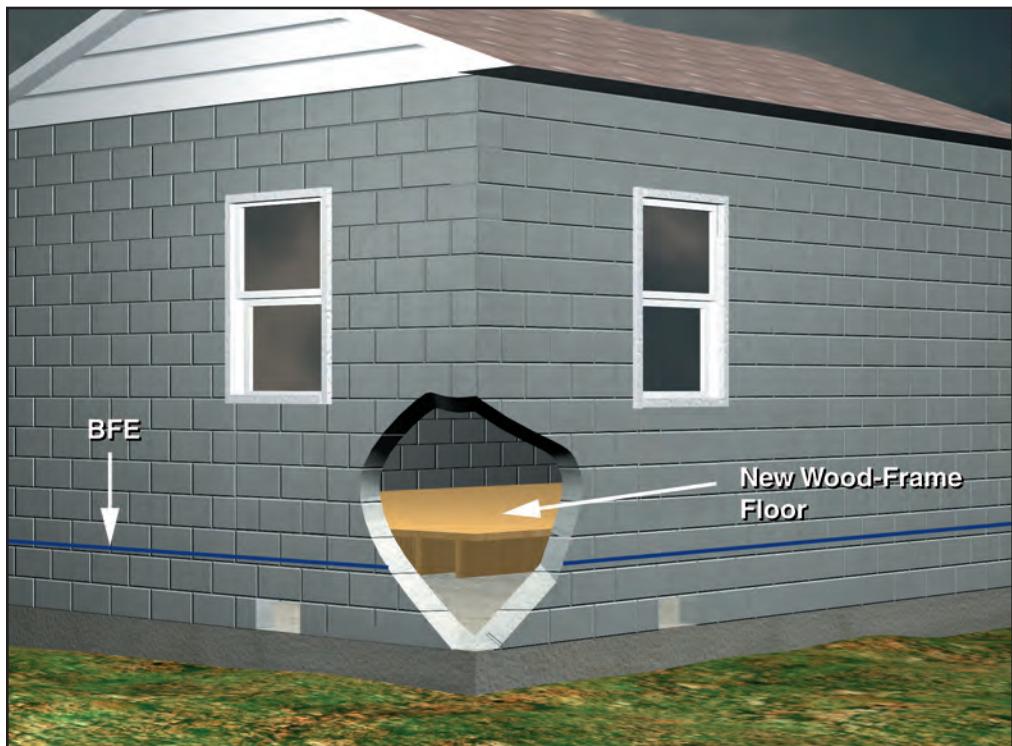
**Figure 13**

A new wood-frame lowest floor is constructed above the flood level, and the roof, windows, and doors are reinstated.

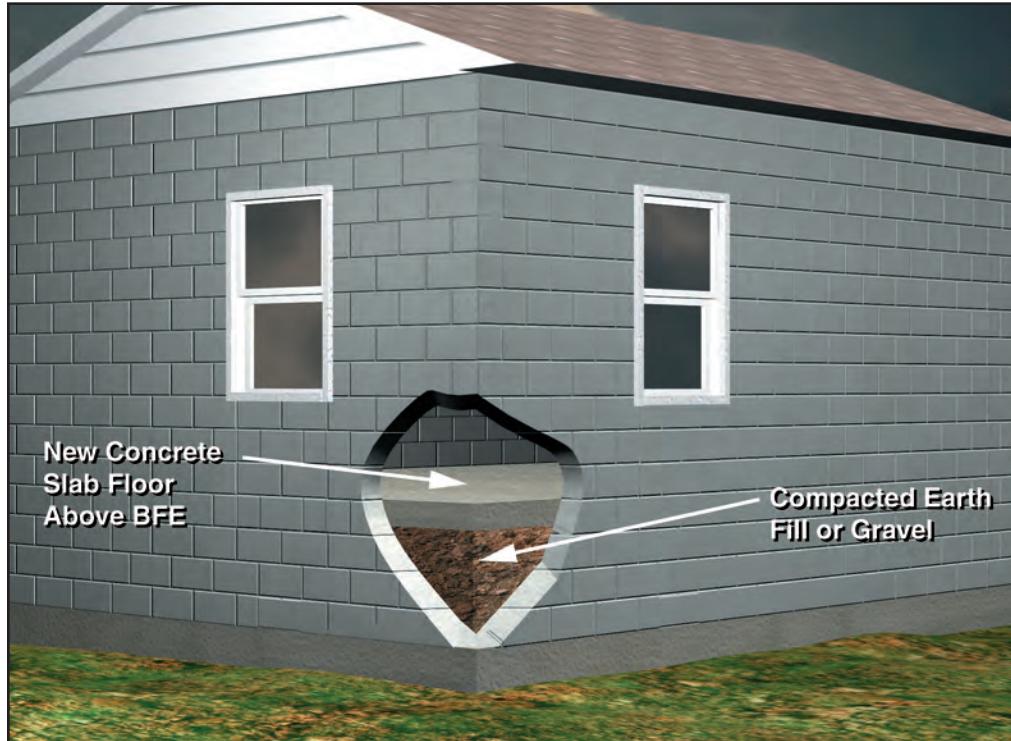
Figure 14
An alternative to building an elevated wood-frame floor is installing a new, elevated concrete slab floor on fill placed over the old slab.

A homeowner who chooses Technique 1 may decide to build a new concrete slab floor instead of a wood floor (Figure 14). When this option is chosen, compacted fill dirt or gravel is placed on top of the old slab and the new slab floor is poured on top. Because the area below the new floor is filled with dirt or gravel, wall openings are not required.

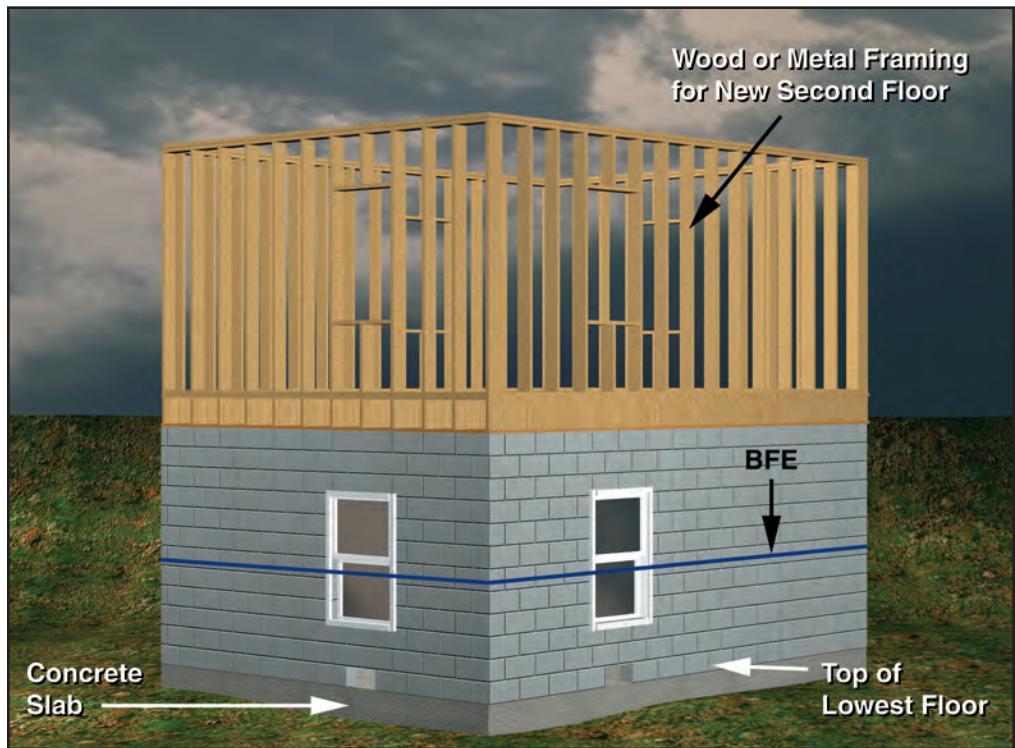
The new second-story floor and walls are built on top of the existing lower story.

As in Technique 1, the repairs begin with the temporary removal of the roof and roof framing (Figure 10). After the roof is removed, construction of the new second story begins. First, a new wood-frame floor is built on top of the existing lower-story walls. The second-story walls are framed with metal or wood studs and set in place on the floor (Figure 15).

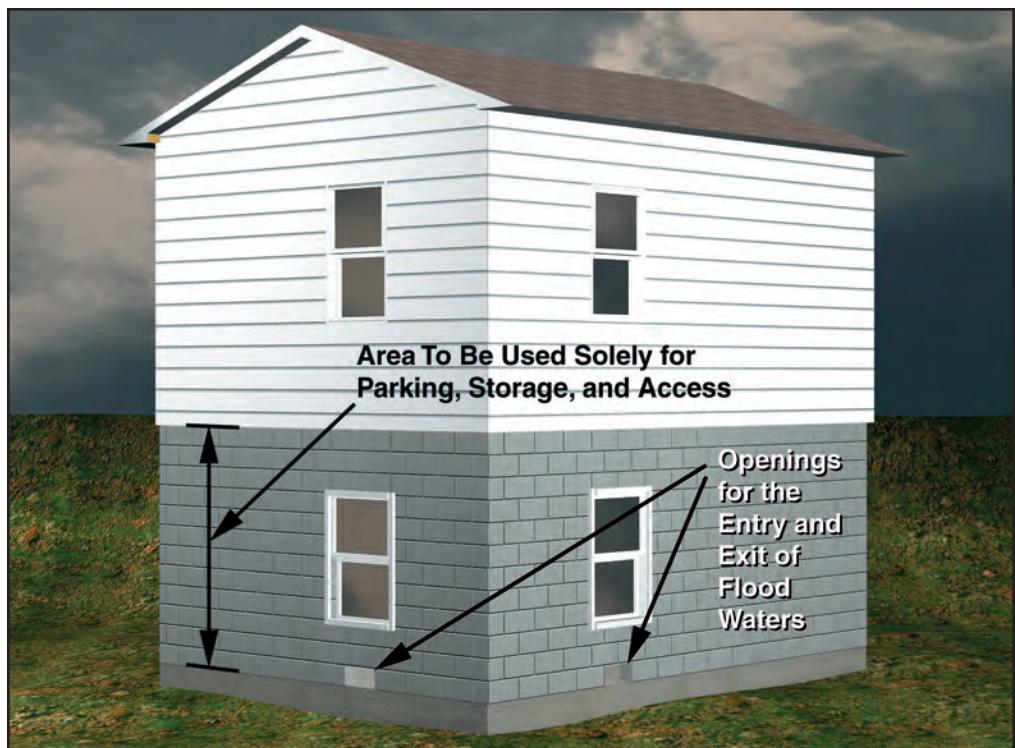
Figure 16

The new second-story walls are covered with siding or stucco.

Some homeowners prefer that the second story be constructed of masonry, but wood- or metal-framing is more common, primarily because it is lighter and less expensive. The roof is replaced, and blocks are removed from the walls to allow flood waters to enter and exit. Exterior sheathing is then added to the framed walls of the second story, the new windows are installed, and siding or stucco is applied to the sheathing (Figure 16).

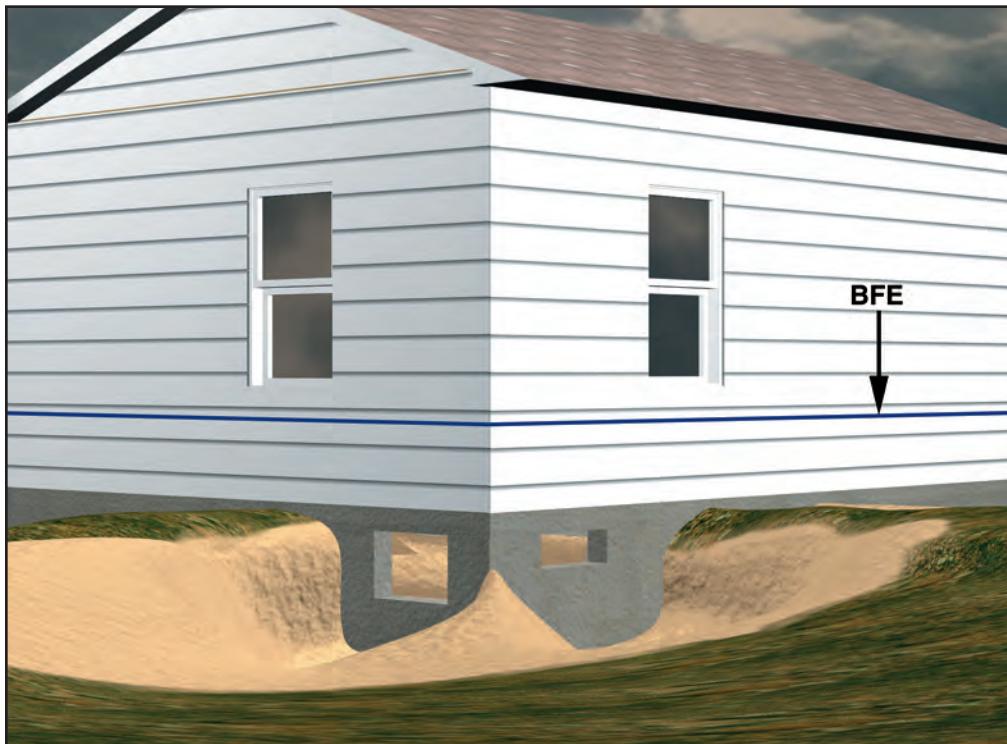
Figure 17
Trenches and tunnels under the slab provide access for the jacks and I-beams that will lift the house.

First, trenches are dug to expose the foundation walls immediately below the slab. Holes are then cut in the foundation walls at intervals around the house, and tunnels are dug under the slab (Figure 17). Jacks are placed in the trenches and large I-beams are inserted through the tunnels and allowed to rest on the jacks. Smaller I-beams are then inserted through the tunnels at right angles to the larger beams and positioned on top of them. The smaller beams support the slab when the house is raised (Figure 18).

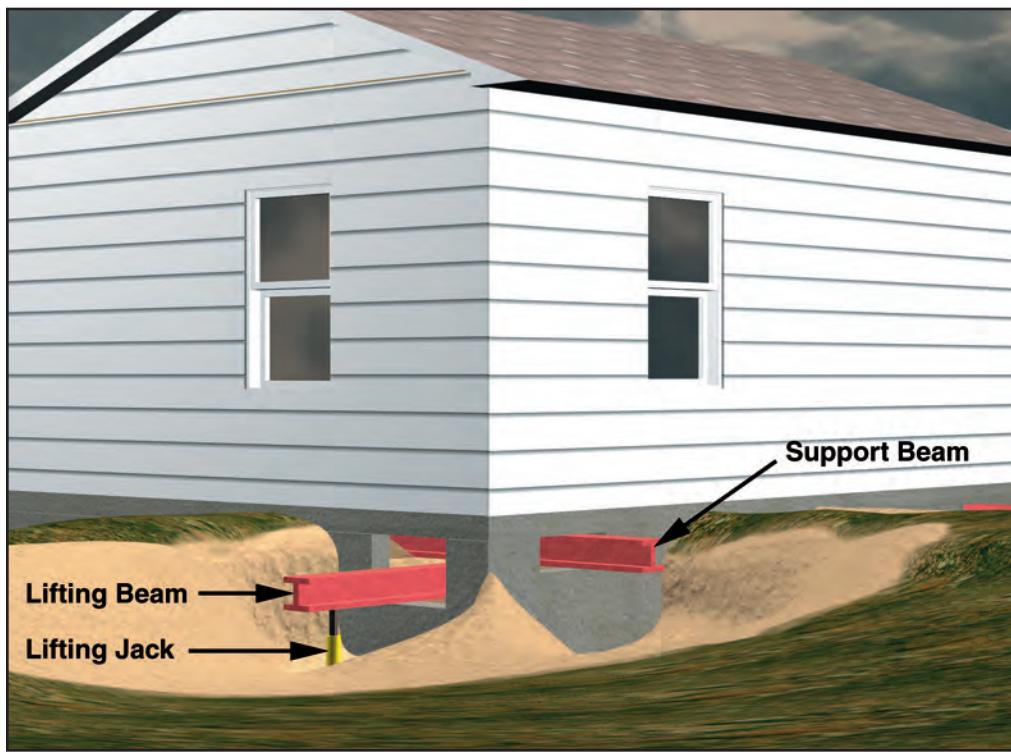
Figure 18

With I-beams and jacks in place, the house is ready to be lifted.

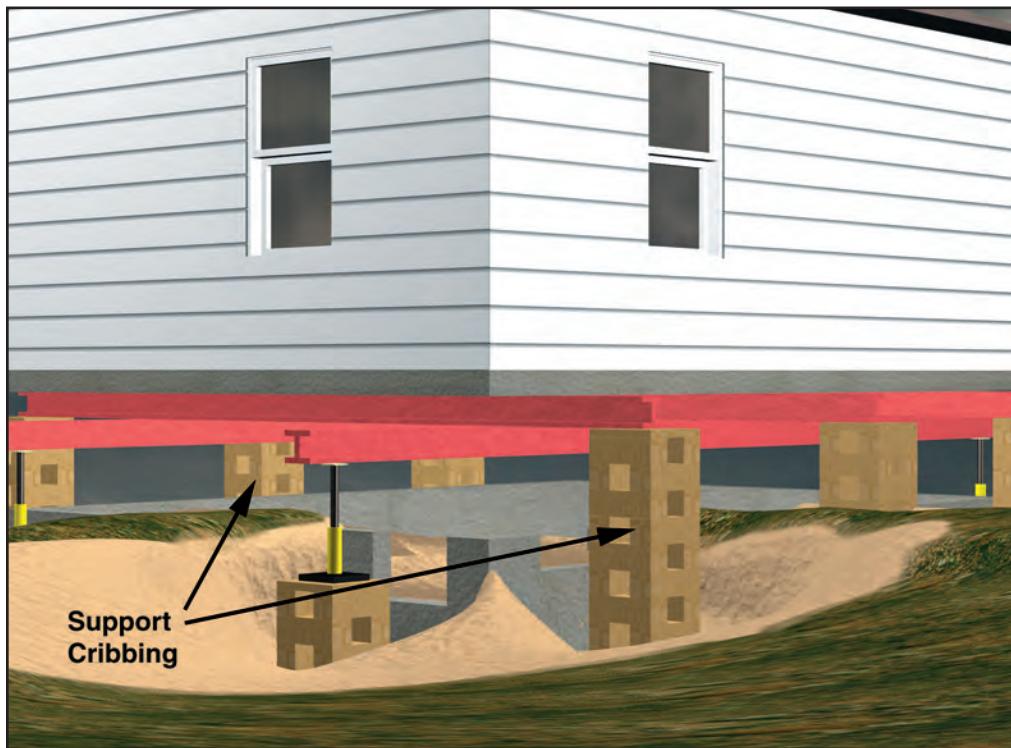
The house is temporarily supported on cribbing.

The house is then jacked up. When the jacks have extended as far as possible, the house must be supported temporarily while the jacks are raised. Both the house and the jacks are usually supported on “cribbing”—temporary piles of crisscrossed timbers (Figure 19). The jacks are then used to raise the house higher.

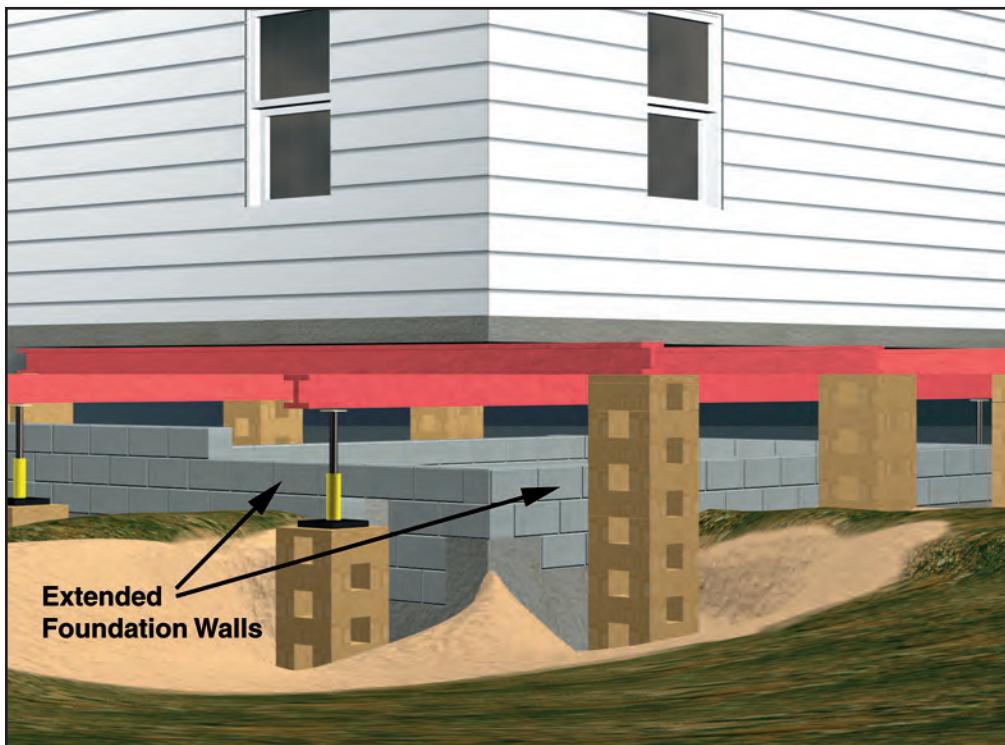
Figure 20
New, extended foundation walls are constructed with concrete blocks.

This process is repeated until the house is raised to the desired height. The foundation walls are then extended upward with additional rows of concrete block (Figure 20). As in the previous techniques, openings are made in the walls within 1 foot of the ground so that flood waters will be able to flow into and out of the area below the elevated floor. The jacks and beams are removed, and the openings left around the beams are filled with blocks (Figure 21).

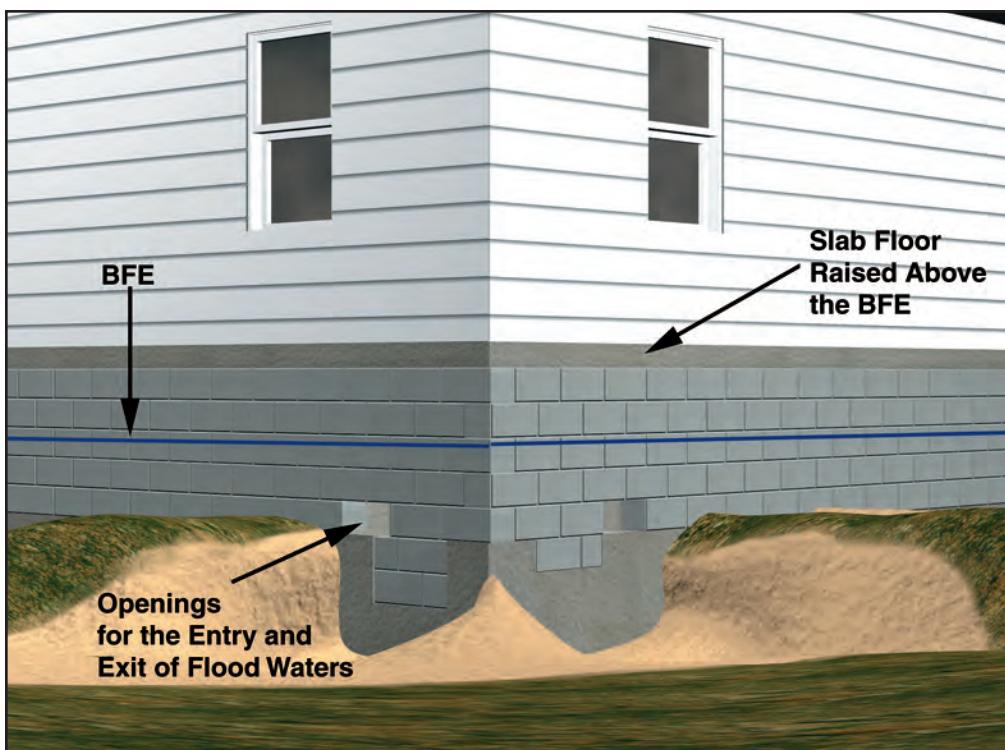
Figure 21
Elevated house and slab on new, extended foundation walls.

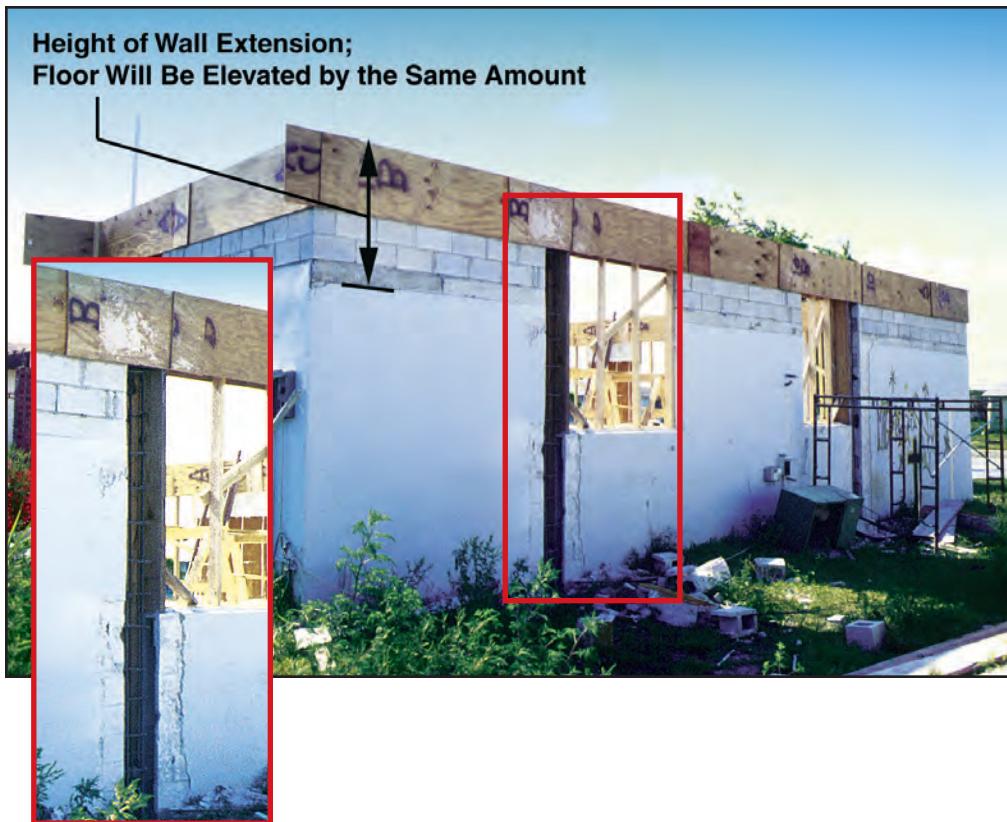
Another view of the extended walls. The vertical cuts in the walls next to the windows are for concrete tiedown columns that will be cast in place to further strengthen the extended walls against wind loads. The owner of this house was able to meet the elevation requirement by raising the floor only a few feet, as indicated by the amount that the walls have been extended.

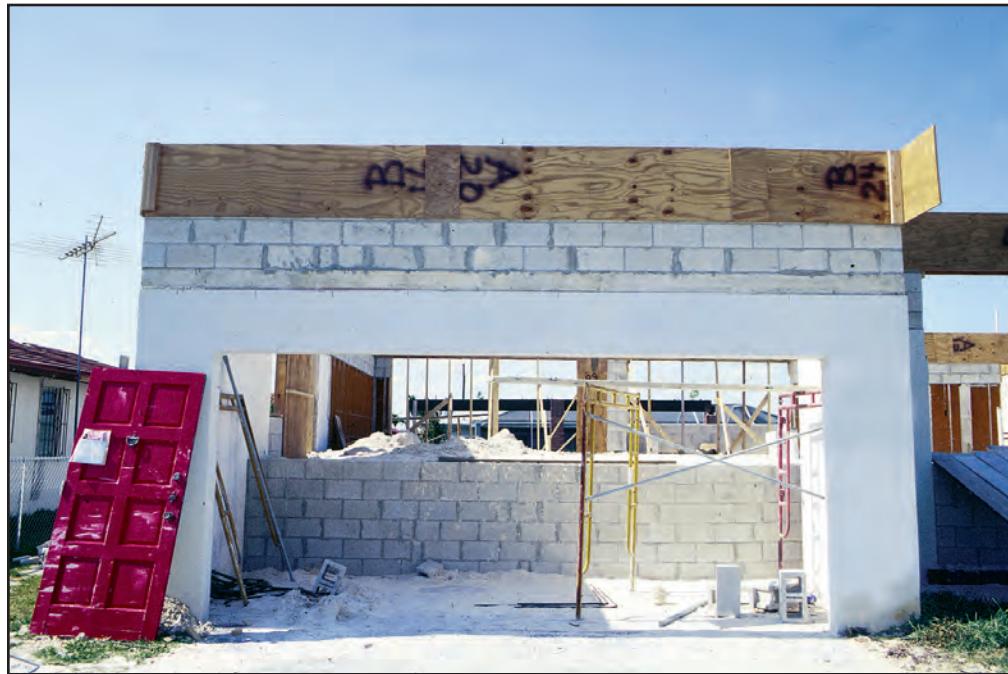
Figure 25

This view through the garage door reveals the different levels of the elevated slab floor, in the background, and the unelevated garage floor.

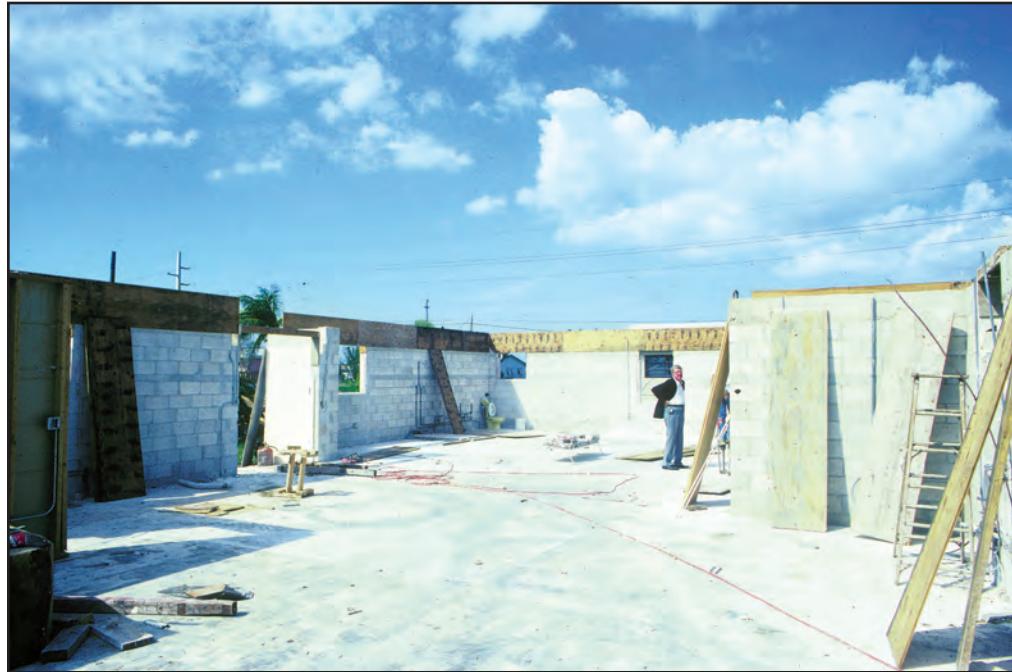
Figure 40

After the roof was removed and the storm-damaged interior gutted, the walls of the house were extended upward and a new bond beam added at the top.

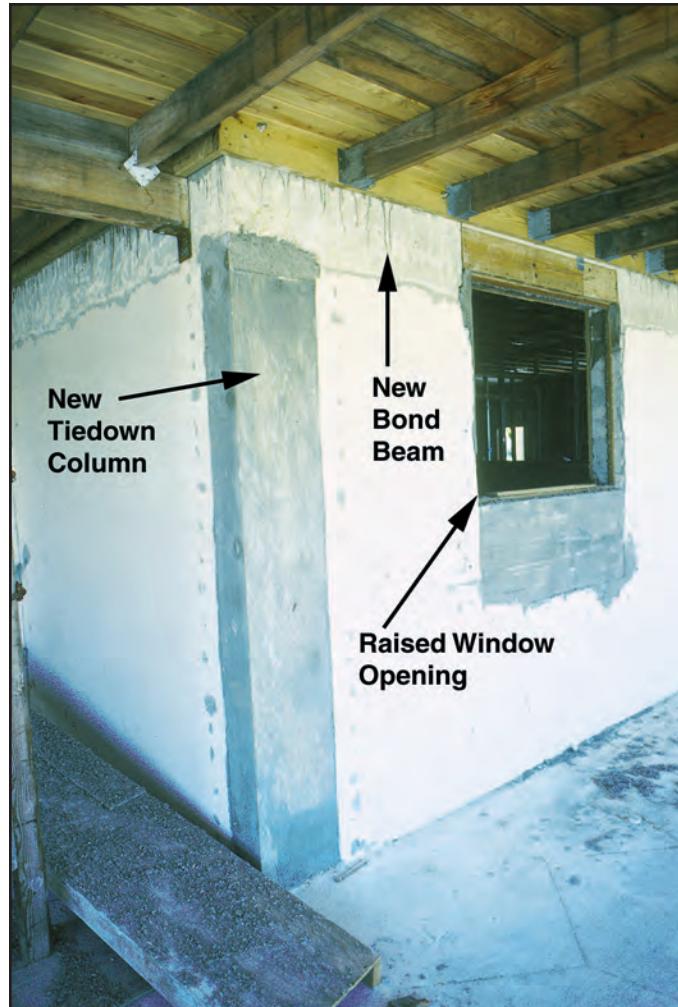
**Figure 41**

Note the new bond beam at the top of the extended wall, the new concrete tiedown column at the corner, and the raised window opening.

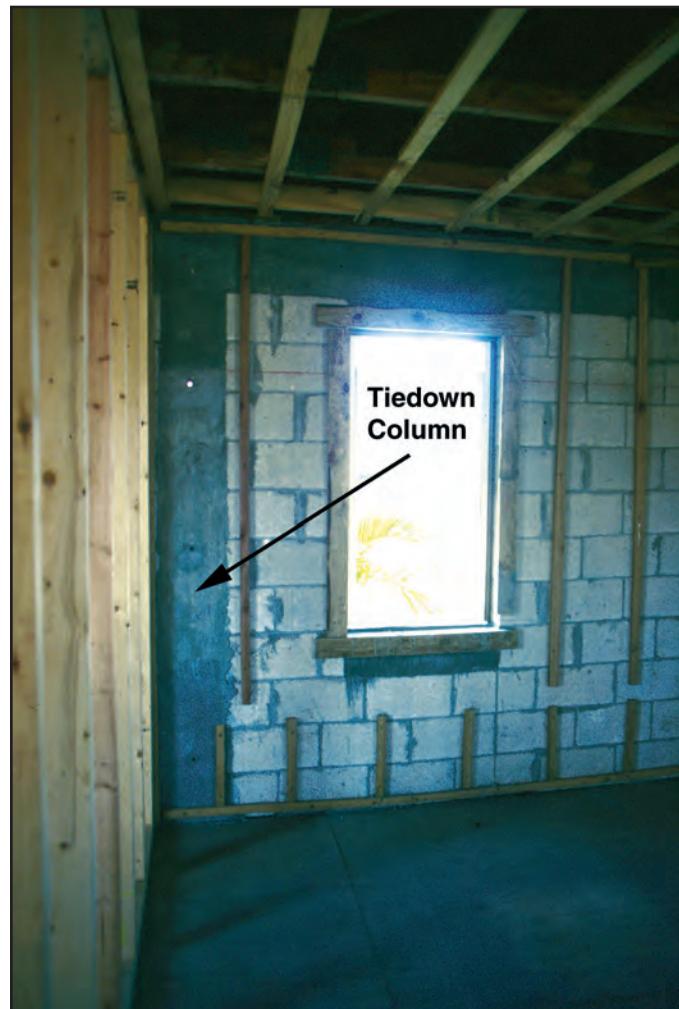
Figure 46
Concrete tiedown
columns, such as the one
to the left of the window
in this photograph, were
also used in this house.

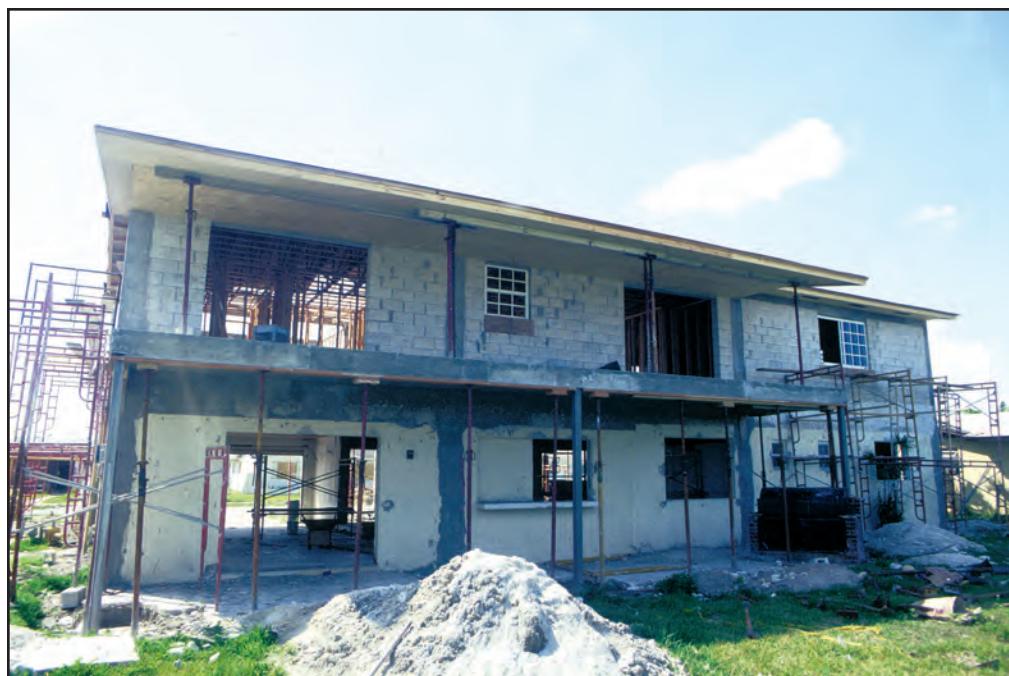
Figure 47
The tiedown columns
extend down from
the new second-story
walls and into the
original first-floor
walls. The columns tie
the first and second
stories together and
provide a continuous
load path that helps
the house resist the
forces of high winds.

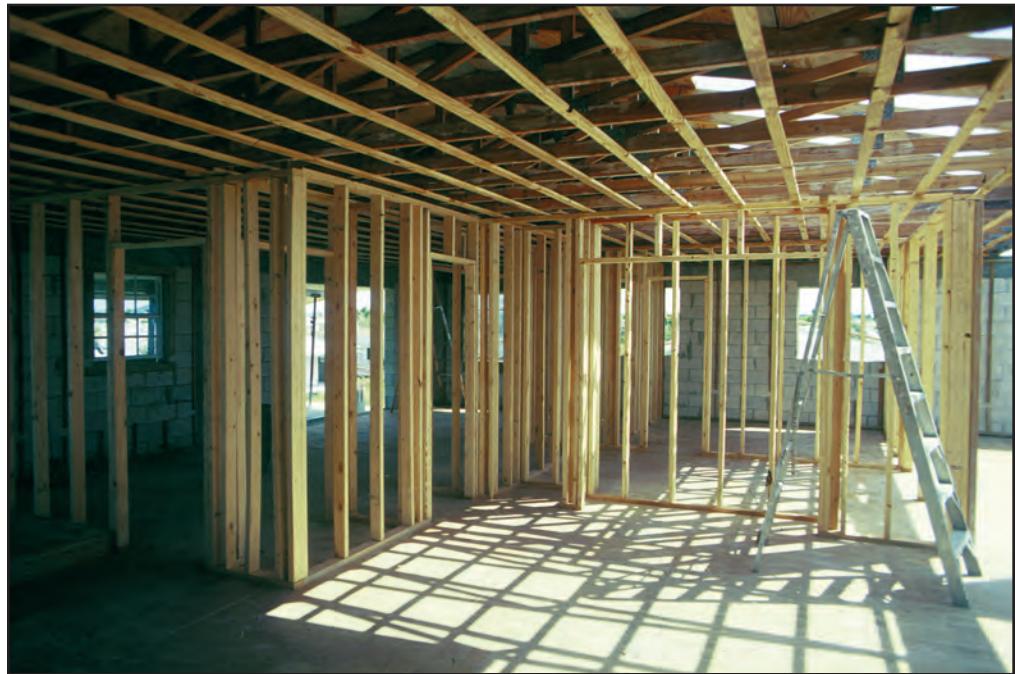
Figure 48

Wood 2 by 4 studs were used to frame the interior walls of the second story.

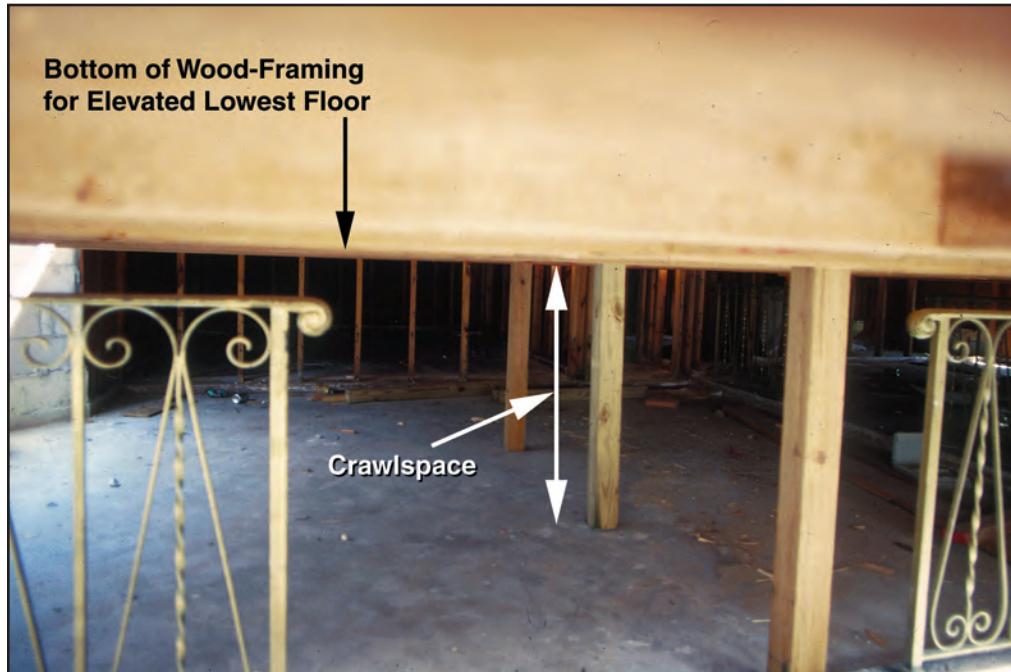
Figure 68

Rather than install a new concrete slab on compacted fill, the owner of this house chose to build a new wood-frame floor above the old concrete slab. This method creates a crawlspace below the new floor.

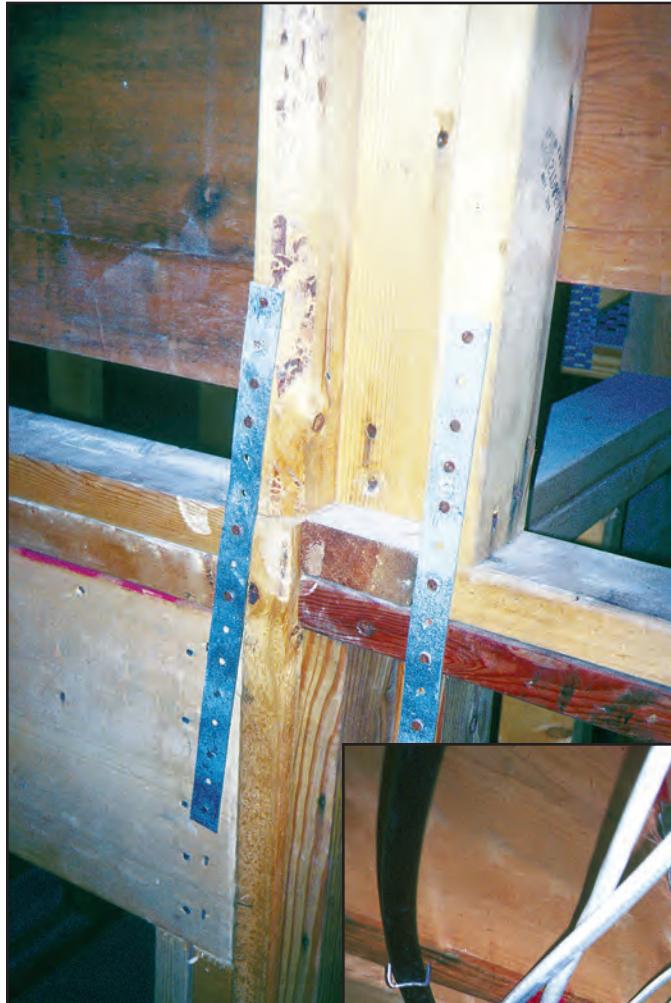
Figure 70

Metal hurricane straps are used to tie the structural members together and create a continuous load path from the roof to the foundation.

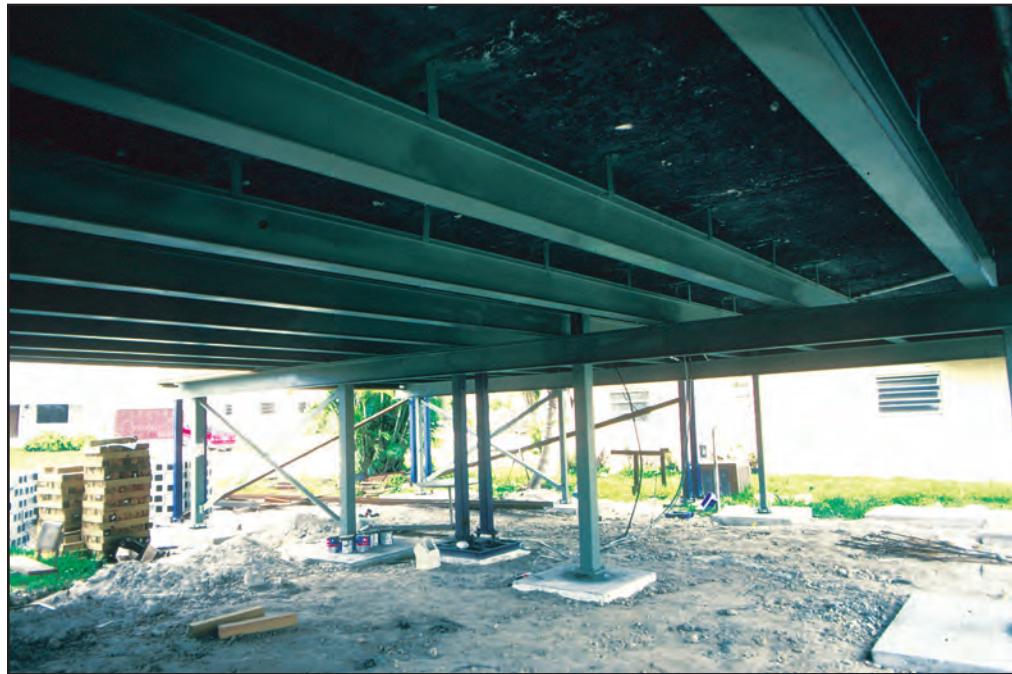
Figure 82

While the jacks and beams supported the house, new steel foundation members were installed below.
