## MEMORANDUM

DATE: December 12, 2019

SUBJECT: Bastrop Corridor Study – Analysis of Safety Performance

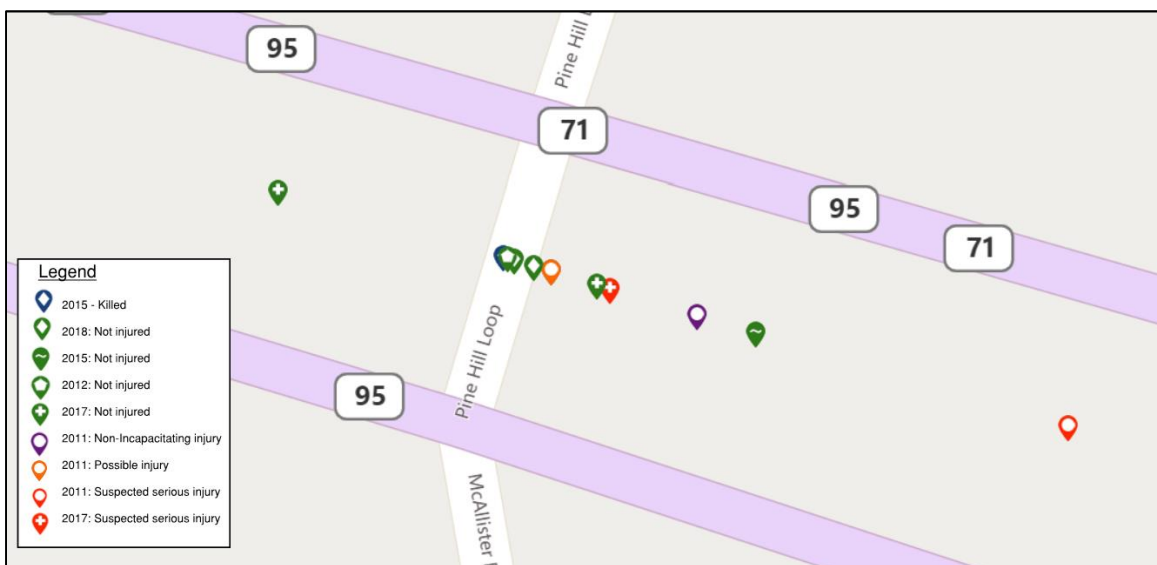
**Figure 2: Collisions at SH71 and McAllister Road/Pine Hill Loop, 1/1/11-7/30/19 (Source: CRIS)**

During the study period, 11 collisions occurred in the vicinity of SH 71 and McAllister Road/Pine Hill Loop. Two of these were injury crashes and one was a fatal crash.<sup>3</sup> The fatal collision occurred on a Wednesday around 9:00 pm due to a northbound motorist at the McAllister Road stop sign failing to yield the right-of-way to an eastbound SH 71 vehicle.

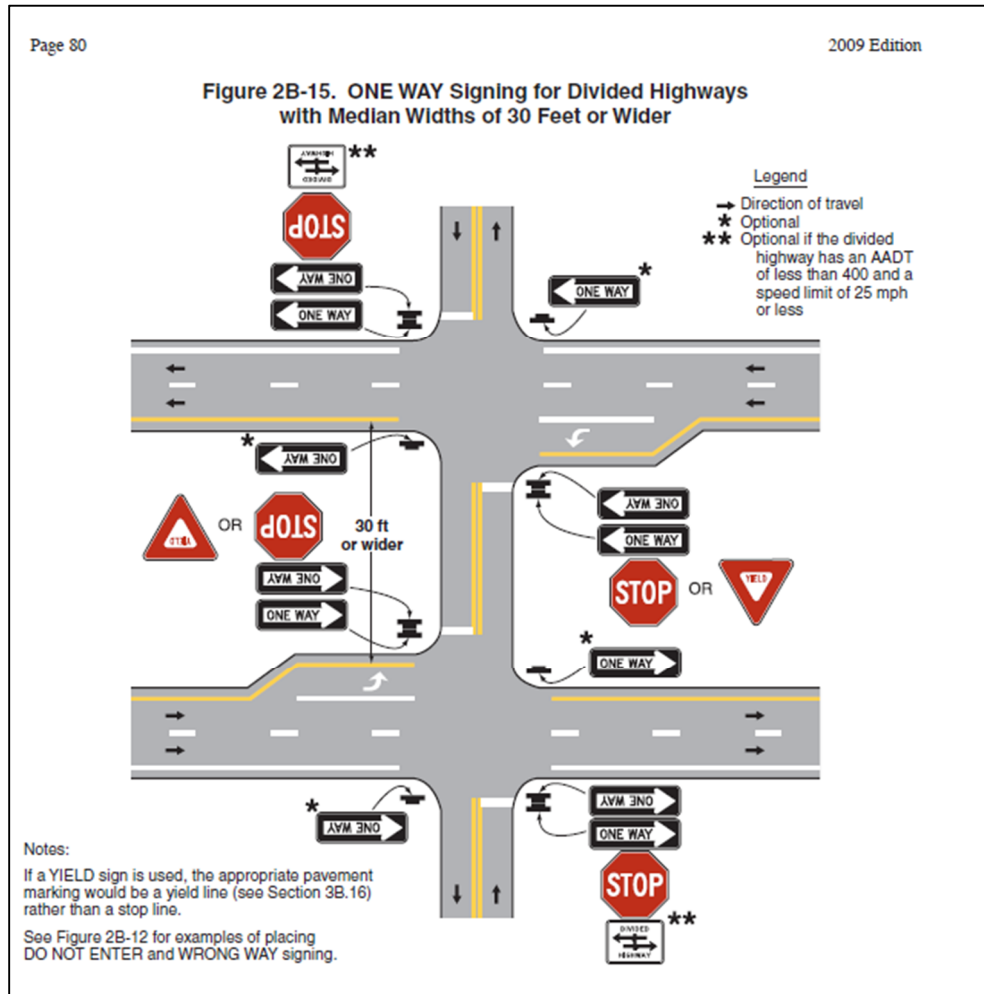
**Figure 5: ONE WAY Signing for Divided Highways  
(Source: TMUTCD, 2011 Edition, Revision 2)**

- Two ONE WAY (R6-1) signs appear to be missing below the Yield signs within the median. Refer to **Figure 3** for a photo at this location and **Figure 5** in the next section for the TMUTCD standard sign package.
- The DO NOT ENTER (R5-1) signs for McAllister Road motorists looking left along SH 71 are faded (see **Figure 4**).
- Both side street approaches have potential sight distance issues based on the vertical curve and current 75 mph posted speed limit of SH 71 (see **Figure 4**). Current TxDOT Roadway Design Manual standards require 820 feet of design stopping sight distance at 75 mph.<sup>5</sup>

- Install street name sign at SH 71 / McAllister Road intersection
- Install/replace ONE WAY signing for divided highways in accordance with TMUTCD per **Figure 5**. Utilize larger ONE WAY signs (54" x 18") due to the distance from the intersection to the median and approach speeds along SH 71.

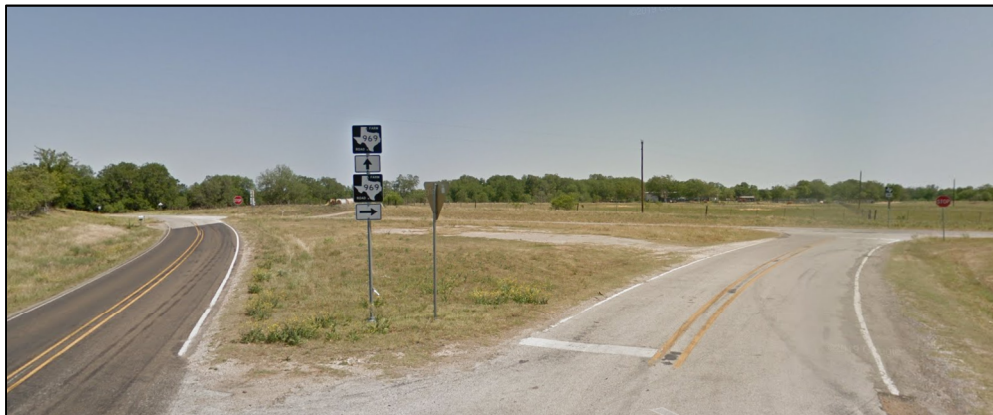
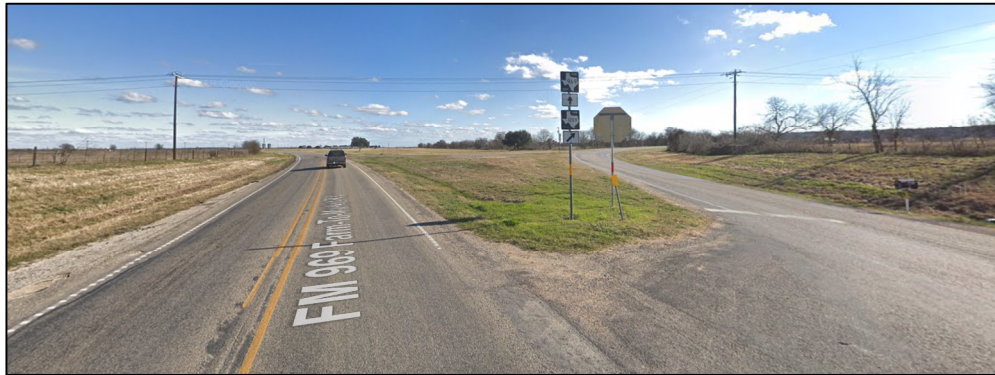
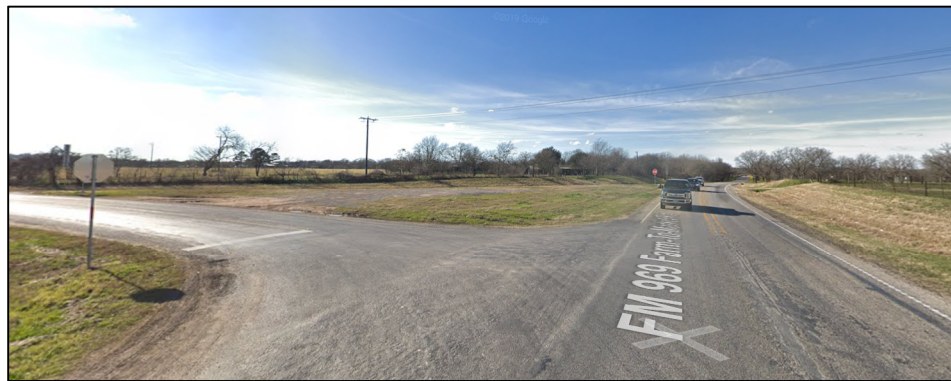
The intersection of FM 1209 and FM 969 is a large, Y- intersection, as illustrated in the figures below.

Researchers visited this intersection and observed the potential for high-speed collisions due to the geometry. It is likely that this intersection performed adequately under low-volume conditions, but as potential conflicts increased, high speeds and awkward viewing angles (due to the Y-configuration) have contributed to crashes.

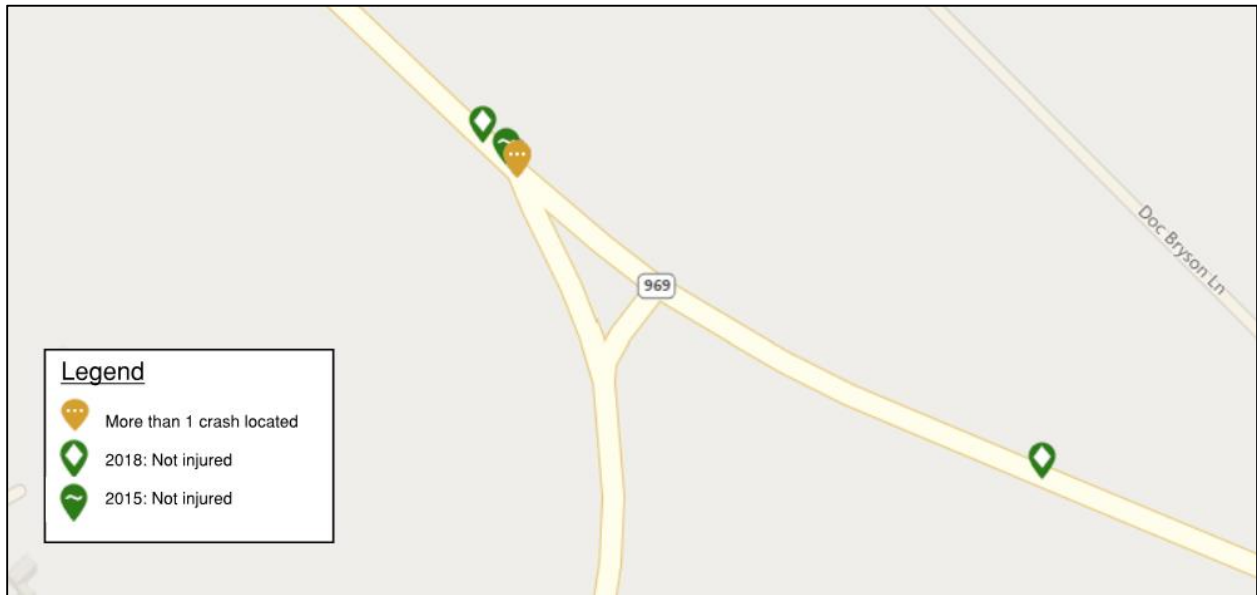
**Figure 19: Collisions at FM 1209 and FM 969 Intersection, 1/1/11-7/30/19.<sup>22</sup> (Source: CRIS)**

Between January 2011 and July 2019, 34 collisions have occurred in the vicinity of FM 1209 and FM 969, where 24 of them were intersection related. One collision that resulted in multiple fatalities was non-intersection related. **Table 6** provides an overall summary of the collision data by year and severity.

Most injury-involved collisions occurred during night-time conditions. There is no existing street/intersection lighting present. There were no distinct patterns in collision type, contributing factors, or roadway characteristics for injury related and fatal collisions. According to the online crash data, there was one fatal collision in 2017, where a motorist swerved and hit a nearby fence.

Approximately 71% of the collisions occurred at intersections (29% occurred on roadway segments). Most intersection-related collisions were caused by motorists losing control, slowing-or-stopping, and/or overturning. The Y-intersection design may contribute to higher-than-typical speeds for turning vehicles (compared to orthogonal designs) within the intersection.

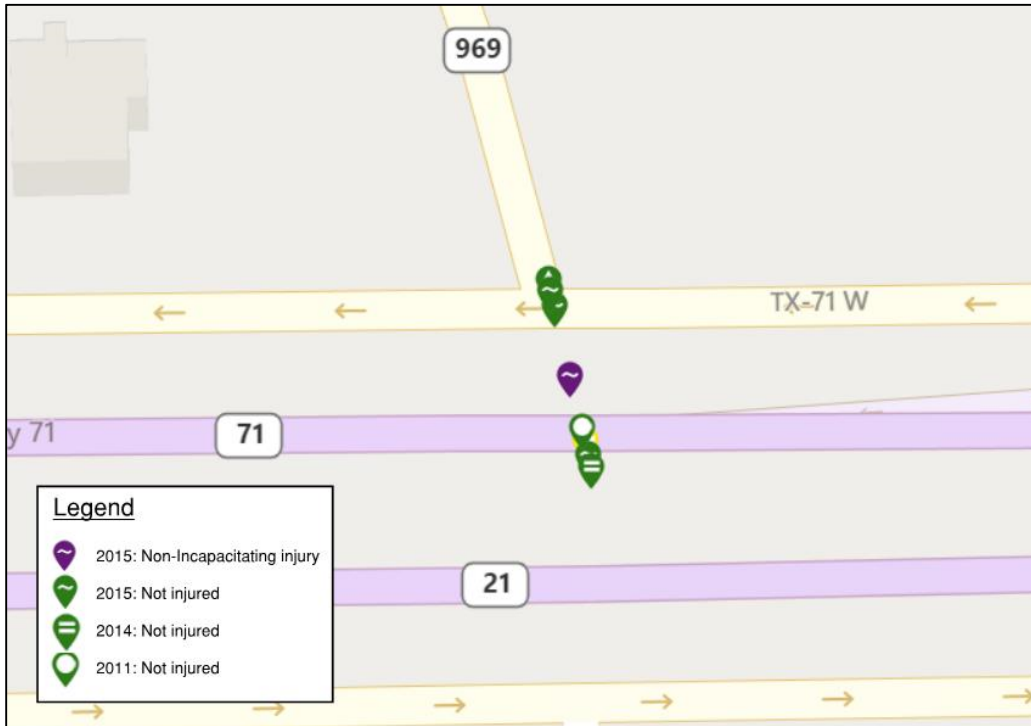
Figure 21: Collisions at FM 969 and SH 21/71 Frontage Road, 1/1/11-7/30/19 (Source: CRIS)

Between January 2011 and July 2019, seven collisions have occurred in the vicinity of FM 969 and SH 21. Of those, none caused injuries. Approximately 72% of all crashes occurred under clear or cloudy skies. The pavement was dry for all crashes. Approximately 57% of crashes occurred in the dark where street lighting was not present. **Table 9** summarizes the collision types by year.

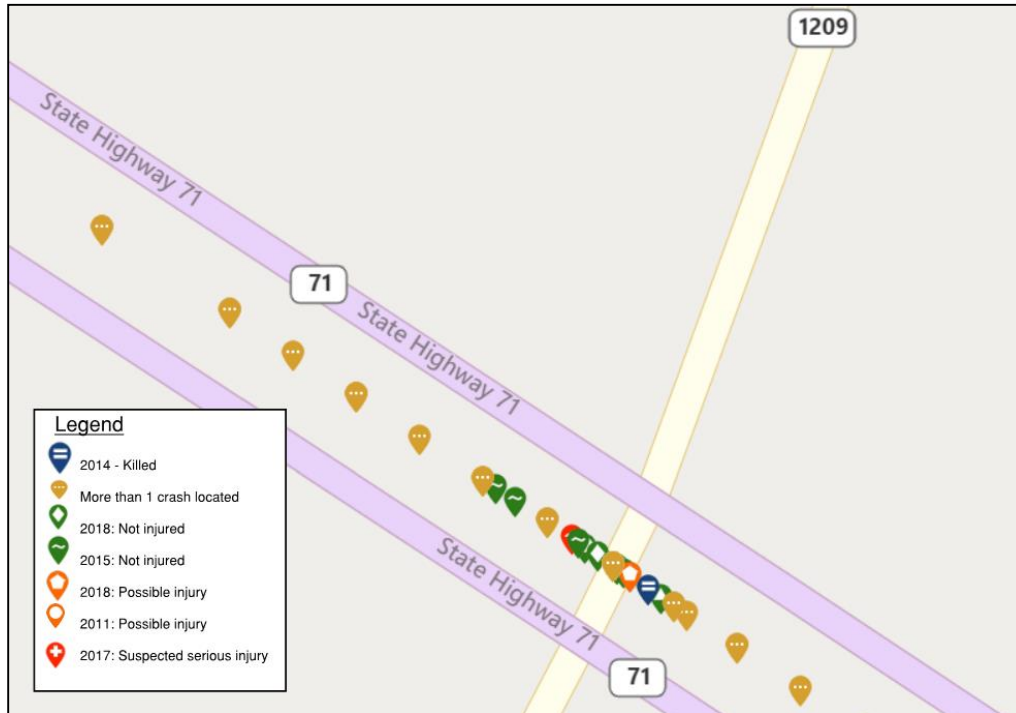
**Figure 24: Collisions at FM 1209 and SH 71 Intersection, 1/1/11-7/30/19<sup>27</sup>** (Source: CRIS)  
 Between January 2011 and July 2019, 259 collisions occurred at the intersection of FM 1209 and SH 71. The table below displays the collisions by year and severity.
